# Mechanical properties and mesoscopic analysis of rock-backfill-rock composite sample under dynamic loading

## Abstract

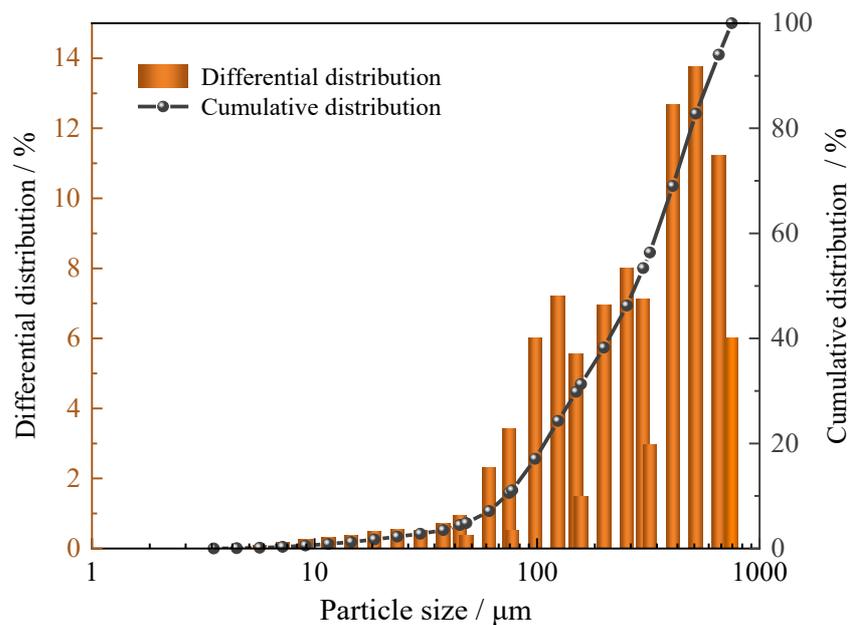
**Figure 1** Unclassified tailings particle size distribution curve

Materials used in this work consist of unclassified tailings, binders, and water. The unclassified tailings used in the test were from a gold mine in China, and the density of the tailings was  $2.34 \text{ g/cm}^3$  with a weight-specific surface area of  $39.595 \text{ m}^2/\text{kg}$ . Before the test, the unclassified tailings were dried, and then the particle size was analysed by the LS-POP laser particle size analyser. Figure 1 shows the particle size distribution curve of the unclassified tailings. The  $d_{50}$  of the unclassified tailings is  $321.3 \mu\text{m}$ , coarse tailings according to the tailings distribution classification (Cao et al. 2021), and the inhomogeneity coefficient  $C_u=5$  for the unclassified tailings.

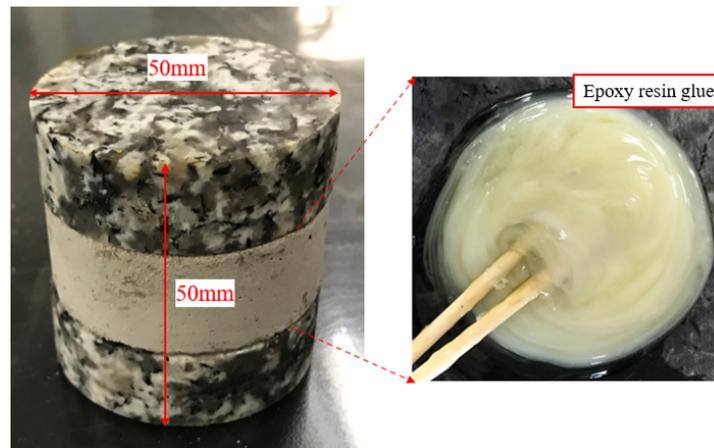
**Figure 2 RBR sample preparation process**

The design sample in this paper is a rock-backfill-rock three-layer combination sample. Due to the difficulty of processing, the height-to-diameter ratio of the RBR sample is chosen to be 1, i.e., the height of the RBR is 50 mm, and the diameter is 50 mm. The height of the rock is 15 mm, and the height of the CPB is 20 mm. The cement-sand ratio of the CPB is 1:4, the slurry concentration is 75%, and the curing age is 28 days.

Nunes et al. (2022) have shown that epoxy resin glue can characterise rock mechanical behaviour well. Therefore, the test used epoxy resin glue to combine the CPB with rock. The preparation process of the RBR sample is shown in Figure 2.

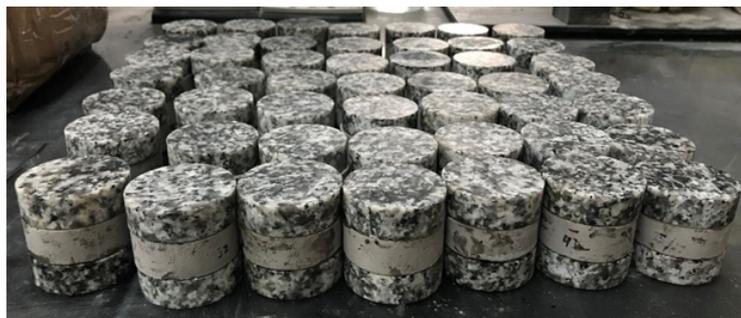
**Figure 3 RBR samples**

The SHPB test was carried out on the RBR sample with different impact amplitudes of 50, 75, 100, 125, 150, and 175 mV, and three sets of tests were repeated for each impact amplitude. Figure 3 shows all the RBR samples prepared in this paper. The test number is named “Y-Impact Amplitude - Serial number”; for example, Y-100-2 represents the second test of the RBR sample at an impact amplitude of 100 mV.

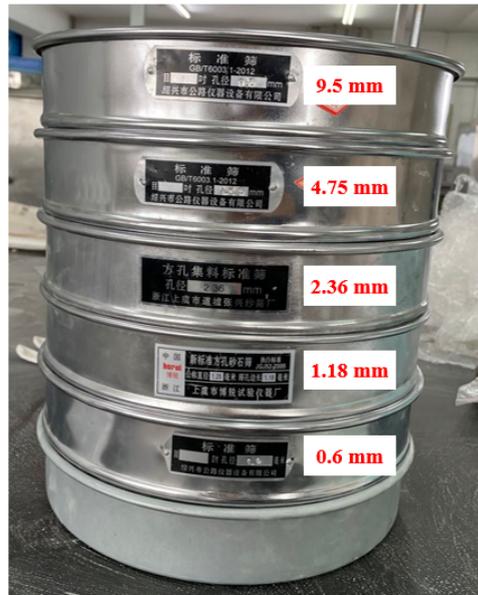
**Figure 4** A set of standard sieves

A set of standard sieves was selected to sieve the broken pieces of RBR samples after the damage of the SHPB test. The aperture sizes of the standard sieve are 9.5 mm, 4.75 mm, 2.36 mm, 1.18 mm, and 0.6 mm, and Figure 4 shows the standard sieve diagram. Since the samples were scattered around after the SHPB test, 100% of the damaged samples could not be collected. The individual sieving results were not weighed and could not be quantitatively analysed. Therefore, the macroscopic damage morphology of the RBR samples was mainly described qualitatively.

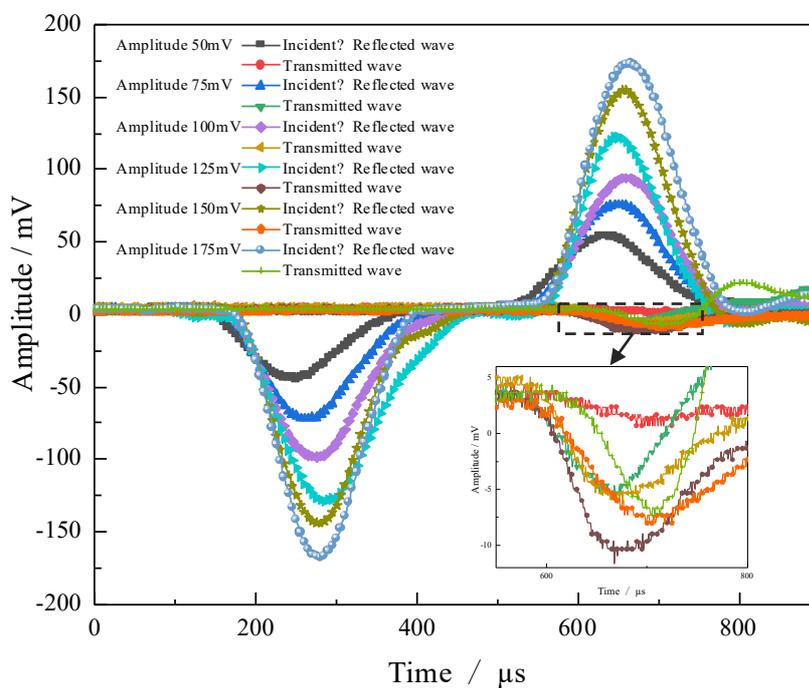
**Figure 5** Initial waveform of RBR samples

The initial waveforms of the RBR samples at different impact amplitudes of 50, 75, 100, 125, 150, and 175 mV are shown in Figure 5. According to the initial waveform diagram, the magnitudes of the incident and reflected waves are similar in magnitude and opposite in direction. The amplitude of the transmission wave is very small, which means that the stress wave is received less by the transmission bar after passing through the RBR sample, only a small part of the energy passes through the RBR sample, and most of the energy is reflected.

This effect is due to the significant difference in wave impedance between the granite, CPB, and metal bar of the SHPB device. The variation of wave impedance strongly influences the propagation of stress waves. When the stress wave propagates into two media, the wave impedance of the media differs. Therefore, regardless of increasing or decreasing, the energy of the incident wave cannot be fully propagated from one medium to the other. When the stress wave propagates in the RBR samples, it undergoes several wave impedance changes, so the transmission wave energy is minimal.

- (1) In the initial waveform of the RBR sample, the directions of the incident wave and the reflected wave are opposite, the impact amplitude is similar, and the transmission wave amplitude is minimal.

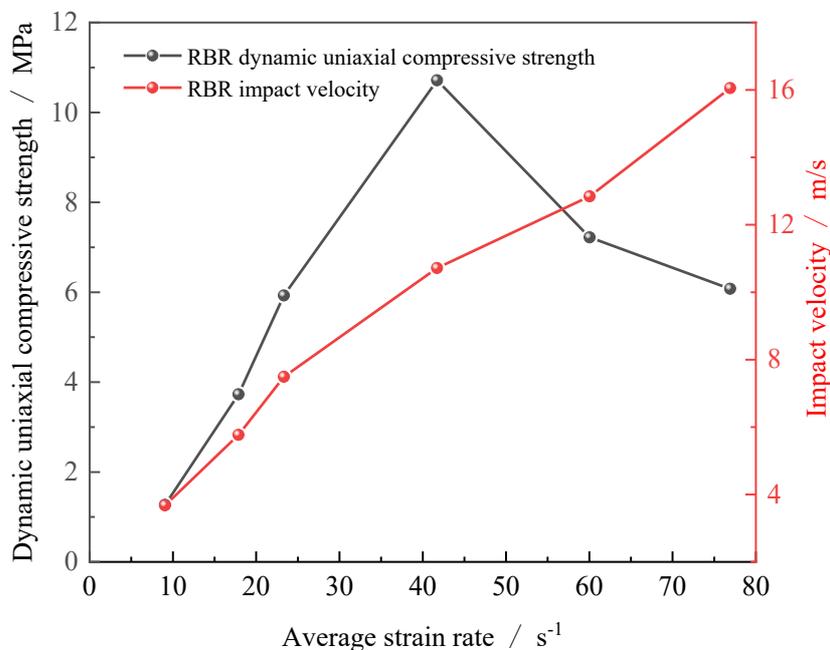
**Figure 6 The relationship between average strain rate and impact velocity and dynamic uniaxial compressive strength of RBR samples**

Figure 6 shows the relationship between the average strain rate of RBR samples and impact velocity and dynamic uniaxial compressive strength. With the increase of the average strain rate, the impact velocity of the RBR sample increases, reaching a maximum of 16.06m/s. The dynamic uniaxial compressive strength of the RBR sample increases first and then decreases with the increase of the average strain rate. When the average strain rate is less than 41.72s<sup>-1</sup>, the dynamic uniaxial compressive strength of the RBR sample increases rapidly with the increase of the average strain rate, and the maximum is 10.72MPa. When the average strain rate is greater than 41.72s<sup>-1</sup>, the dynamic uniaxial compressive strength of the RBR sample decreases, and the decreasing trend tends to be gentle. When the impact velocity is 16.06m/s, and the average strain rate is 76.92s<sup>-1</sup>, the dynamic uniaxial compressive strength of the RBR is reduced to 6.08MPa. Energy dissipation occurs after the stress wave passes through the four interfaces of the incident bar and rock, rock and CPB, CPB and rock, and rock and transmission bar. Therefore, the energy received by the transmission bar is very low. Energy escapes from the interface, separating the parts of the assembly.

- (2) The impact velocity of RBR samples is positively correlated with the average strain rate, and the strain rate effect exists in the RBR samples. When the average strain rate is  $41.72 \text{ s}^{-1}$ , the maximum dynamic uniaxial compressive strength is 10.72 MPa. When the average strain rate is greater than  $41.72 \text{ s}^{-1}$ , the strain rate effect decreases.

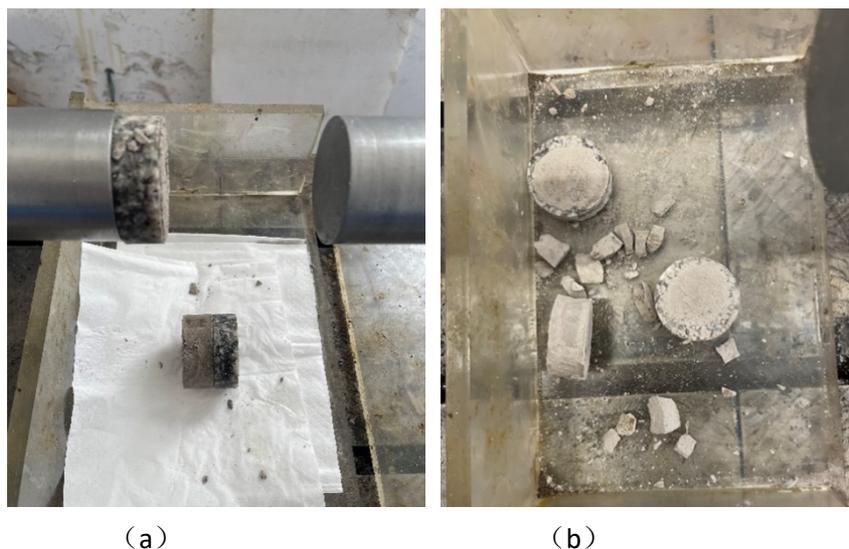
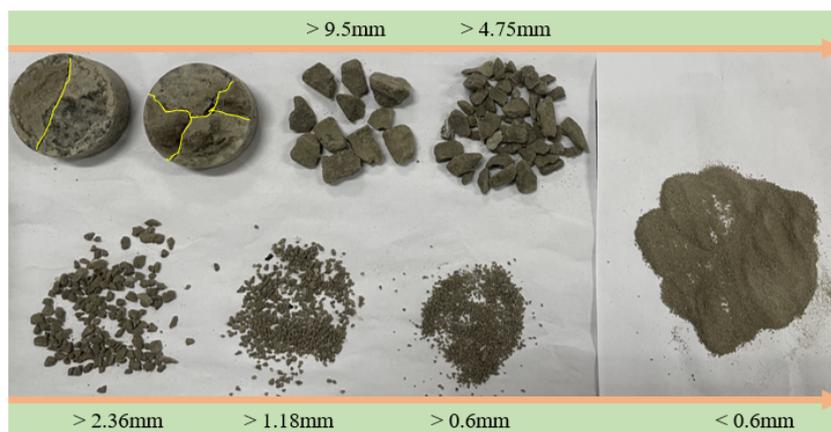
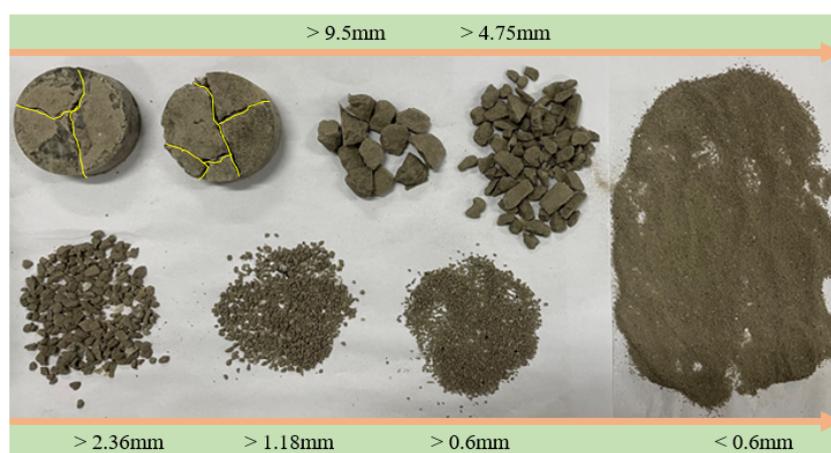
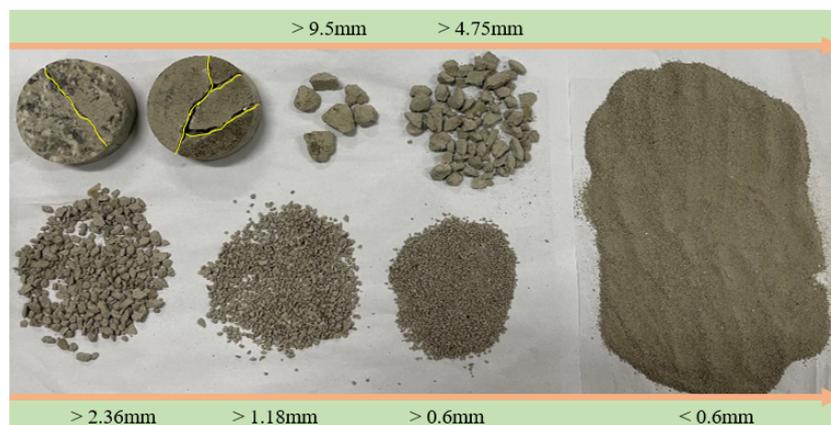
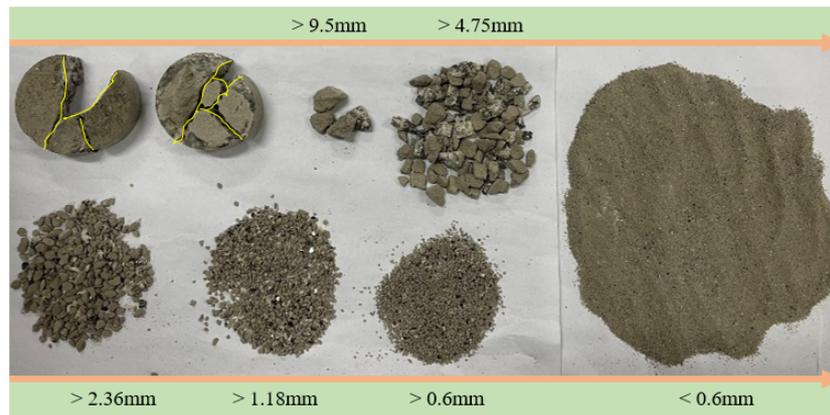
**Figure 7 Sieving of RBR samples after SHPB test. Impact amplitude (a)50 mV; (b)75 mV; (c)100 mV; (d)125 mV; (e)150 mV; (f)175 mV**

Figure 7 shows the photos of the RBR sample after impact crushing, where (c) to (f) are the results after screening with the sieve. It can be seen from Figure 7 (a) that when the impact amplitude is 50 mV, the rock near the incident bar of the RBR sample is separated along the interface adjacent to the CPB. In contrast, the CPB is not separated from the rock near the transmission bar. All parts of the CPB and rock remain intact. During the falling process, the edge of the CPB sample is peeled off with debris. The analysis shows that when the stress wave passes into the RBR sample, energy dissipation occurs at the interface between the first rock and the CPB, resulting in the separation of the composite. The residual energy did not cause obvious macroscopic damage to the rock and CPB.

Figure 7 (b) shows the failure of the RBR sample when the impact amplitude is 75 mV and the CPB is separated from the rocks on both sides. The CPB sample was damaged, and some crushed particles fell around, but most of the CPB was intact and still had residual strength. The rock is partially intact with no macroscopic surface damage, which indicates that the energy dissipation of the stress wave at the interface between rock and CPB leads to the separation of RBR samples, and the reflected wave does not cause obvious damage to the rock, while the transmission wave enters the CPB and causes slight damage.

When the impact amplitude increases to 100 mV, the RBR samples are entirely separated, the rock part also has visible damage, and the CPB samples are broken without residual strength. Figure 7 (c) shows that the rock fragmentation degree is greater than the maximum value of the standard screen of 9.5 mm. The fragmentation degree of CPB is mostly greater than 9.5 mm and 4.75-9.5 mm.

When the impact amplitude increases to 125 mV, the screening diagram of RBR samples after failure is shown in Figure 7 (d). There is no significant difference in the fragmentation degree of CPB. However, the powder of the CPB less than 0.6 mm increased significantly, and visible damage occurred on both sides of the rock.

Figure 7 (e) shows the failure of the RBR sample under the impact amplitude of 150 mV. The fragmentation degree of CPB larger than 9.5 mm decreased obviously, and the powder CPB increased obviously. The fragmentation degree after rock failure is still greater than 9.5 mm.

We can see from Figure 7 (f) that when the impact amplitude increases to 175 mV, the rock damage increases significantly, and the rock sample cannot be restored. The rock lumpiness appears between 4.75-9.5 mm and 1.18-2.36 mm. The fragmentation degree of CPB is also significantly reduced.

- (3) Under a low strain rate (less than  $17.89 \text{ s}^{-1}$ ), the stress waves mainly dissipate at the interface, and the incident waves dissipate at the interface between the rock and the CPB. They resulted in the separation of the rock and the CPB. The reflected wave and transmission wave do not cause significant damage to the rock and the CPB. With the increase of the impact amplitude, the fragmentation degree of the CPB in the middle of the RBR decreases gradually, the crushed particles increase, and the granite is broken into small pieces from the complete form.

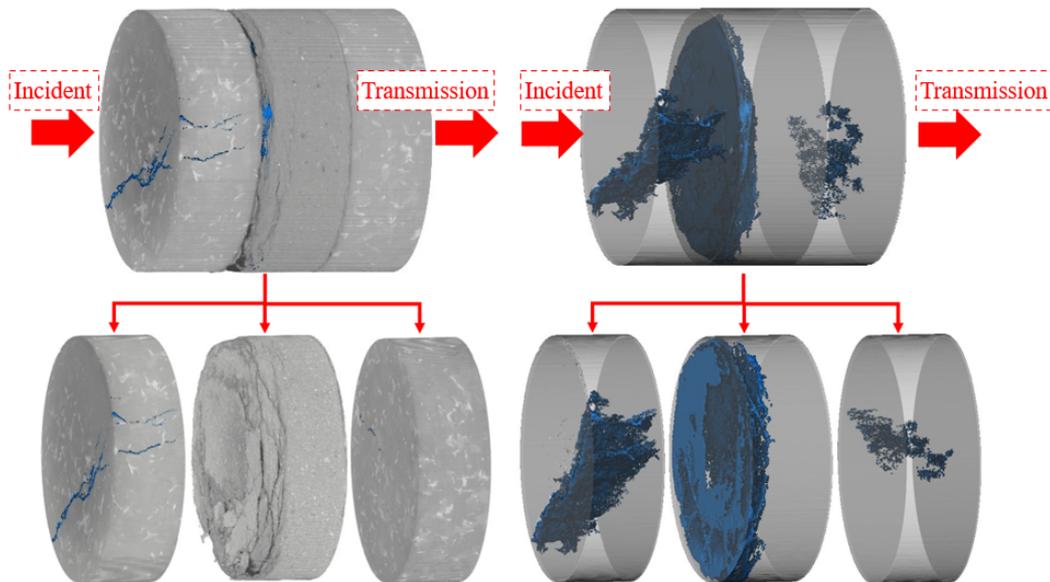
**Figure 8** 3D reconstruction of RBR

Figure 8 shows the 3D reconstruction of the RBR sample. We can directly observe that the rock near the incident bar separates from the RBR sample, and microcracks occur on its surface, but they are not fractured at the macro level. Moreover, the specific morphology of cracks at corresponding positions is shown on the right. The right side shows the specific morphology of the crack at the corresponding position. There is no apparent damage on the rock outside near the transmission bar. Micro cracks are on the rock's upper end, side, and inside. However, the microcrack width is minimal and does not penetrate through the rock, so its macroscopic morphology is complete. According to the crack morphology, the rock is mainly a shear failure. Damage occurs at the interface between the CPB and the rock near the incident bar, primarily manifested as a ring-layered crack, resulting in its separation from the rock near the incident bar. There is no damage inside the CPB. There is no apparent damage on the rock surface near the end of the transmission bar, but microcracks are inside.

When the stress wave passes through the RBR sample and reaches the transmission bar, the energy carried by the stress wave mainly acts on the interface between the rock and the CPB, resulting in the separation of the rock and the CPB at the incident bar. In addition, shear microcracks are formed in the rock near the incident bar. In this case, no apparent damage is caused to the interior of the CPB, only lamellar fracture occurs near the end face, and microcracks appear in the rock at the distal end of the transmission bar. This shows that most energy escapes from the interface between rock and CPB when dynamic load occurs. The rock near the incident bar is damaged by the superposition of the incident wave and the reflected wave energy of the CPB, but the transmission wave does not cause apparent damage to the CPB.

- (4) According to micro-CT results, after the SHPB test with an impact amplitude of 50 mV, significant amounts of damage in the RBR samples occur in the rock at the incident bar, which produces shear cracks. There is no damage inside the CPB, and an annular crack occurs at the end. There is no damage on the rock surface at the transmission bar, and microcracks are initiated inside.
