Design of a reliable pressure measurement method for paste backfill pipelines

C Lee WSP, Canada

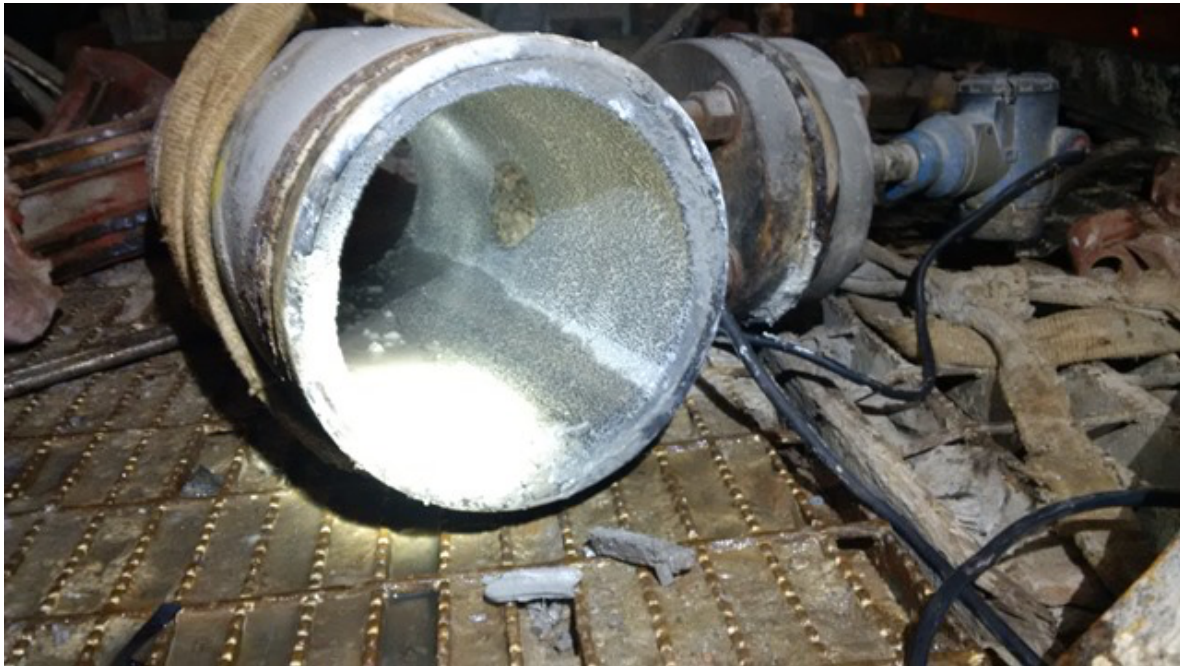
Figure 1 shows how a dead leg can be filled with cemented paste backfill material. This material, if strong enough, can form a rigid beam that bridges across the sensor head of the PIT and reduces the pressure that

Figure 1 Dead leg of pressure transmitter branch filled with cemented paste

In Figure 1, the sensor head is approximately 6 mm away from the inside diameter of the steel pipe. Since this particular pipe is lined with a ceramic lining that is 12 mm thick, the distance of the sensor head to the inside diameter of the lining is approximately 18 mm when the liner is not worn.

the sensor head can measure. The effect is noticeable when the underground distribution system (UDS) is empty, and PITs show residual pressure despite there being no pressure in the system.

- Dead leg filling with cemented paste results in residual pressures measured by the PIT. This failure mechanism seems clear and results from a thin wafer of cemented paste curing while under pressure during a long pour. When the pressure is removed, the wafer continues applying some pressure to the PIT diaphragm seal (sensor head), resulting in a residual pressure reading of the PIT when no load is applied.

- Dead leg filling with cemented paste results in improper readings measured by the PIT. In this case, the wafer of cemented paste works in reverse compared to the previous bullet item. The wafer acts as a beam which spans the PIT diaphragm and prevents the full load of the pipeline pressure from being applied to the sensor head. As a result, the measured pressure will be reduced compared to the actual pipeline pressure. It should be noted that both a residual pressure reading when the pipeline is empty and a reduced pressure reading when the pipeline is under pressure could apply from the same dead leg plug of cemented paste.

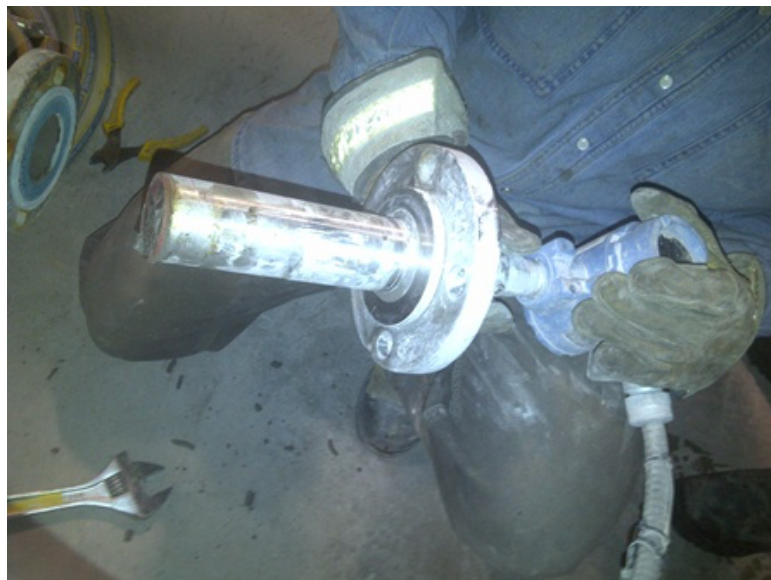
There have been many different attempts to solve this problem in the past. Figure 2 shows a PIT with a circular piece of 6 mm rubber lining that is epoxied to the face of the PIT sensor head. While this solution effectively reduces the replacement rate of PITs, it is ineffective at eliminating the dead leg effect.

Figure 2 Rubber-capped PIT

Even with this rubber lining, the life of the PIT was less than expected. This may be because the rubber lining rubbed away from the face of the PIT, with wear on the inside diameter of the pipe, and the offset distance from the rubber lining to the inside diameter of the pipe reduced.
