Stability assessment and ground support design for drifting through a cemented paste filled stope at the Big Gossan mine, Indonesia

This paper focuses on the process of developing a safe and stable drift through cemented paste fill (CPF) at PT Freeport Indonesia's Big Gossan mine which allows access to the Kucing Liar mine. The access drift was designed with dimensions of 5.5 m width and 6.5 m height with a length of 20 m through a CPF stope.

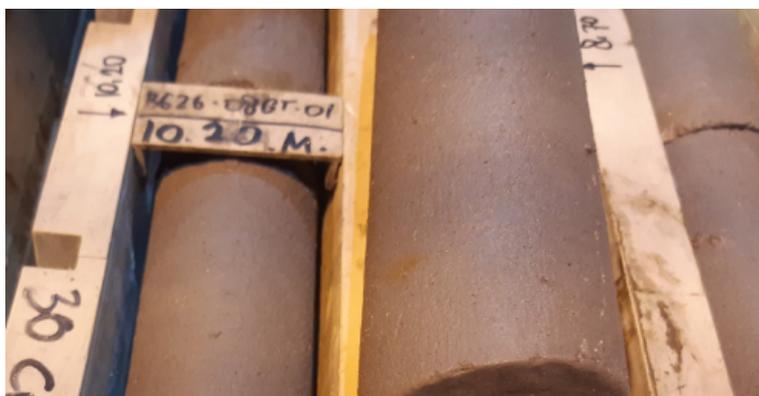
Figure 3 Cemented paste fill core samples

Drilling of the in situ fill material was conducted at the top crosscut of Stope A. The ground conditions were inspected in the field, and minimal rehabilitation was required prior to the drill rig setup. Given that the filled Stope A dimensions are 40 m high, 15 m wide and 49 m long, a 90° downhole (NX with 75 mm diameter) intersecting Stope A and B was planned in the centre of the stope. The core was visually inspected (Figure 3) and logged to identify any layering (e.g. cold joints). Samples with a minimum length of 20 cm at approximately 2 m intervals were collected. Field test data (penetrometer) and laboratory data (UCS, triaxial compressive strength [TCS] and density) were collected. Laboratory testing was conducted at a laboratory on site, as well as at two third-party laboratory facilities with a total sample size of 51.

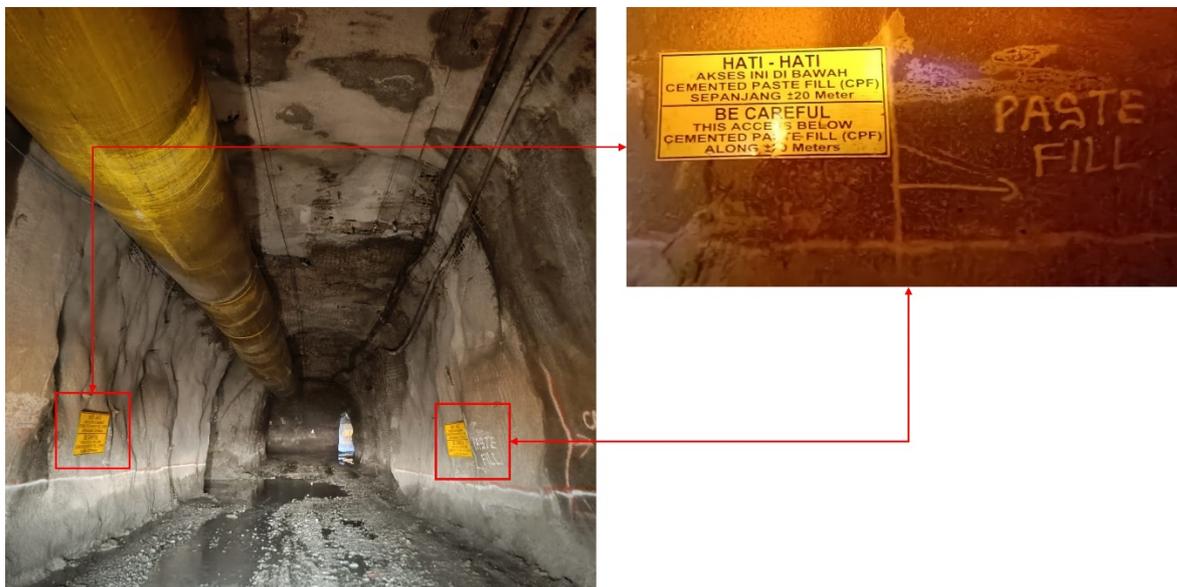
Figure 6 Cemented paste fill drift condition looking south after development and with signage

After completing the development, the CPF contact was demarcated within the drift, as illustrated in Figure 6. This will provide awareness to operations and personnel. In addition, the signage is used as a reference point to inspect the support conditions (brow to brow) and to ensure no heavy loads are suspended from the roof in the CPF drift.
