The development of the peg bolt

Bradley Darlington ^{a,*}, Matthew Farrington ^b, Osvaldo Vallati ^a

^a Sandvik, Australia

^b Fosterville Gold Mine, Agnico Eagle Mines, Australia

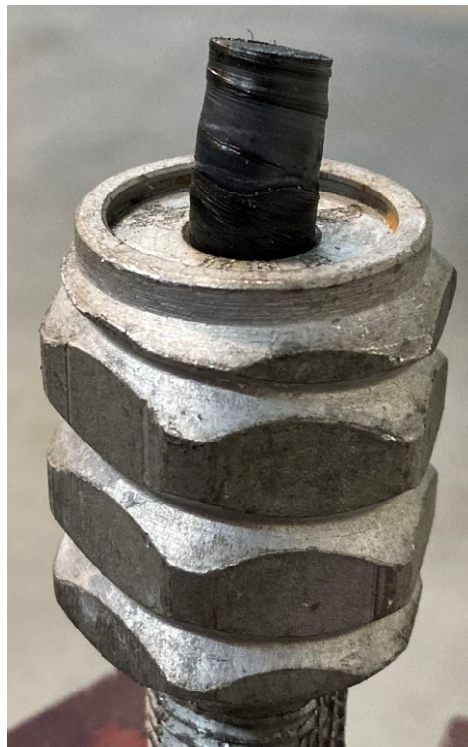
Figure 6 Extruded polyethylene peg

In contrast, the HDPE material extruded in a solid peg for the full test, and remained intact and secured to the blind nut, as shown in Figure 6. The HDPE disc was a clear standout and demonstrated excellent extrusion while maintaining structural integrity.

The torque comparison between the three sample sets was quite interesting, as shown in Figure 7. The UHMWPE reached an initially high torque within two rotations, but then reduced the torque at three rotations before peaking at four rotations. The PTFE also showed a similar initially higher torque before reducing towards 3.5 rotations. This reduction in torque seems to replicate the behaviour of the peg, where the initial solid extrusion requires a higher torque, and the torque reduces as the extruded peg loses solidity. The HDPE samples showed quite different behaviour, with a gradual increase in torque through the test and only a minor decrease at three rotations. This is reflected in the consistently solid extrusion of the HDPE peg as shown in Figure 6.

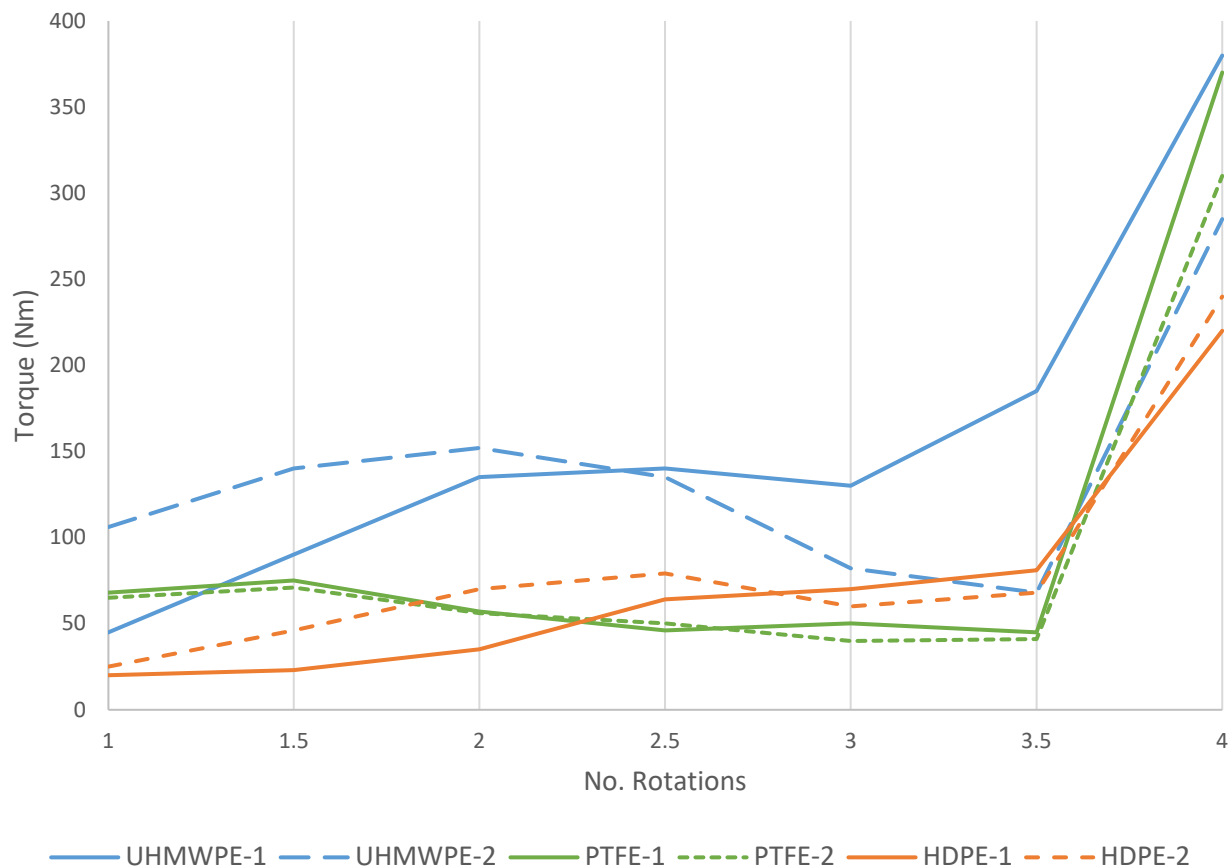
Figure 7 Rotations versus torque results

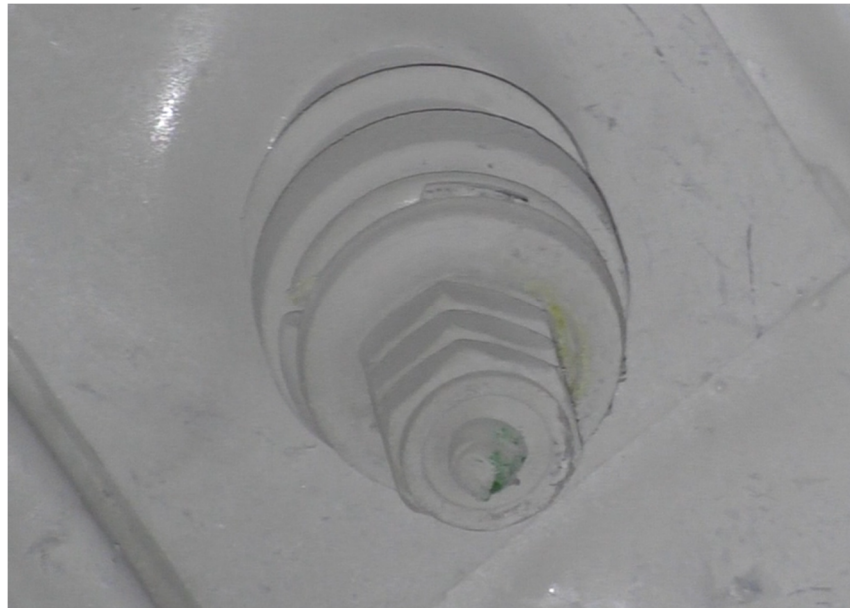
Figure 13 MD peg bolt still visible covered in blasting dust

This trial location allowed an inspection of the MD peg bolt after a full drill and blast cycle, where the dusty MD peg bolt was inspected the following day. This provided an insight into the visibility of the peg bolt after some time in the mining cycle, and as seen in Figure 13 the peg is still visible after drilling, blasting, bogging and application of shotcrete.

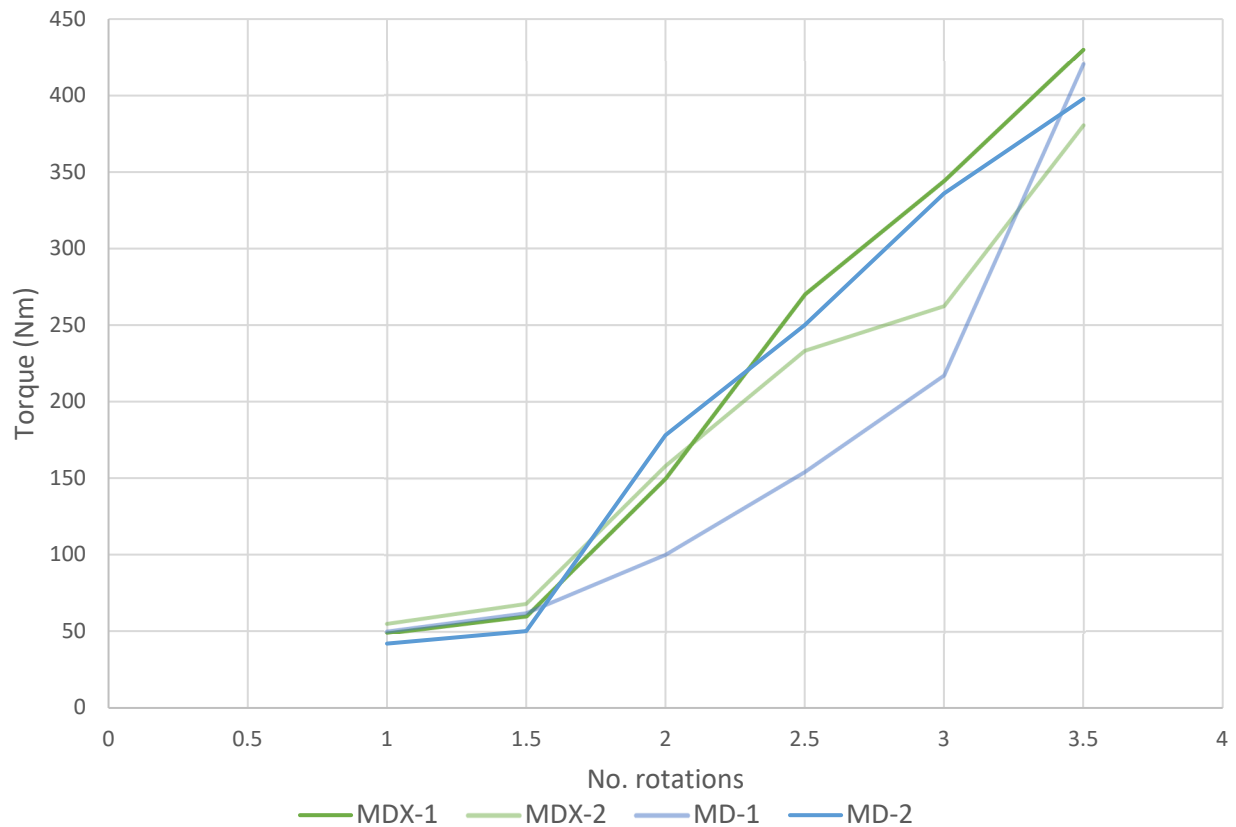
Figure 14 MD and MDX Peg torque readings

Additional testing was conducted on the two plastic peg discs (MDX-white and MD-green), to determine if there was a variance in the HDPE material. However, when both samples were tested under laboratory conditions, they both showed similar extrusion behaviour at similar torque values. The torque per rotation is shown in Figure 14 to demonstrate the steady increase in torque as the peg is extruded. The four samples at 2.5 rotations (233–270 Nm torque) are shown in Figure 15.
