Geotechnical instrumentation in high seismic risk tunnels and support replacement criteria

Carlos Moraga ^{a,*}, Cristóbal Bahamondes ^a, Daniela Pulgar ^b, Diego Romero ^a, Alejandro Muñoz ^a

^a Codelco, Chile

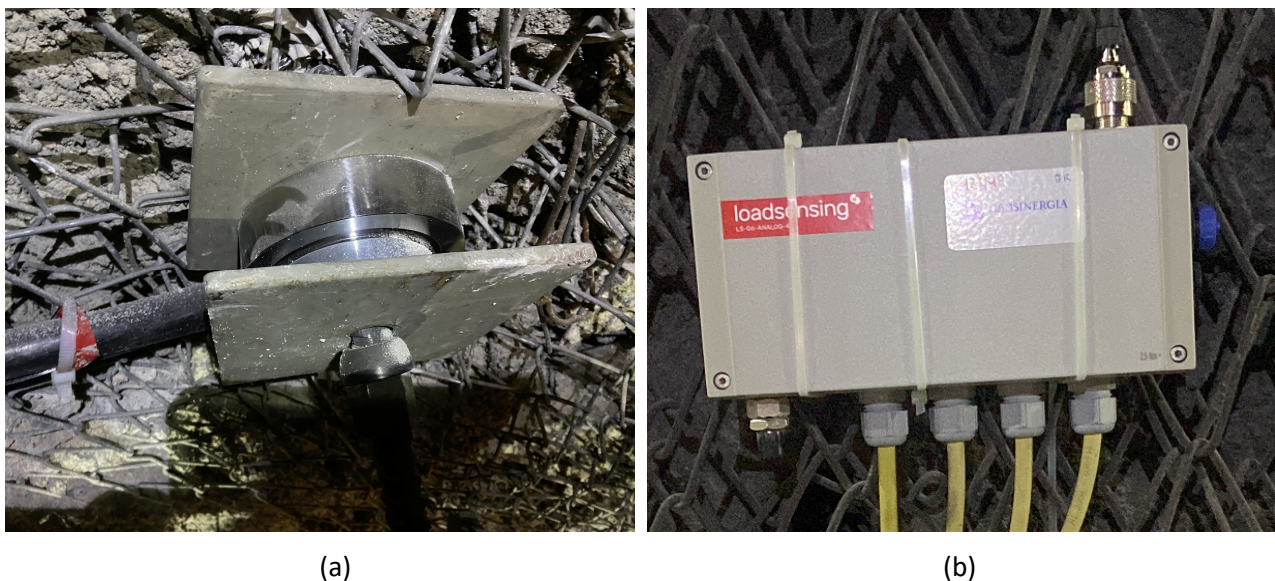
Figure 1 (a) Sisco 500 kN load cells; (b) Loadsensing four-channel datalogger

Electronic load cells from Sisco (Model 0L207V05000) with 4–20 mA output have been implemented in the monitoring system. The 500 kN model was chosen because the helical bolt used in the support system has a maximum capacity of 37 t. A 71 mm diameter has also been selected for use in the support system, which is comprised of double cable bolt. A Loadsensing wireless node (model LS-G6-ANALOG-4) with capacity for four sensors has been used for storage of the collected data (Figure 1). In addition, an HDM datalogger (model Quantum CX-22B-W) with a sampling rate of up to 4,800 Hz and a capacity for eight sensors has been used.

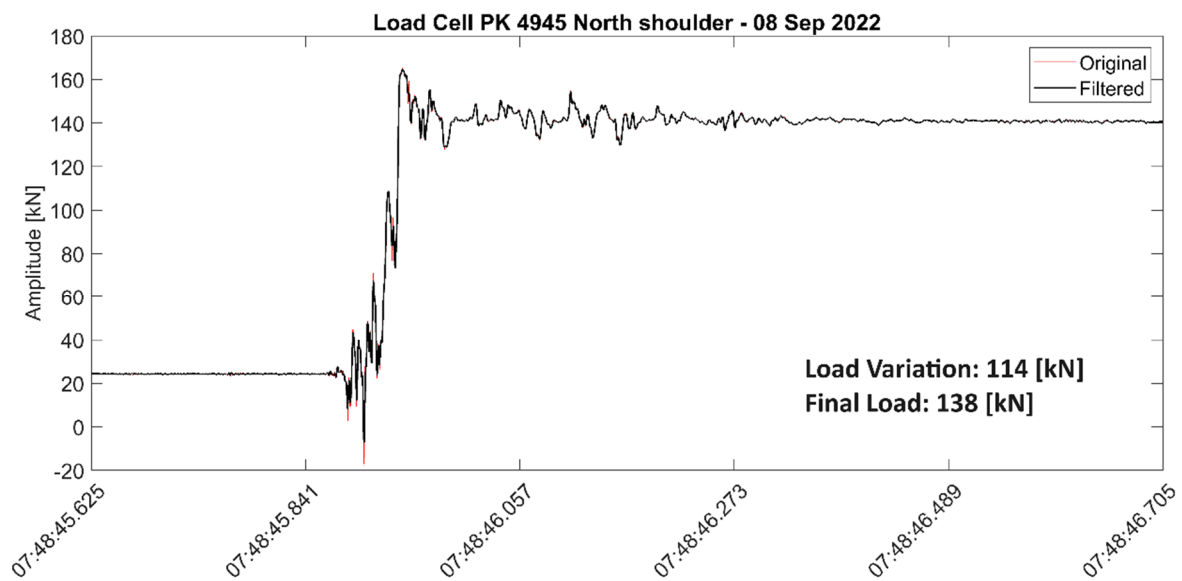
Figure 4 Signal recorded from dynamic monitoring for a crush-type event. Data shows a significant change in load that remains after the event

Observation of seismic events recorded in tunnels during crush-type events shows that there is a significant change in the load imposed on the support system. However, it is not common to observe high frequency vibration during the event. On the other hand, for slip-type events, low changes in load have been observed before and after the event but high amplitude vibration with high frequency have been observed during the event. Figures 4 and 5 show the differences between both seismic sources and how the load behaves over time in each case.

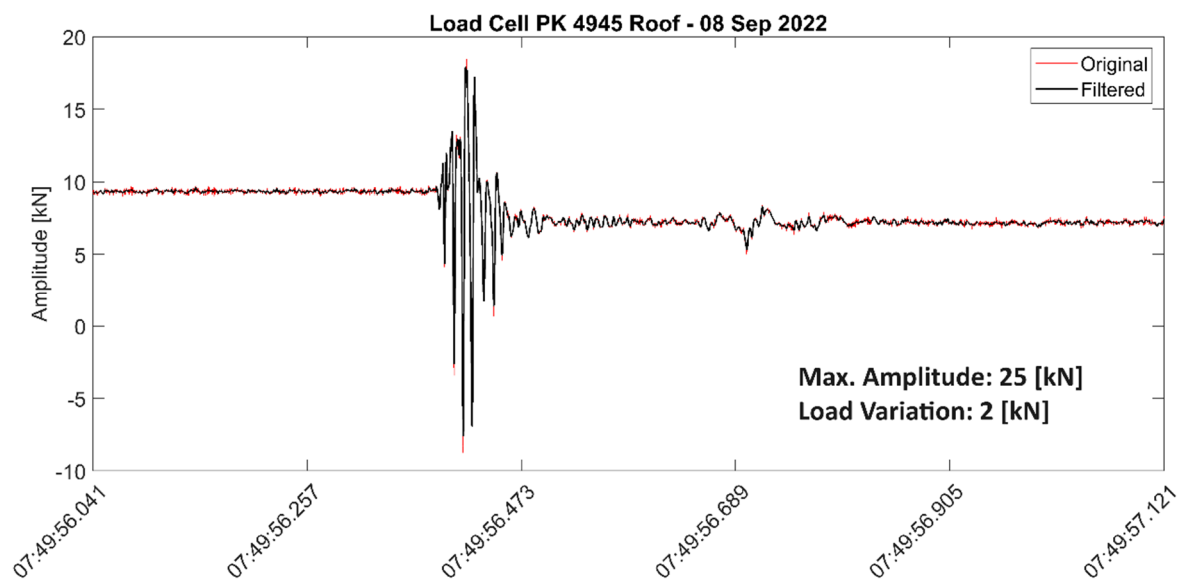
Figure 5 Signal recorded from dynamic monitoring for a slip-type event. Data shows amplitude variations during a seismic event, but low changes in load before and after the event

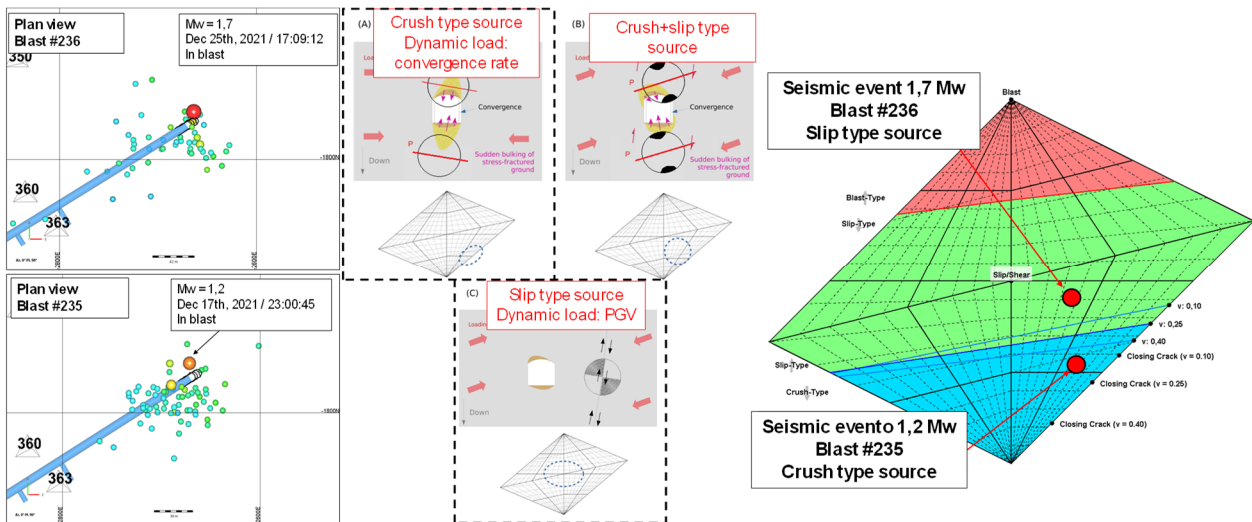
Figure 6 Seismicity associated with blasts #235 and #236 TC-P0. Seismic events of MW1.2 magnitude (crush-type source) and MW1.7 magnitude (slip-type source), respectively, were recorded

As a result of development blasts #235 and #236 in the CT front P0 (TC-P0), two seismic events with magnitudes of MW1.2 (crush type) and MW1.7 (slip type) were recorded. The events had energies of $8.7 \cdot 10^5$ (J) and $5.1 \cdot 10^6$ (J), respectively (see Figure 6). For the slip-type event, one of the solution planes agrees with the structural set 15/280 (dip/dipdir) orientation, which is sub-horizontal and predominant in some locations within the tunnel. It is worth mentioning that the presence of this structural set is associated with a greater frequency of slip-type events (Figure 7) (Bahamondes et al. 2022a).

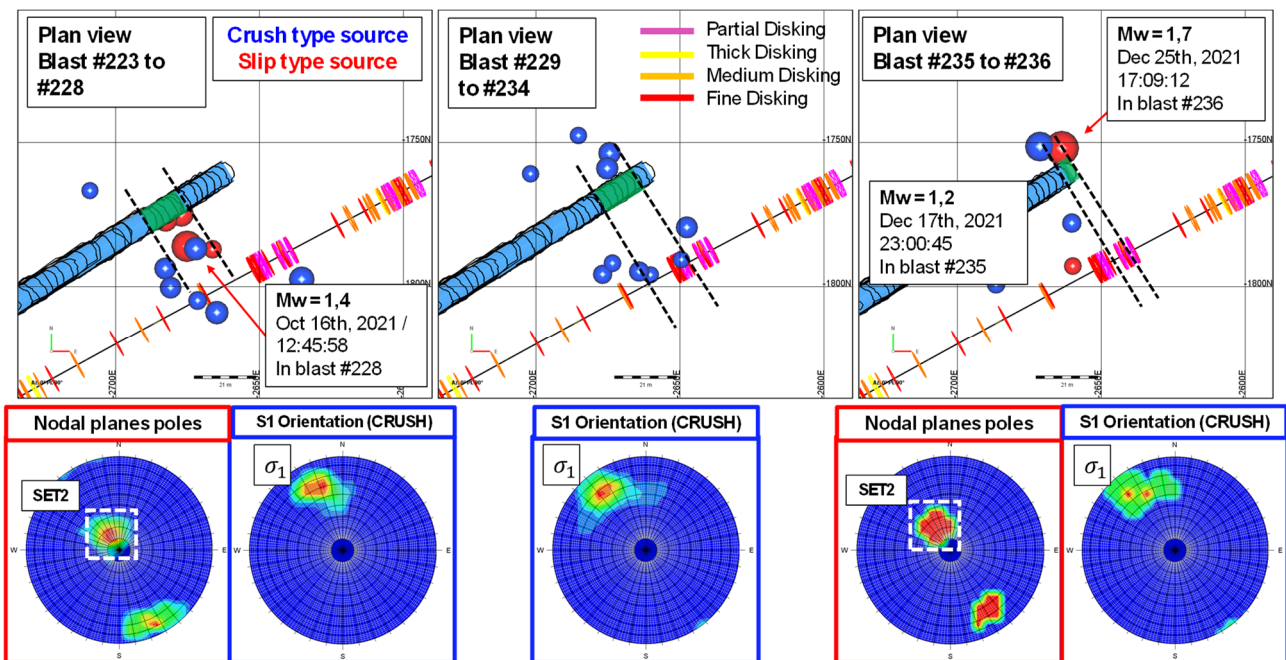
Figure 7 Seismic source types identified from blast #223 to #236 and their relationship with the presence of set two (sub-horizontal)

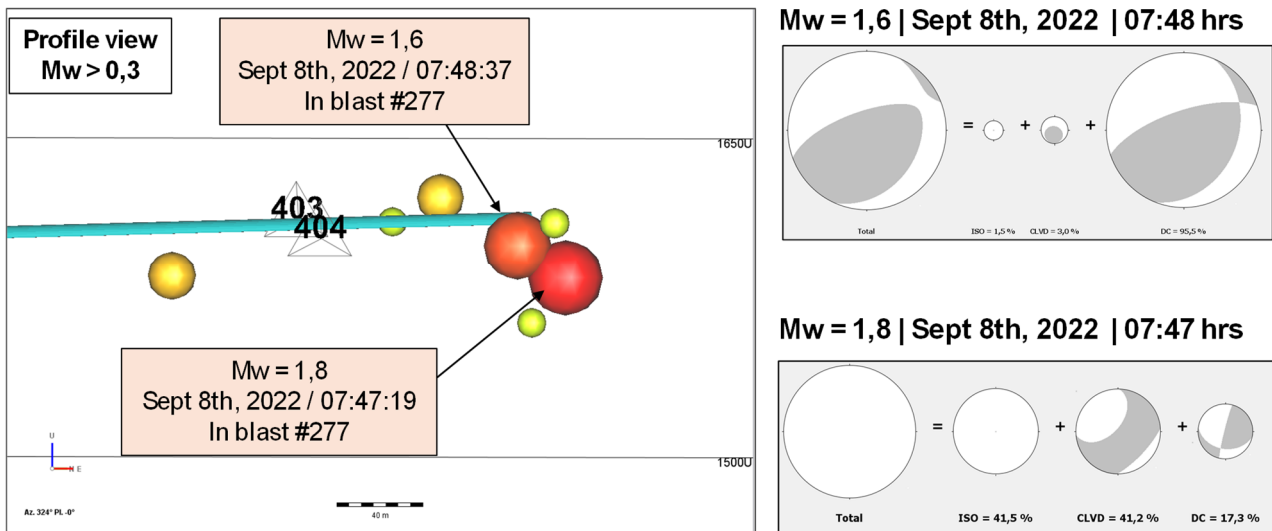
Figure 9 Profile view of seismic events MW > 0.3 recorded after blast #277. Focal mechanisms' decomposition for MW1.6 slip-type and MW1.8 crush-type seismic events

On 8 September 2022 at 07:47 hours, development blast #277 of the TC-P0 was fired. Induced by the blasting, three seismic events of local magnitude MW1.8 (crush type), MW1.0 (slip type) and MW1.6 (slip type) were recorded. The events radiated energy of $2.51 \cdot 10^7$ (J), $6.23 \cdot 10^5$ (J) and $4.71 \cdot 10^6$ (J), respectively, as shown in Figure 9. (Bahamondes et al. 2022b).

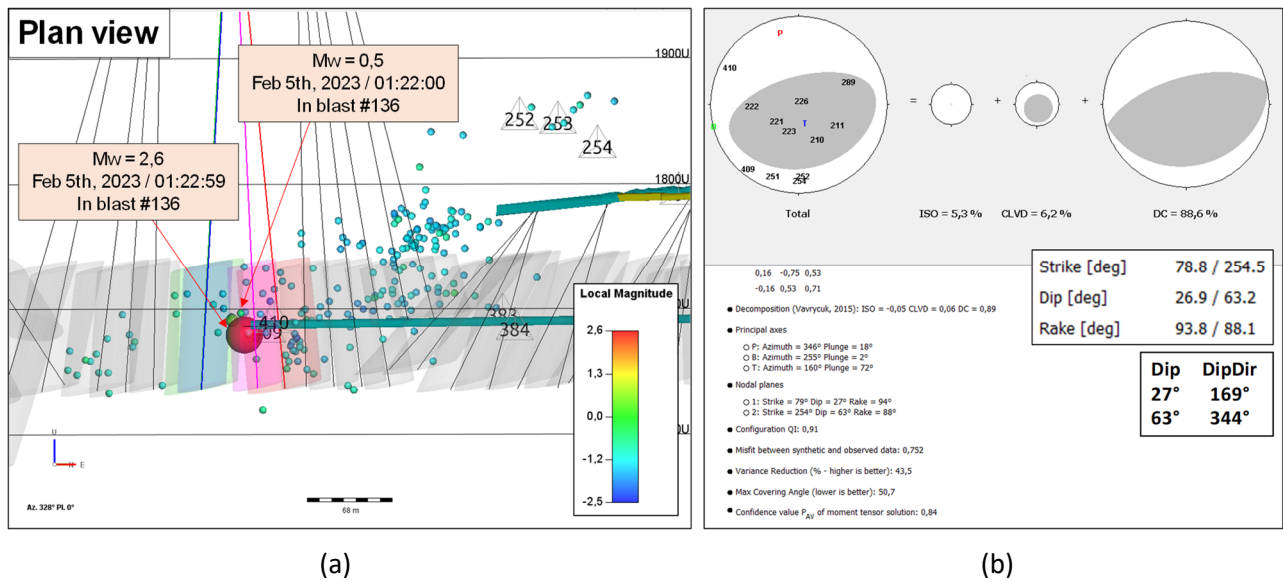
Figure 15 (a) Seismic event location in section view; (b) Focal mechanism decomposition

As a result of the advance blast #136 of CT OIM front (TC OIM), a large seismic event with magnitude MW2.6 (fault slip) and radiated energy of $2.8 \cdot 10^8$ (J) was recorded (Figure 15). The seismic event generated deformations in the tunnel contour over a distance of 100 m without ejection of the rock mass inside the tunnel (Figure 16) (Cordova et al. 2023).

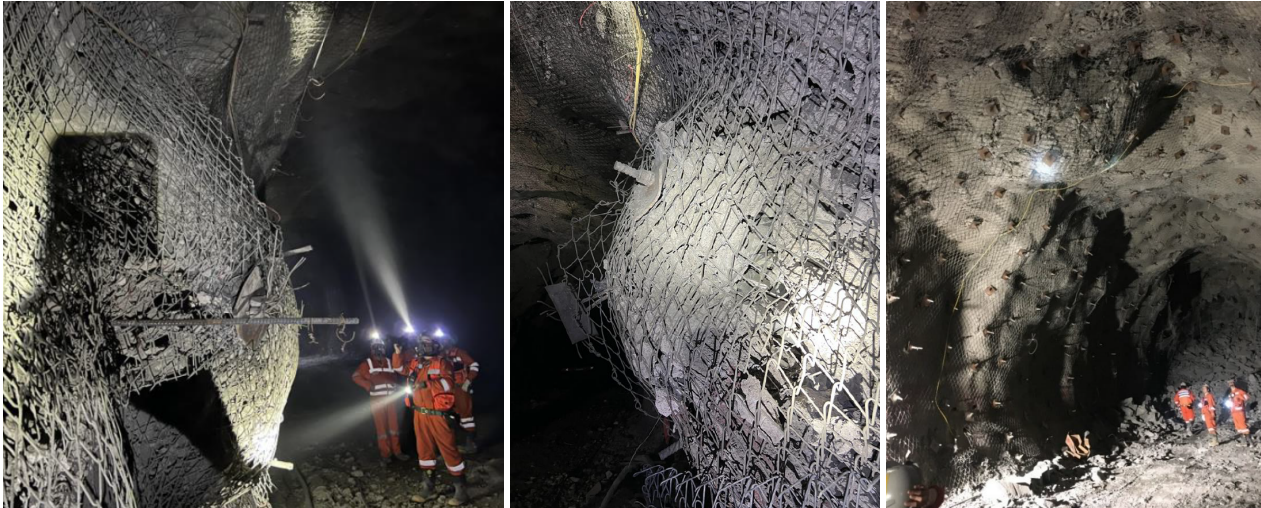
Figure 16 Photographic register from the ground inspection after a seismic event. Deformation is evident in the contour of the excavation

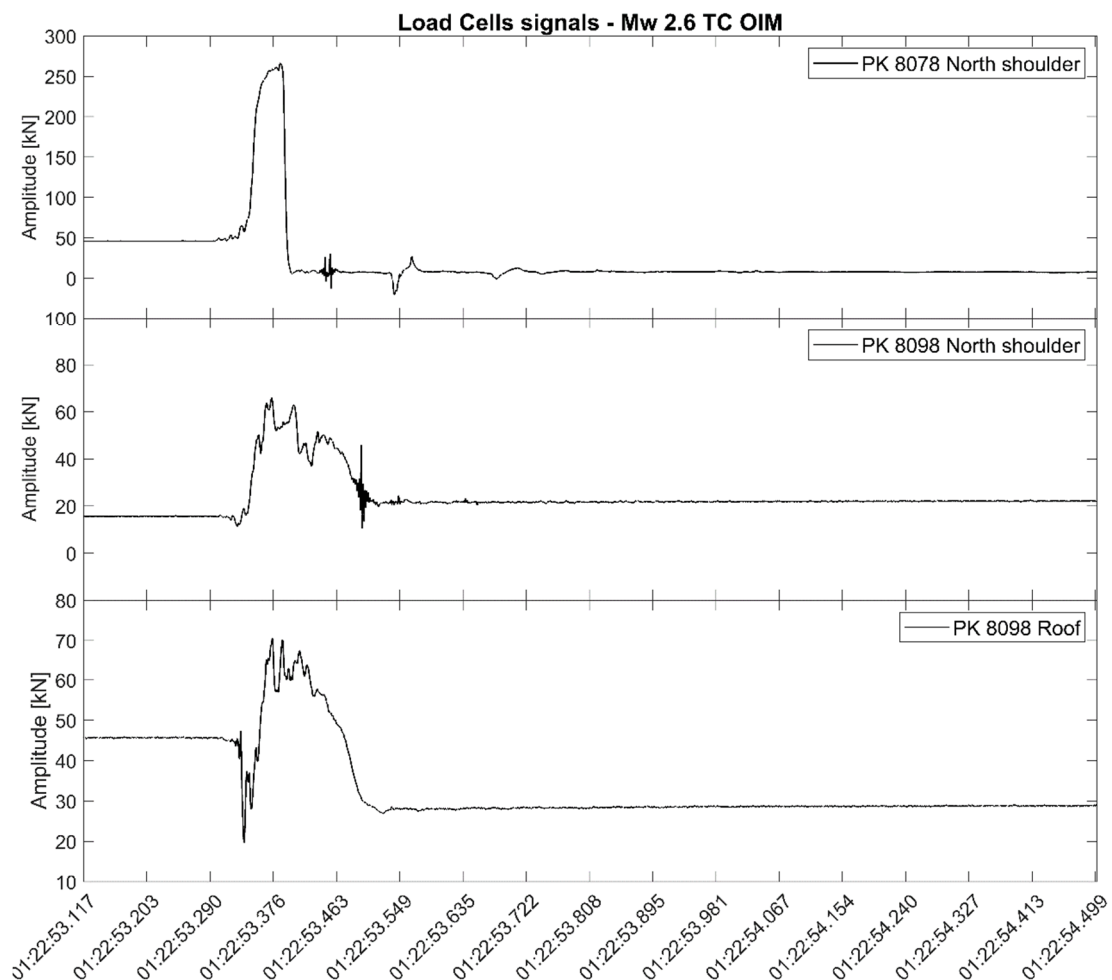
Figure 17 Dynamic monitoring signal from load cells installed in a tunnel

From the analysis of load cell data it was observed that the highest transient load recorded was 272 kN, while two other cells had values of 70 kN, with a permanent load change of 50, 5 and 20 kN, respectively, as shown in Figure 17.

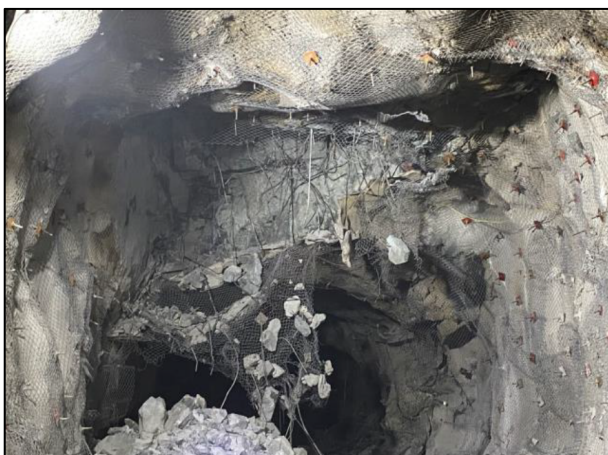
Figure 19 (a) Depth of damage observed during rehabilitation; (b) Drill orientation relative to the tunnel contour

As a result of deformation recorded along the tunnel, five boreholes were drilled to introduce an inspection camera to determine the depth of the damage after the seismic event. Figure 19b shows the borehole orientation relative to the tunnel contour. The blue line represents the 25 m borehole, the grey line represents the depth reached when introducing the camera, and the numbers, in metres, represent a disturbed zone characterised by fractured rock. From the borehole camera logs it was possible to estimate, on average, a depth of failure of about 1.8 m in the north wall and 1.5 m in the south wall.
