Assessing the impacts of artisanal and small-scale mining on rehabilitated land

Macdonald T Wanenge ^{a,*}, Nosiseko Mashiyi ^a

^a AngloGold Ashanti, South Africa

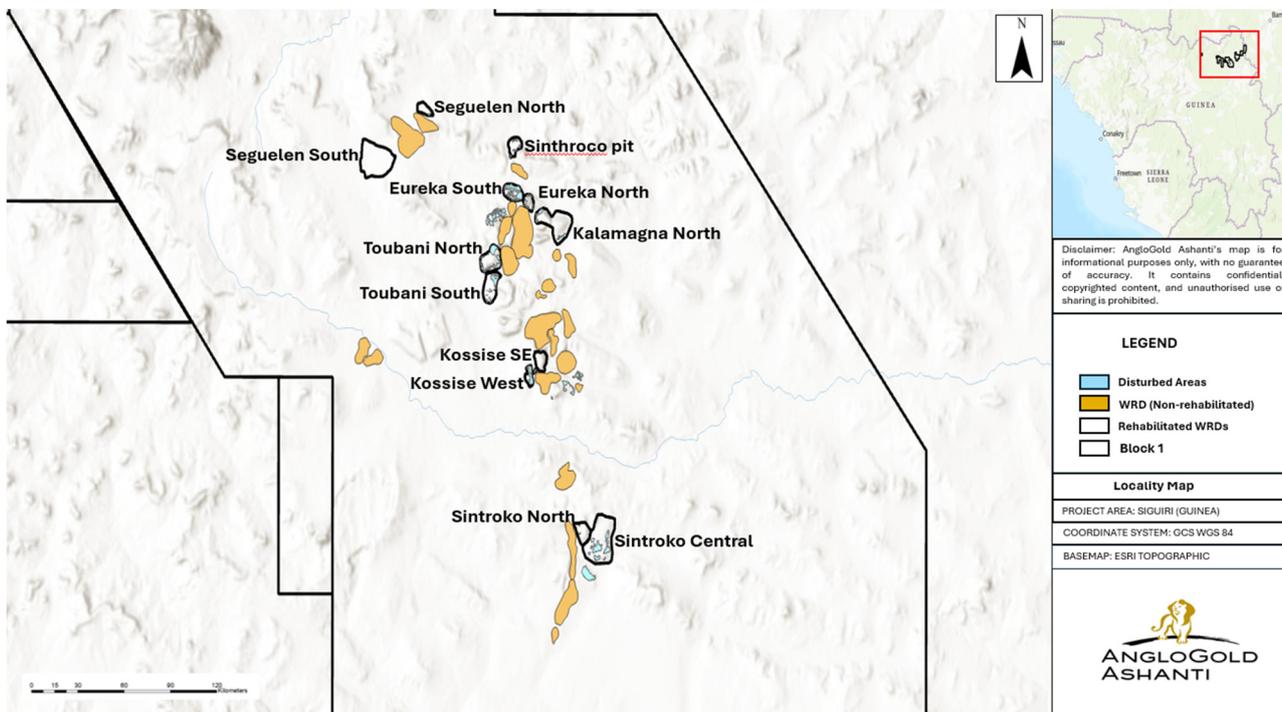
Figure 1 Location of the rehabilitated (black outline) and non-rehabilitated (brown) waste rock dumps in Block 1 at the Siguiri Gold mine

The Siguiri Gold mine is situated in the remote Siguiri district, approximately 850 km northeast of Conakry, the capital of Guinea, in West Africa (Figure 1). Between 2015 and 2019 the mine was able to rehabilitate almost half (i.e. 12 of the 25) of the WRDs established since SAG’s inception in 1997 (Figure 2). However, in 2020 SAG decided to stop the rehabilitation of WRDs due to the extensive disturbance of these areas by ASM.

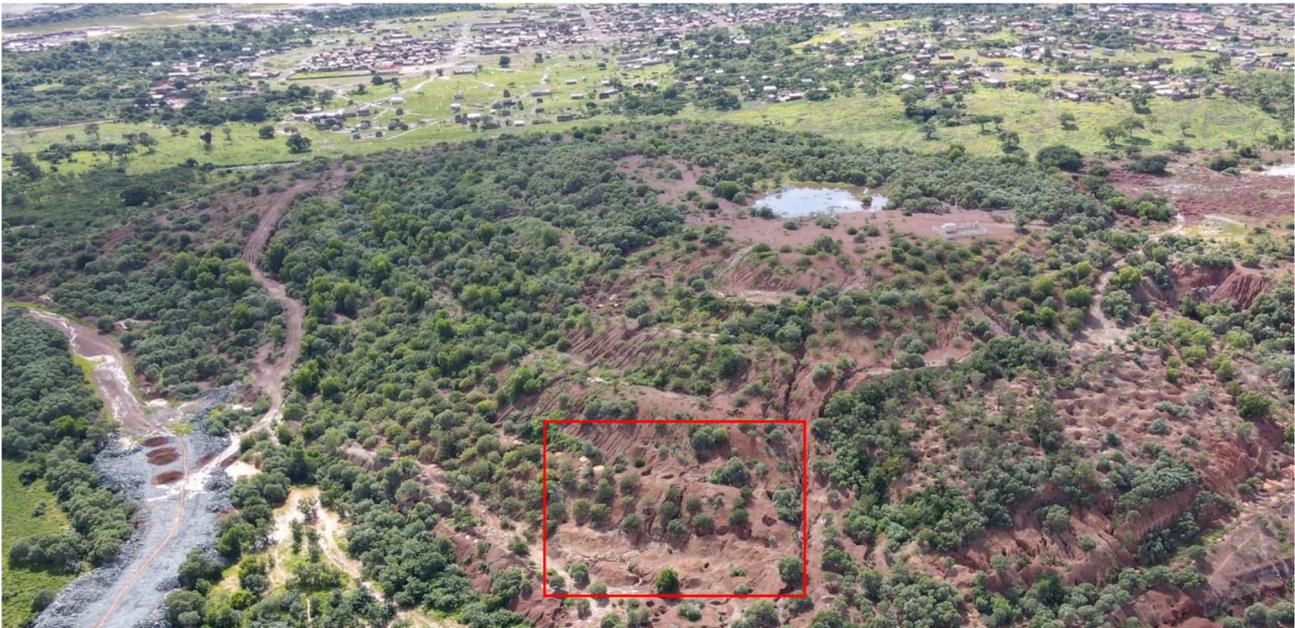
Figure 3 Extent of artisanal small-scale miners' disturbance at Toubani North (see area highlighted in red)

The visual assessment revealed that the severity of damage to the rehabilitated landforms varied significantly (Figures 3 and 4). In some areas the destruction was relatively minor, involving small-scale excavations and limited uprooting of vegetation coupled with natural erosion (Figure 3). However, in other locations, the damage was far more severe, characterised by extensive excavations, the complete removal of vegetation and the digging of deep wells, some exceeding 15 metres in depth (Figure 4). These observations highlighted the range of disturbances impacting the rehabilitated areas, from localised disruptions to widespread and profound degradation.

However, although the survey assessment is more accurate in assessing ASM impact, this method is relatively more labour intensive and expensive, and requires more experienced personnel to conduct the work. Conversely, although less accurate than the survey assessment, the field and satellite assessments can be easily implemented in-house on a mine utilising mine personnel and aerial data. Due to the ease of implementing field and satellite assessments, more frequent measurements of ASM disturbance can be done at short intervals (e.g. quarterly or annually), unlike the more involved survey assessment which might be best conducted at 3–5-year intervals. Consequently, before considering which assessment to adopt, it is best to first have a good understanding of the extent and severity of the ASM disturbance and the intended objective for conducting the assessment. For example, the survey assessment could be ideal for areas where there is extensive ASM disturbance characterised by deep excavations and severe deformation of the topography, such as those exhibited at Sintroko Central WRD (Figure 5), while the field and satellite assessments could work for areas exhibiting minor ASM disturbance, such as those at Toubani North WRD (Figure 3).

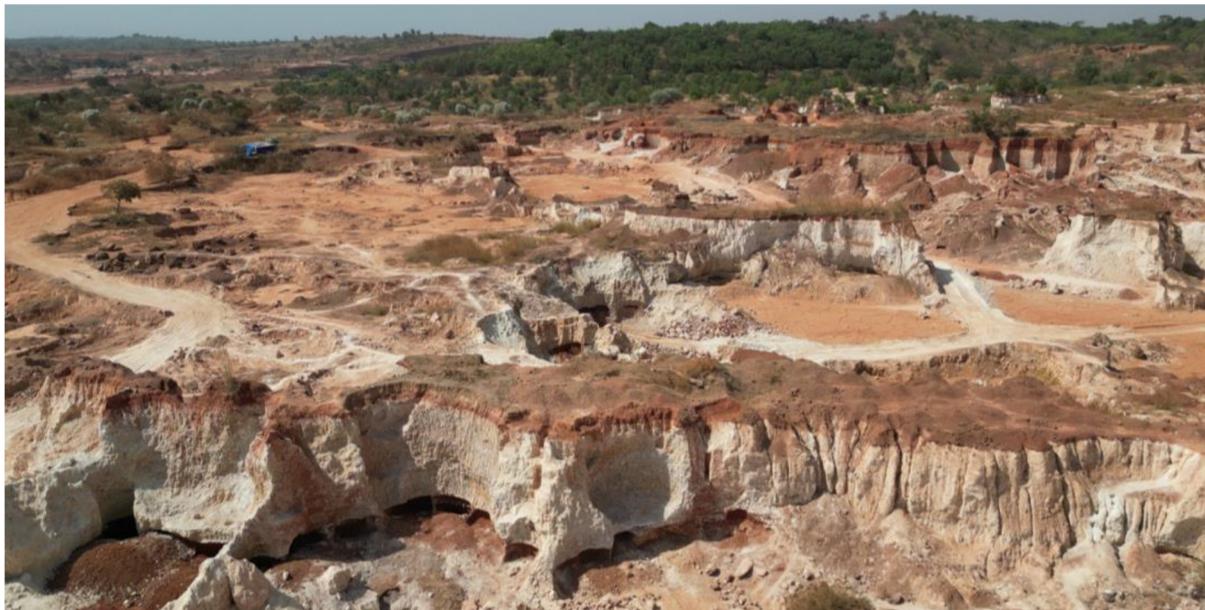
Figure 5 Status of the Sintroko Central waste rock dump as of January 2024 after artisanal and small-scale mining disturbance

Since the start of ASM destruction of rehabilitated areas (around 2015) within SAG's concession, Sintroko Central and other rehabilitated WRDs have been significantly affected. As a result, the previously covered oxide material at Sintroko Central has been exposed, large gullies have formed due to erosion and the landscape has experienced substantial changes (Figure 5).

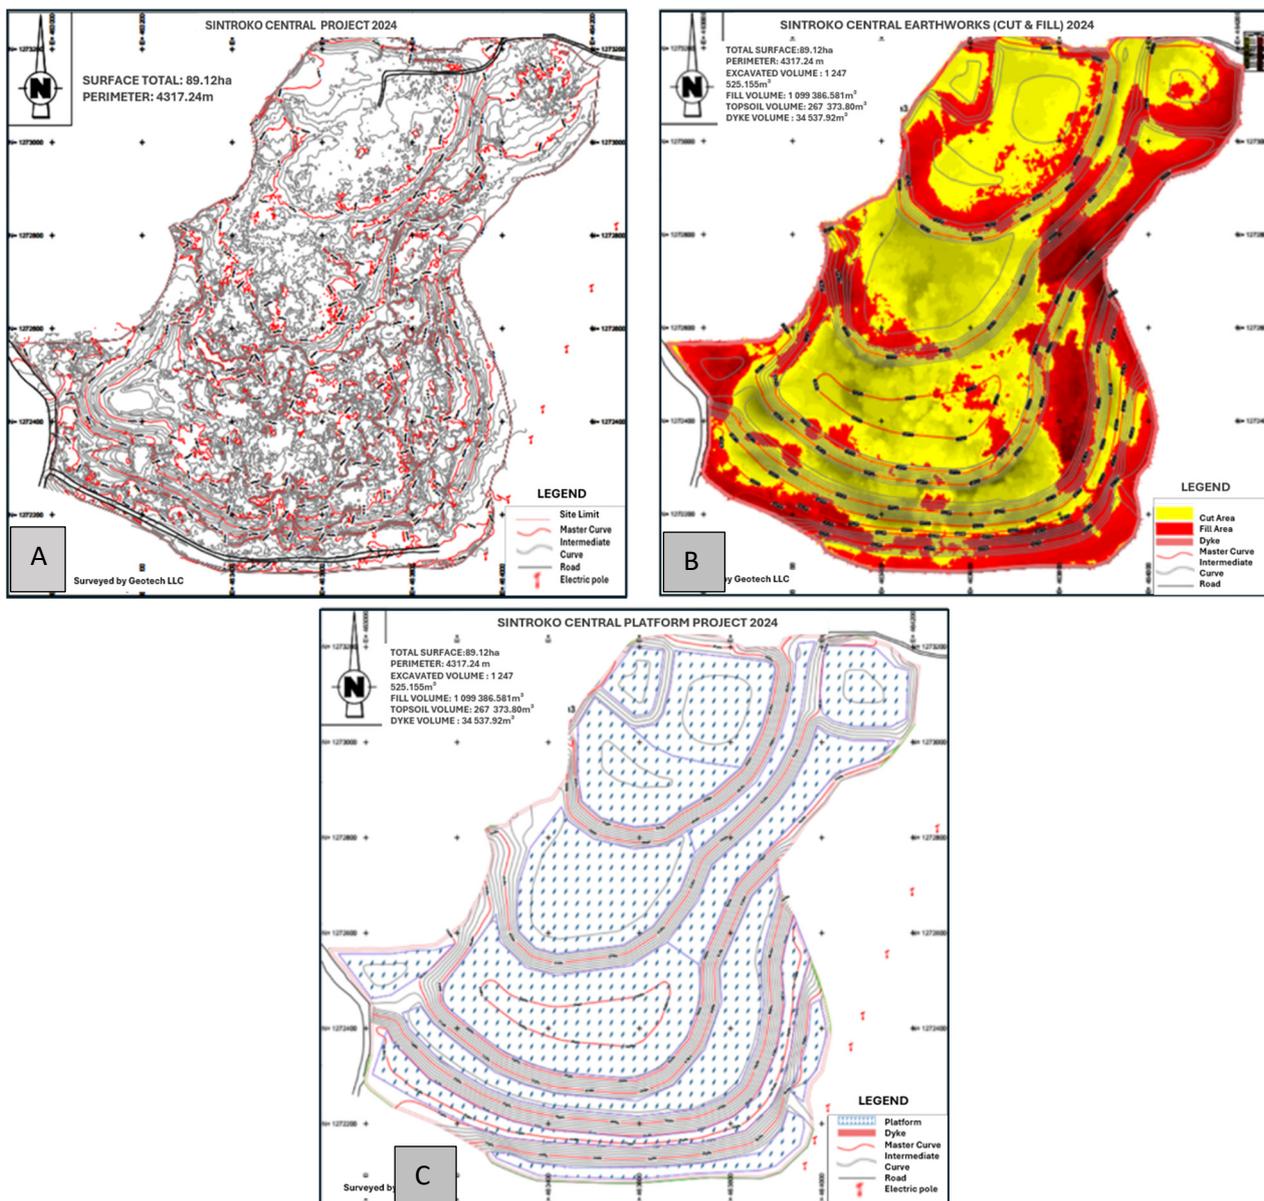
Figure 6 Survey models for Sintroko Central waste rock dump depicting: (a) The extent of artisanal and small-scale mining disturbance; (b) Areas requiring cut (yellow) and fill (red); (c) The remodelled landform

The external survey estimated almost three times more damage (i.e. disturbed area) than that found during the internal audit (Tables 1 and 2). This finding can be explained by the difference in assessment methods utilised between the internal audit and the external survey. Unlike the internal audit, which only estimated the ASM damage based on hectares disturbed, the external survey went further to look at how the disturbance had impacted the overall topography and remodelled the landform into stable and free-draining facilities (Figure 6). Further to this, some of the ASM disturbance had resulted in the complete deformation of the landscape and removal of significant material, so fixing and reprofiling of these areas would require importing large amounts of material. The importation of material would mean potentially disturbing intact areas. Therefore, the most feasible option proposed was cutting material from undisturbed parts of the WRD to fill damaged areas. So, depending on the type (e.g. deep/shallow excavations) and extent of damage, WRDs like Kalamagna North WRD, Seguelen North WRD and Eureka West WRD, which showed low damage in the internal audit, ended up showing huge damage in the external survey.

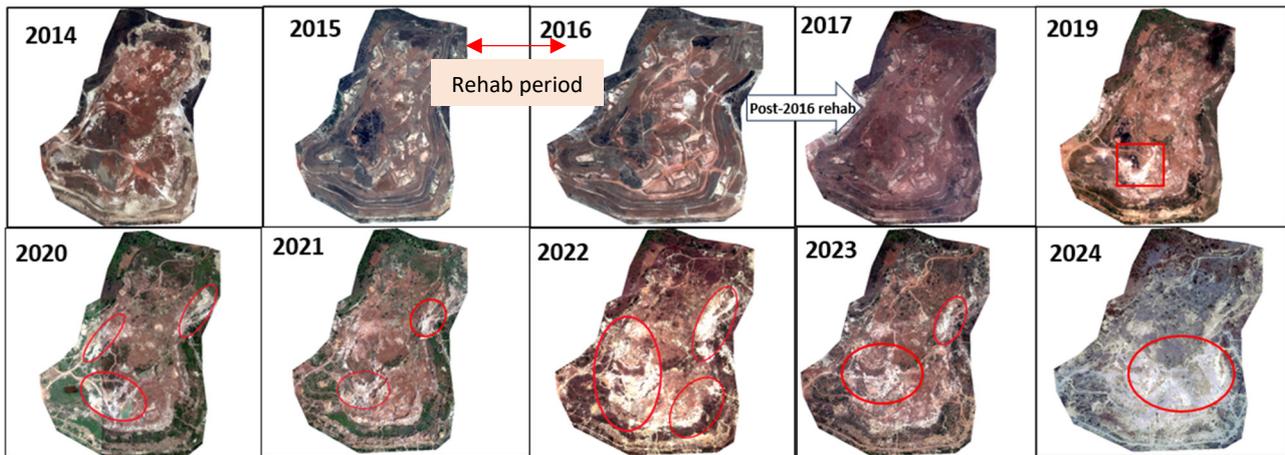
Figure 7 High-resolution images depicting the changes in Sintroko Central waste rock dump from 2014 to 2024, with artisanal and small-scale mining-affected areas highlighted in red

As illustrated in Figure 7, ASM activities on the Sintroko Central WRD first became noticeable around 2019 after the 2016 rehabilitation. Due to the transient nature of ASM operations, ASM miners have shifted their activities to various sections of the WRD over time, as evidenced by the changes observed in the 2022 image. Despite ongoing impacts, the 2024 image reveals that damage remains visible, particularly at the lower section of the WRD. However, natural vegetation regeneration is occurring in certain areas, indicating some degree of ecological recovery.

Since the initial ASM impact at Sintroko Central WRD in 2019, no major disturbances were observed during the subsequent assessments (i.e. visual, aerial and survey) conducted in either 2022 or 2024. However, as noted earlier, vegetation has begun to recolonise the disturbed areas, which is clearly visible in the 2023 and 2024 images shown in Figure 7. Although not detailed in this paper, similar patterns observed at Sintroko Central WRD were also evident across the other 11 WRDs, suggesting that the most significant ASM activity likely occurred between 2019 and 2022.

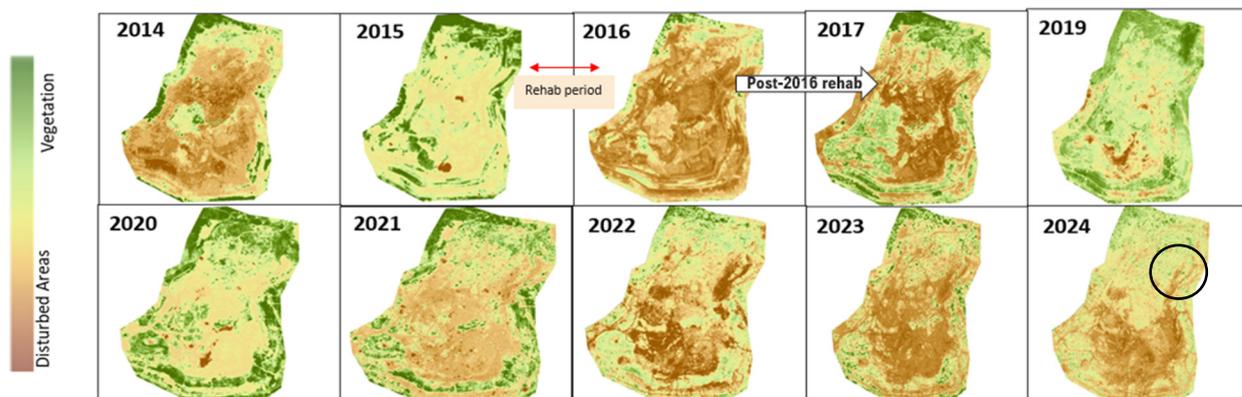
Figure 8 Normalised difference vegetation index images showing vegetation regrowth (highlighted in black) on the Sintroko Central waste rock dump following rehabilitation efforts since 2016

The NDVI images presented in Figure 8 illustrate the gradual regrowth of vegetation on the Sintroko Central WRD, despite the environmental disturbances caused by ASM activities. The 2024 image highlights this regrowth, demonstrating that plant life is beginning to recover in the affected areas. However, while vegetation is returning, the extent of the damage remains apparent as the surface still shows visible signs of degradation. Therefore, although natural regeneration occurs, the underlying risk of unstable ground, deep wells and excavation remains.
