# To topple or not to topple: managing failures at a case study site

*This paper presents a case study of managing toppling failures at a short-life open pit lithium mine in Australia, where adverse slope performance was encountered early in operations. The geological setting comprises a steeply dipping pegmatite orebody hosted within regionally foliated phyllite. The dominant failure mechanism was flexural toppling along sub-vertical foliation planes, with additional complex toppling and minor wedge failures observed. Slope instability was exacerbated by high pore pressures, poor understanding of rock mass conditions, and limited initial slope monitoring.*

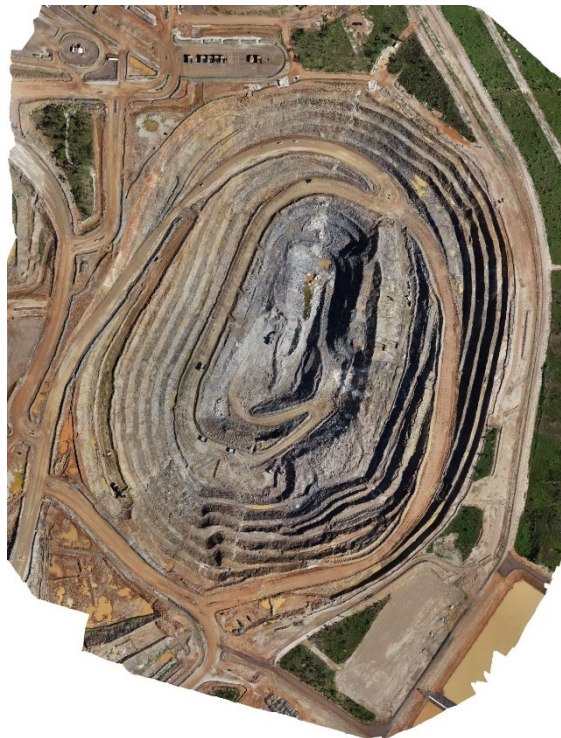
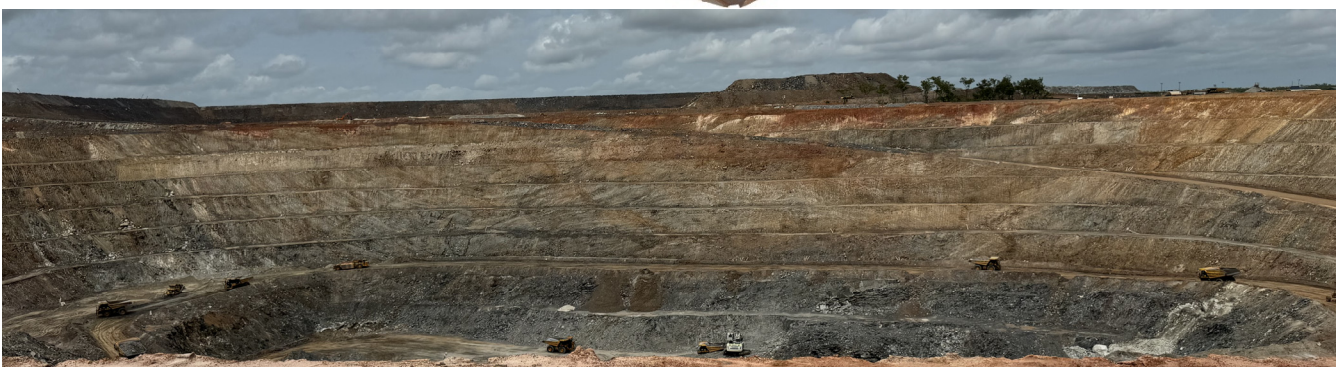
**Figure 7** Aerial view of the site and an overall photo of the upper west wall in December 2023

While slope deformations and some failures were still observed, the overall slope performance was improved, attributed to both the design and depressurisation program (Figure 7). In addition, there was a significant uplift in slope monitoring that enabled improved risk management and reduce stand-down times after a failure or heavy rainfall. The depressurisation and slope monitoring program are discussed further in the following sections.
