# A case study for rock clad non-topsoiled native woodland rehabilitation in Central Queensland

## Abstract

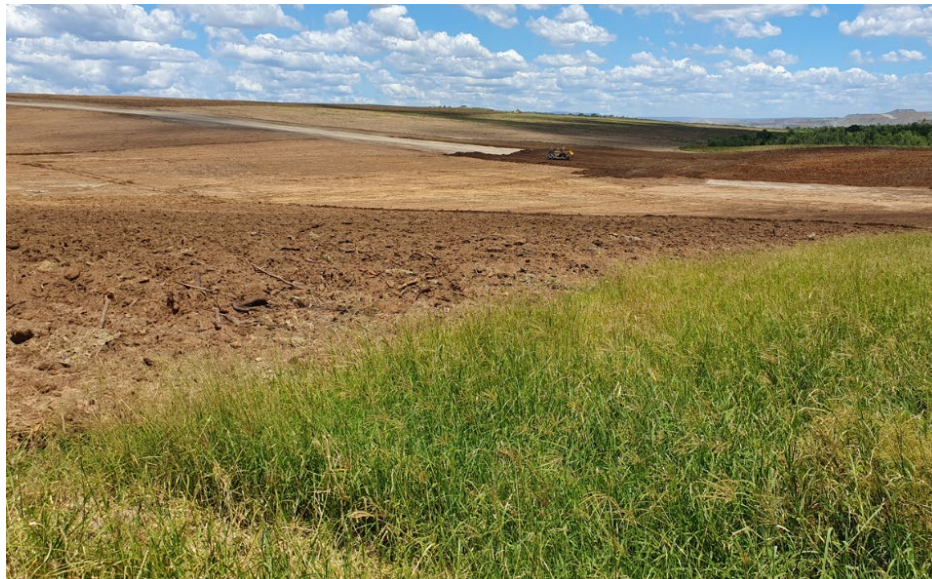
**Figure 1** Example of topsoil application on dozed spoil with a plot established the previous year evident in the foreground

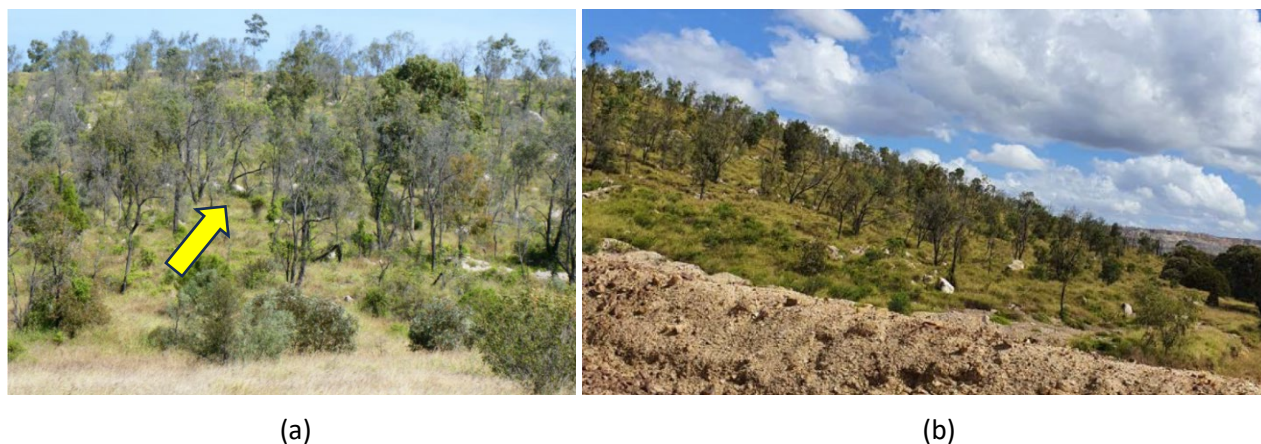
**Figure 7** (a) Rock clad rehabilitation area looking up the slope with gradient change (arrow); (b) Profile view

During inspections in 2023 it was observed that most of the area had a good coverage of vegetation (Figure 7); however, the ground cover was dominated by Buffel grass which is endemic to the region and is a widely acknowledged problem in the region. The entire slope was not exhibiting any visible signs of erosion and this was being achieved without the use of any formal engineering structures such as spine drains or contour banks. Figure 7a shows the slope break between the lower 23% gradient and the steeper (40%) upper section.

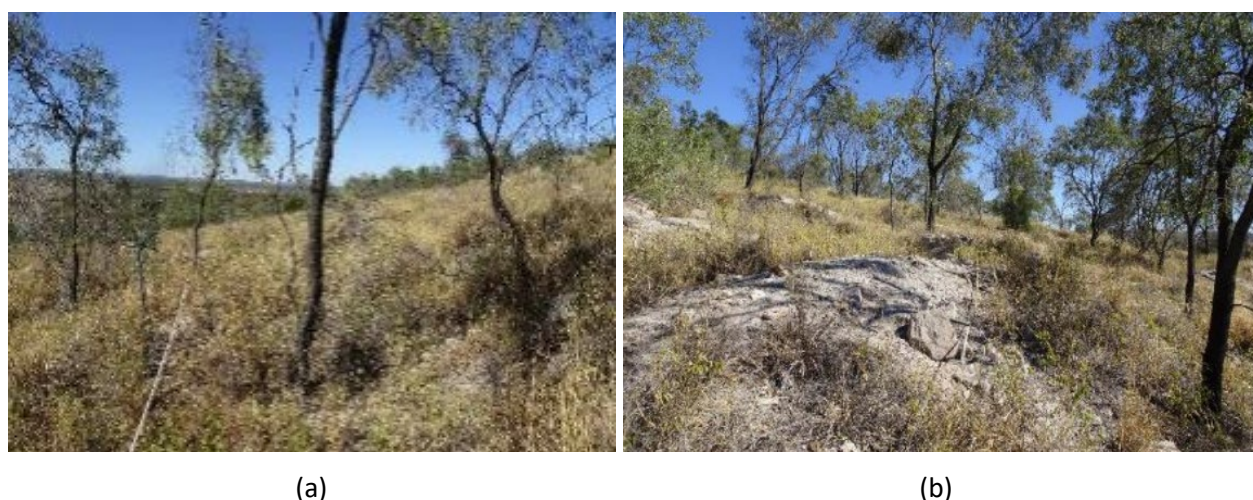
**Figure 8** Rock clad rehabilitation area showing vegetation cover of Buffel grass and acacias and soil loss from mound tops. (a) Site 6; (b) Site 36

A more recent rehabilitation monitoring report assessed 2 established locations (Site 6 and Site 36) on the RCRA (Figure 8) against a cattle grazing end land use. The report stated that in fact there was a moderate amount of species diversity at Site 6 (11 total) and good amounts present at Site 36 (15 total), but again there was a dominance of Buffel grass that was retarding greater diversity. The vegetative ground cover percentage was higher at Site 6 (80%) and 47% at Site 36.

The spoil condition at Site 6 was rated a good as the surface pH, EC and sodicity were within limits. Site 36 reported strongly alkaline spoil, with EC and sodicity increasing with depth. Erosion at Site 6 was good, with minimal erosion evident due to the ground cover, while Site 36 had local erosion with soil loss from the mound tops and deposition into the furrows (Figure 8).

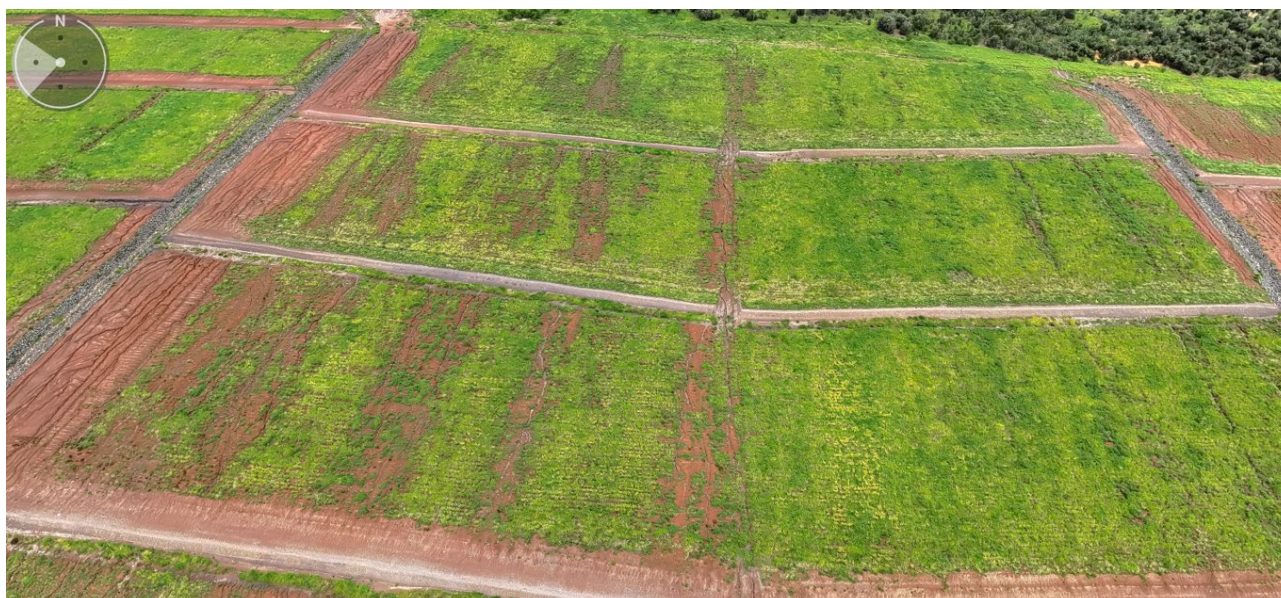
**Figure 9 Recent topsoiled grazing PMLU with cross banks and spine drains after a single wet season**

The conventional view is that erosion can be controlled by establishing a vegetation cover and managing how water is moved off the slope. Even when these soils are used in conjunction with conventional engineering controls of cross banks reporting to rock lined spine drains, the result is still rill network development after the first wet season. This is mainly due to the planted seed requiring natural rainfall from February to April to grow, but this rainfall typically comes in the form of summer storms which cause erosion before the ground cover can develop (Emmertson 2018) as shown in Figure 9.

The RCRA design does not direct water flows along cross banks or into drains and dams. The example in Figure 9 shows the failure of the fertilised, amended, and seeded topsoil areas between the cross banks. The RCRA erosional performance can be highlighted by a comparison with an inspection report to other trial areas that followed conventional design of cross banks and spine drains. The inspection was conducted due to storm damage to the rock lined drainage system. This east-facing rehabilitation area was a relatively new area that had been constructed in response to a previous ‘catastrophic’ failure of a similar cross bank and rock drain in the same area in 2007 (Restricted 2010). The drains were lined with high-quality quarried basalt estimated  $D_{50}$  to be on average around 300 mm, underlined with a geotextile to protect the underlying spoil from water ingress. The most recent failure event caused the scour of the rock armouring material as well as the tearing of the geotextile (Figure 11). The duration of the rainfall event was approximately 3 hours, with peak intensities of 30–42 mm/h depending on the weather station (Restricted 2010). Note that the RCRA is approximately 1 km from this site and that a water-concentrating design brings other problems; a water-dispersing design like the RCRA therefore warrants further investigation. This is in line with previous observations that contour banks will concentrate flows and over time will overtop and lead to the formation of gullies (Hancock & Willgoose 2021).

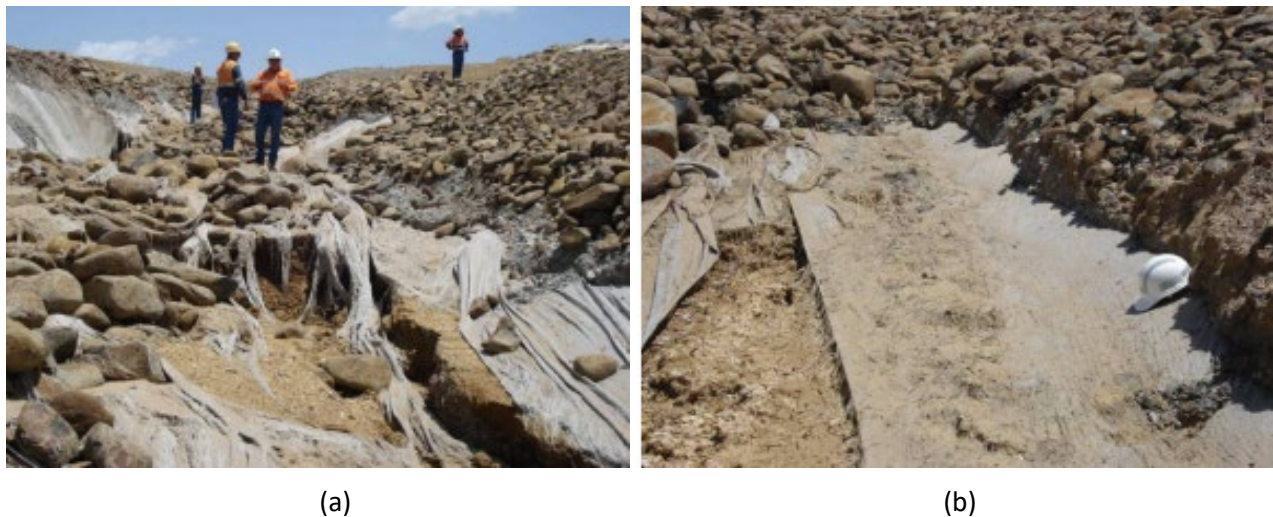
**Figure 11 (a) Erosion failure of a rock lined drain; (b) Detail of the scour (hardhat shows rock scale)**

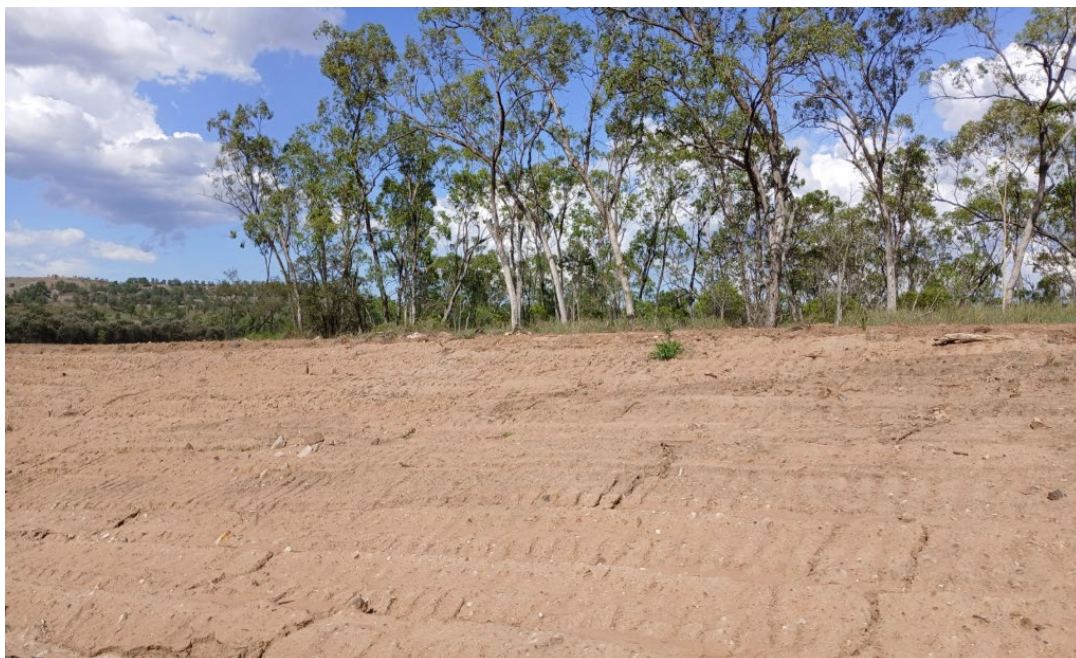
**Figure 12 Cross ripped rehabilitation slope where the rip lines have failed to stop erosion and rills formed down the slope after a single rainfall event**

Following on from the above point (Section 6.2), it is further speculated that erosion resistance is additionally increased with the very rough surface treatment (also known as microrelief). The backstacking construction method has created something similar to moonscaping but rather than a herringbone pattern the arrangement is mostly in rows along the contour. Recent rehabilitation work frequently shows that in the final step of cross ripping the slope, the rip lines quickly fill with water during a rainfall event and then overtop into the next rip line and begin to form rill networks down the slope (Figure 12). The current surface of the RCRA shows an approximately 500 mm difference between the mound peak and the adjacent furrow, typically more. This leads to a very large on-slope storage capacity for any rainfall event. Unlike moonscaping where flows can travel downslope in a zigzag pattern, backstacking retains this water in place. There was no evidence from this area of furrows filling and overtopping onto lower slope areas (Figure 13).

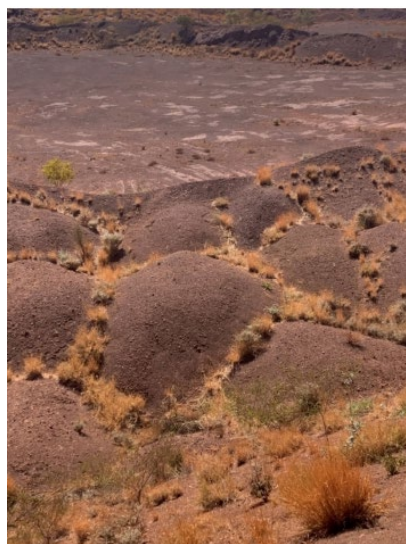
**Figure 17 Western Australian waste dump with no vegetation development in the flat-dozed background, but grass recruitment in the heterogenous paddock-dumped foreground area**

As shown in Figures 5–8 and Figure 13, the RCRA has a high degree of surface roughness consisting of a mound and furrow arrangement due to the backstacking construction technique. This has inadvertently created zones of resource loss and gain. The furrow tops are areas of sediment loss and some of these areas are active today. This was one of the reasons the RCRA was given an overall lower score during the rehabilitation monitoring inspection (Table 1). As a consequence the surface roughness also creates areas of resource gain where finer material accumulates along with other windblown sediment, seed and water flows. This has been observed by other authors as shown in Figure 17 where for uniform waste material there is no self-seeded vegetation on the flat-dozed area, but grass has begun to colonise the furrow areas of the paddock-dumped spoil areas (Salfate et al. 2024). The civil engineering approach to mine site rehabilitation tends to create homogenous surfaces as opposed to the usual variability seen in nature. This variability can then be exploited by native species that have adapted to surviving in tough substrates through mechanisms such as root zone weathering for mineral alteration to unlock nutrients (e.g. Wu et al. 2021).
