# From design to implementation: lessons from large-scale rehabilitation trials in Botswana

Leon Koekemoer <sup>a</sup>, Gerhard van Wyk <sup>a,\*</sup>

<sup>a</sup> E-TEK Consulting, South Africa

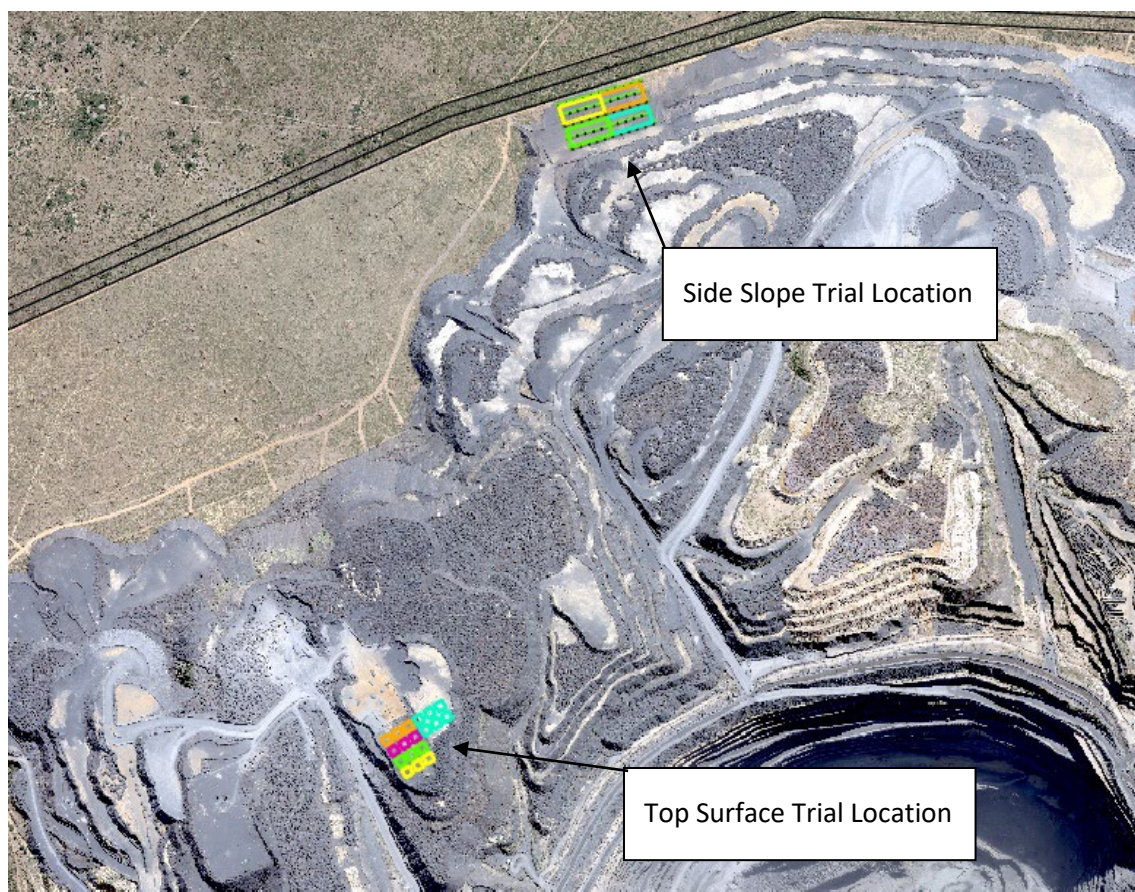
**Figure 2 Trial site locations**

Implementation of the rehabilitation trials commenced during 2025 under a structured rehabilitation trials plan developed for both the WRD top surface and side slope environments (Figure 2) (E-TEK Consulting 2026a).

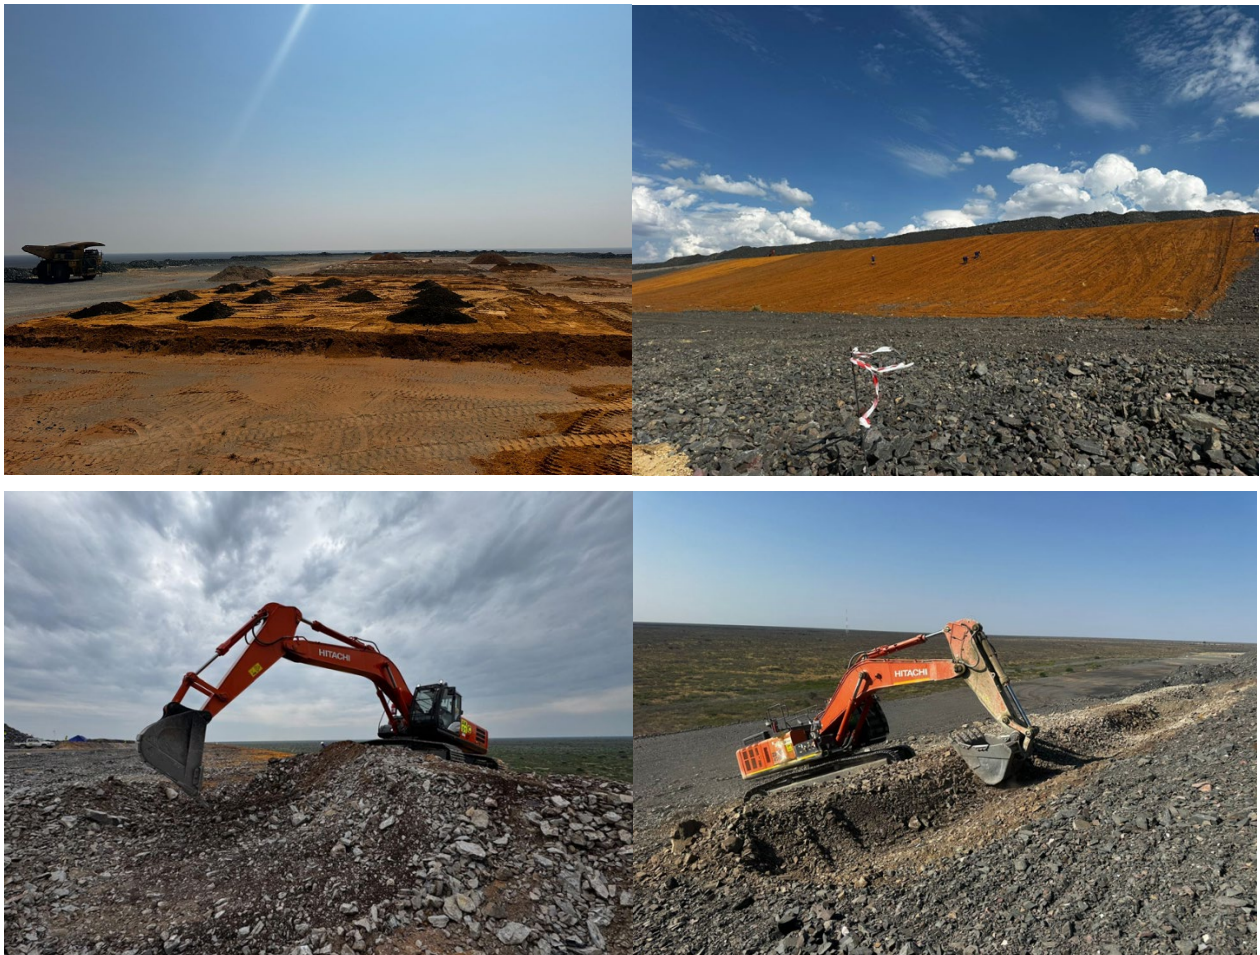
**Figure 3 Implementation of trials (growth medium placement and stormwater structure construction)**

The implementation activities undertaken during the rehabilitation trials, including growth medium placement, construction of stormwater control structures, ripping and seeding, are illustrated in Figures 3 and 4.

Growth medium placement and spreading generally achieved acceptable compliance with the design intent; however, isolated areas of exposed calcrete and inconsistent material coverage required corrective lateral dozing and redistribution of material. Stormwater control structures also required continuous oversight during construction. Minor deviations in crest berm geometry, contour paddock alignment and cross-wall construction highlighted the difficulty of achieving precise construction tolerances under operational conditions (E-TEK Consulting 2026b).

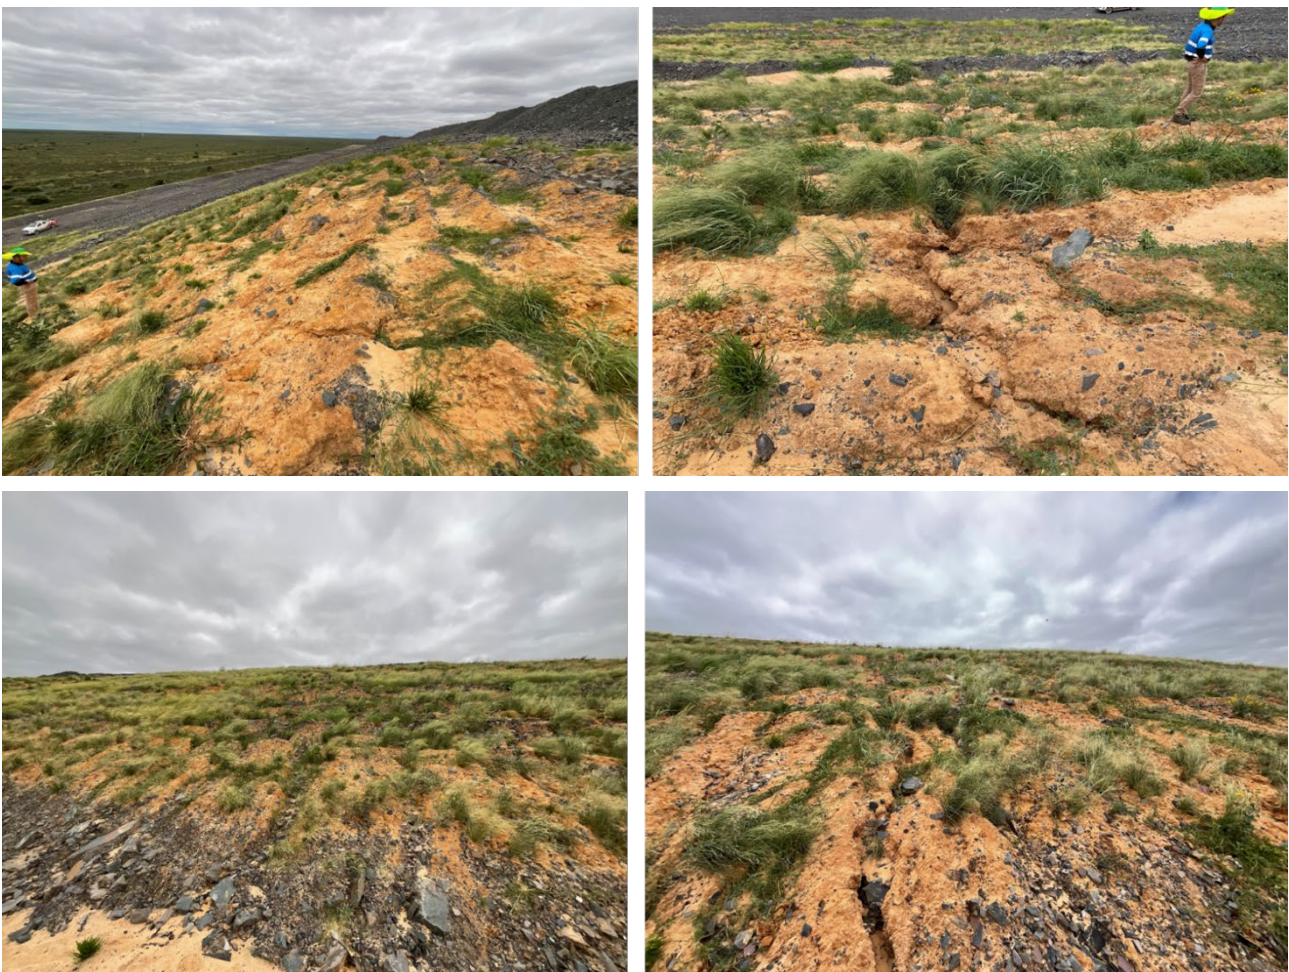
**Figure 7 Trials assurance findings – side slope erosion**

Following reshaping and seeding activities, monitoring identified several early-stage rehabilitation performance trends requiring adaptive management and ongoing technical oversight (Figures 7 and 8).

- localised sheet, rill and gully erosion on reshaped side slopes
- siltation within contour paddocks, with some sections reaching significant sediment accumulation levels
- localised overtopping risk associated with silted stormwater structures
- areas of inconsistent growth medium thickness resulting from operational spreading variability
- erosion associated with insufficient ripping depth
- differential vegetation establishment linked to micro-topography and soil variability
- localised voids and instability around stormwater cross-wall structures.

Corrective actions identified during implementation included desilting of stormwater paddocks, repair of localised erosion features on side slopes, improvement of ripping practices and equipment selection, filling of voids within berm cross-wall structures, procurement of additional seed and ameliorants, and implementation of ongoing vegetation and invasive species management programs. It was identified that certain erosion areas were not related to deficiencies in the rehabilitation landform design but rather to the use of inadequate ripping machinery during construction. The equipment utilised was unable to consistently achieve the specified 500 mm ripping depth within the waste rock and growth medium profile, resulting in shallower ripping, insufficient material mixing, reduced infiltration capacity and increased susceptibility to erosion in certain areas. Long-term monitoring programs for climatic conditions, erosion performance, stormwater stability and vegetation establishment were also identified as critical components of the rehabilitation strategy (E-TEK Consulting 2026a).

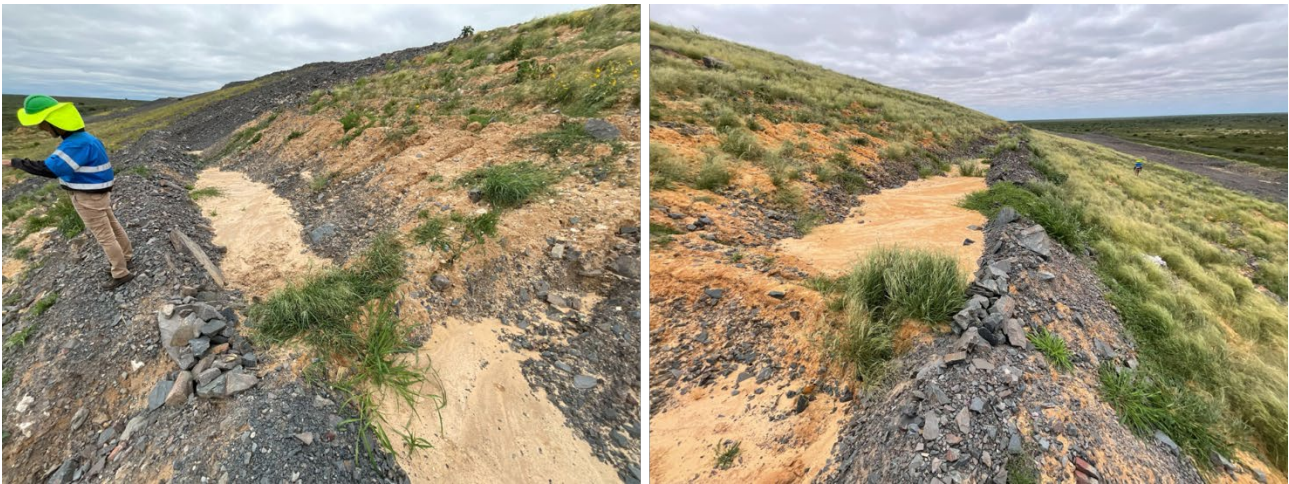
**Figure 8 Trials assurance findings – siltation of stormwater structures**

The implementation phase demonstrated that the period between reshaping and successful vegetation establishment represents one of the most vulnerable stages of rehabilitation. During this transition period, reshaped slopes remain highly susceptible to erosion until sufficient vegetative cover and root establishment occur. Monitoring indicated that early-stage erosion on the rehabilitated side slopes (Figure 7) contributed directly to siltation of contour paddocks and reduced stormwater holding capacity, increasing the risk of overtopping and structural failure during future storm events (Figure 8)(E-TEK Consulting 2026c).

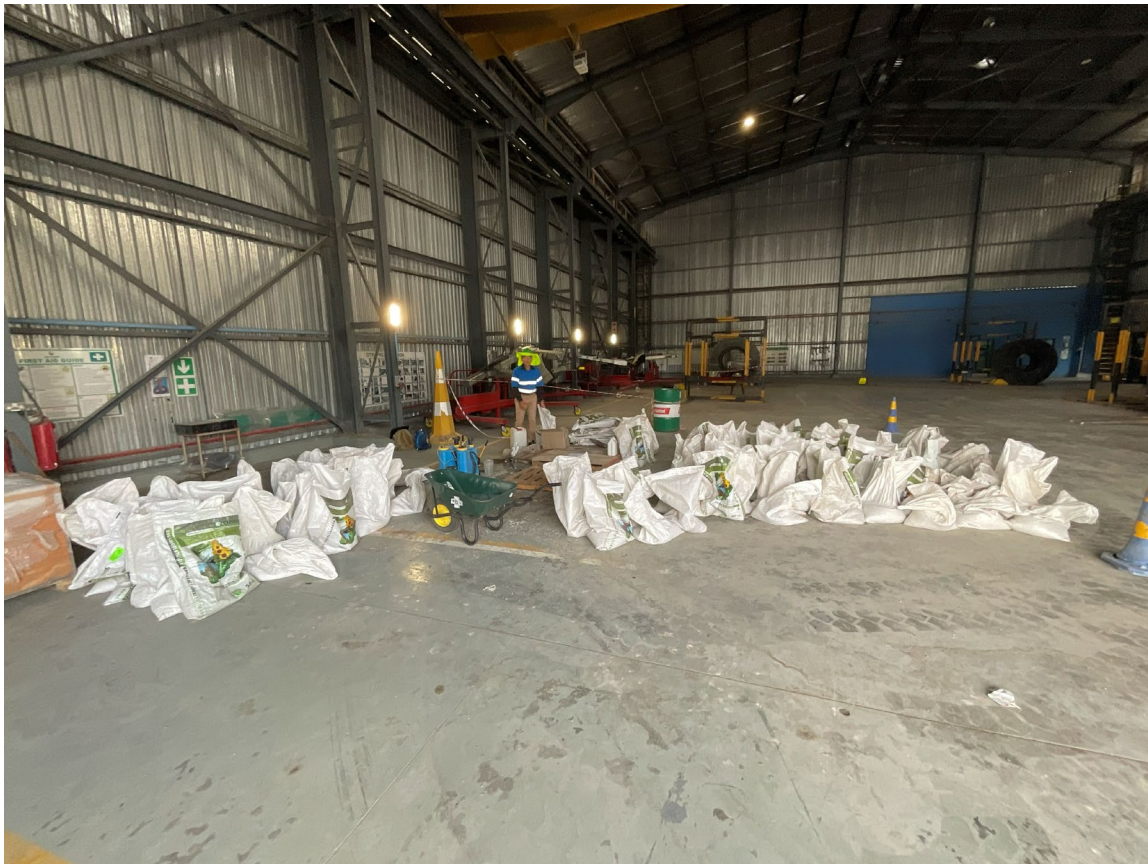
**Figure 9 Seeds and ameliorants sourced for the trials project**

One of the most significant constraints identified during implementation was not geotechnical but biological and logistical; specifically, the availability of suitable indigenous rehabilitation seed and ameliorants at the scale required for large-scale WRD rehabilitation (Figure 9).

Seed procurement therefore required sourcing from South Africa. However, even within a more mature agricultural and rehabilitation supply market, available volumes remain constrained, seasonal and dependent on supplier production capacity. Similarly, the procurement of suitable ameliorants and organic material at the required scale remains logistically challenging and subject to regional supply variability (Figure 9).
