# Geotechnical challenges for final landform: a case study at Werris Creek

## Abstract

*This paper presents a case study of an open pit coal mine that experienced a major endwall failure within the final 6 months of resource extraction. This occurred during advanced stages of landform development, posing significant challenges to both operational continuity and closure compliance. The study details the integrated geotechnical assessment undertaken to characterise the failure, and risk mitigation strategies implemented to enable continued resource recovery alongside adaptive slope redesign and waste placement methodologies.*

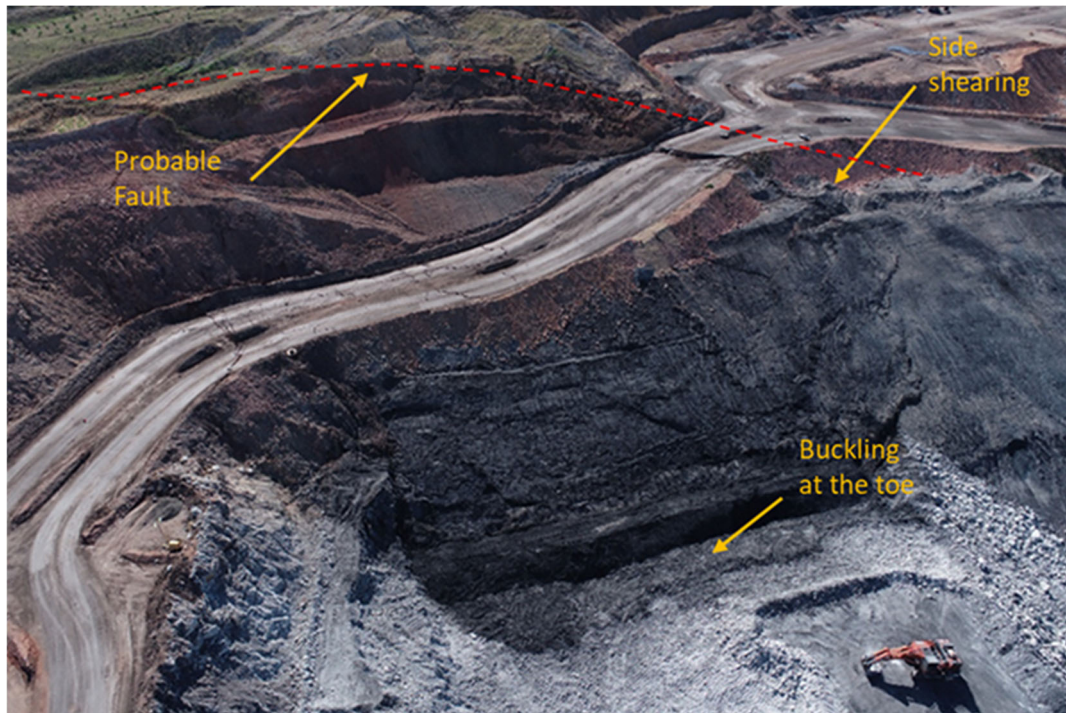
**Figure 4 Unmanned aerial vehicle drone image of the initial slope movement**

- a large and extensive headscarp that extended beyond the 'failure zone' several metres to the north
- an extensive side shear evident in the mid-slope haul road that was particularly prominent in the south where the topography was open and less in the north where confinement is provided by the pit topography
- buckling at the toe with no break out observed but a bulging and cracking of the rock mass was noted
- opening up of cracks within the body of the displaced mass.

Based on the initial observations and morphology, the slope failure appeared to be a translational or sliding-type failure with a major fault structure defining the headscarp and a possibly steep and weak bedding parallel plane that the mass was sliding on. Figure 4 below shows a drone image of the failure soon after occurrence, with the key features clearly shown.

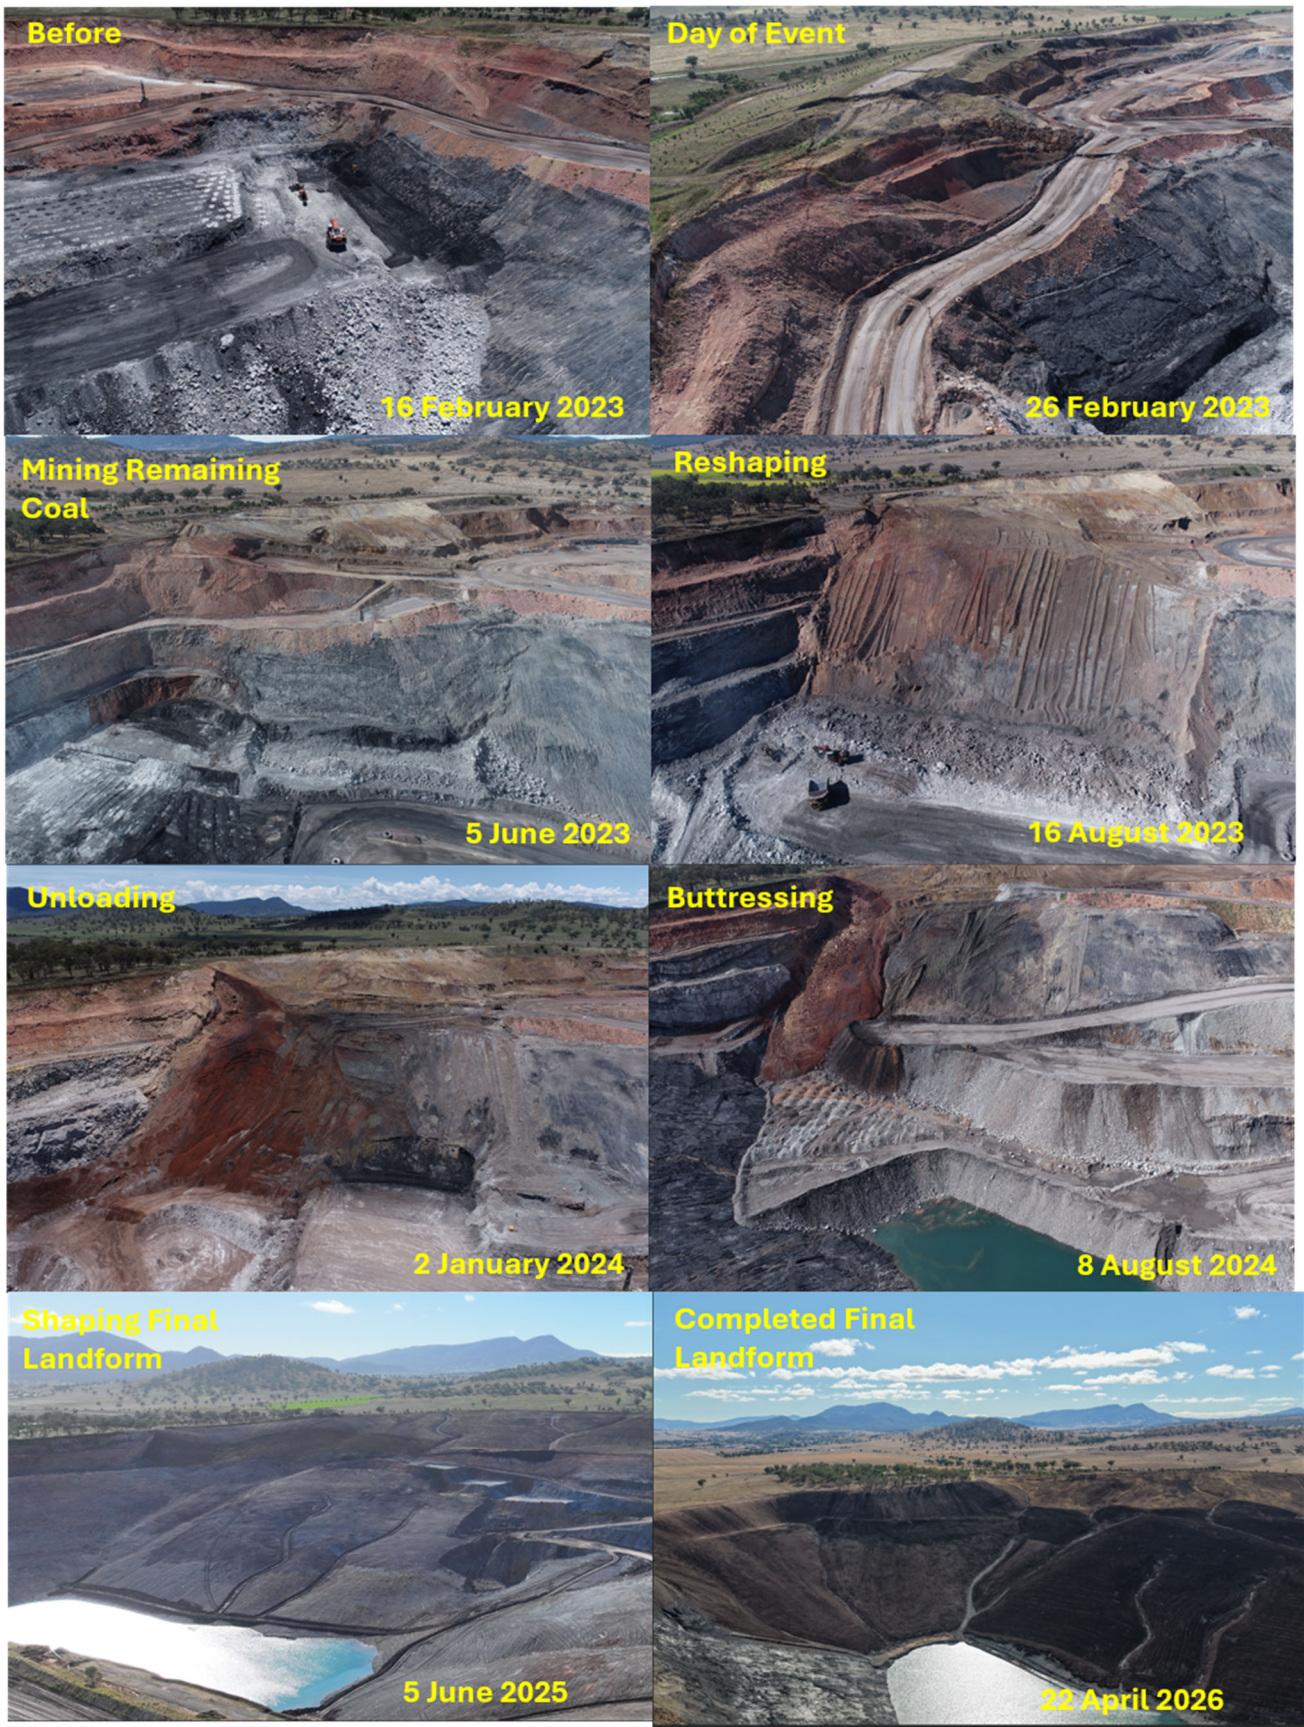
Figure 10 Eastern slope progression to final landform

A progression of the concurrent slope failure mitigation, final resource extraction, and formation of the final safe and stable landform is presented in Figure 10.
