# Dirt, design and downpours: the Maules Creek Coal Mine landform case study

Emma Bulkeley<sup>a,\*</sup>

<sup>a</sup> Whitehaven Coal, Australia

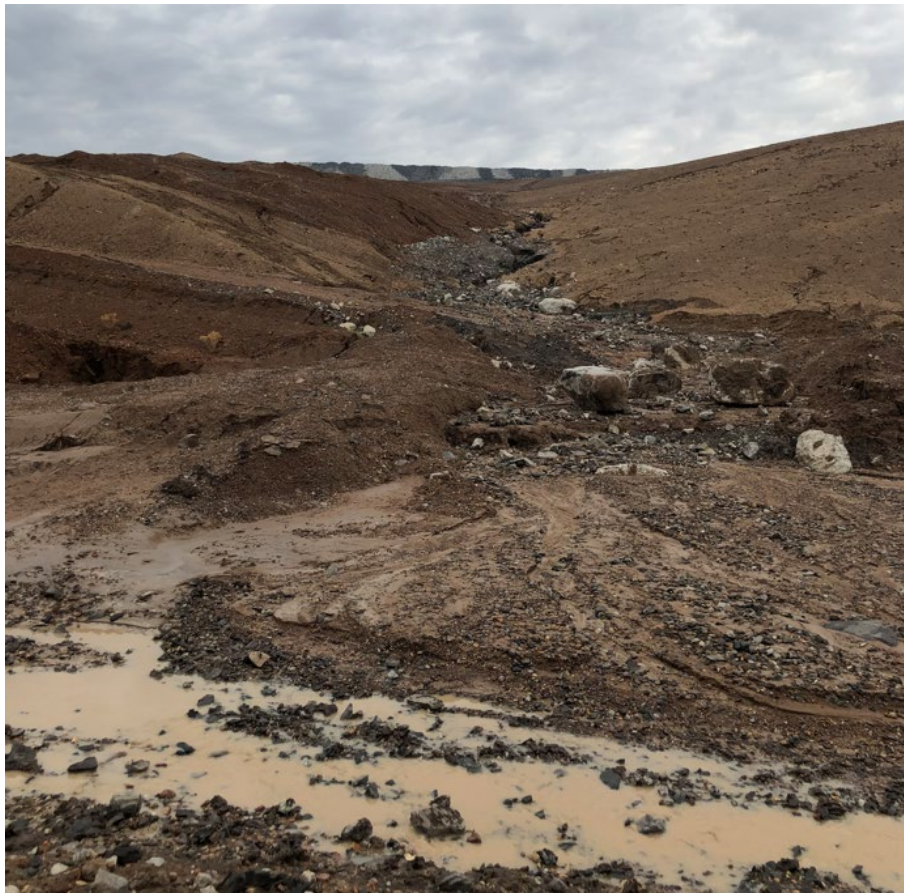
Construction of the geomorphic landform and, specifically the drainage structure and adjacent slopes, was still underway during onset of the traditionally wetter summer season, which began with an intense storm in

January 2020. Topsoil was also still stockpiled to the left of the drainage structure, and rock lining was yet to be installed. The combination of an exposed geomorphic slope (rock and vegetation cover) and the concentration of run-off from the adjacent linear slope resulted in flow velocity contributing to the erosion and damage. This led to failure of the drainage structure, and material wash-down (Figure 4).

**Figure 4 Status of the geomorphic landform adjacent to the failed drainage structure following an intense summer storm (January 2020)**

Discharge from the drainage structure flowed into a perimeter surface drain designed to convey run-off to a sedimentation dam. The outlet entered the surface drain at approximately 90°, directing flow into the opposite batter. This caused localised erosion of the surface drain wall, breaching containment, and allowing water to flow into a non-operational area of the mine.

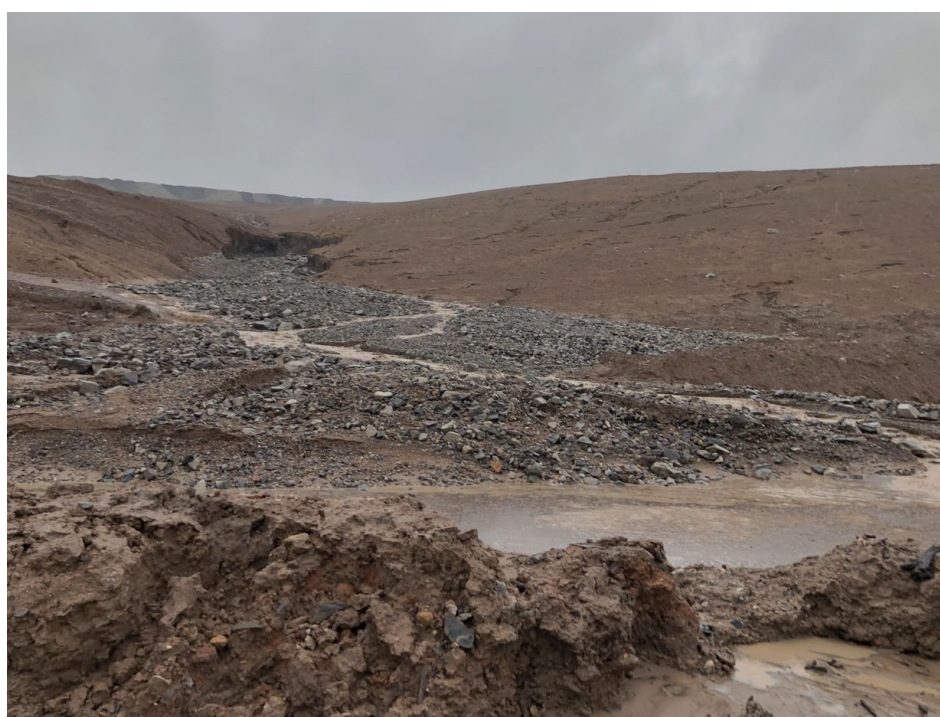
While not uncommon for the region, the intense summer storms observed at MCCM in January and February 2020 demonstrated that the combination of prolonged drought, reduced material stability and partially completed drainage structures, when subjected to high-intensity rainfall, resulted in a significant increase in run-off and erosion potential. This led to degradation of the landform and the observed drainage and slope failures (Figure 5).

**Figure 5 Status of geomorphic landform following second intense summer storm (February 2020)**

The landform was also in its most vulnerable state during this period, as vegetation had not yet established across the rehabilitated surfaces. Dressler & Waygood (2025) identified that geomorphic landforms are subject to additional erosion risks during the revegetation phase, when surface materials are more vulnerable to erosive forces and vegetation cover has not yet developed sufficiently to provide surface protection. As vegetation cover develops, erosion rates reduce and landform stability progressively improves through increased surface protection, improved infiltration and reduced run-off velocities (Hancock et al. 2019; Dressler & Waygood 2025). Consistent with these findings, MCCM landform evolution modelling identified the period prior to vegetation establishment as representing the greatest risk to long-term landform performance, with stability improving substantially as vegetation cover developed.

- The period immediately following construction and prior to vegetation establishment represents the highest risk period for geomorphic landforms. Rehabilitation activities should therefore be scheduled to maximise opportunities for rapid vegetation establishment and surface stabilisation, reducing erosion risk and improving long-term landform performance.

Forward forecasts are now reviewed to determine appropriate timing for rehabilitation activities. This allows reshaping, topsoiling and plantings to be undertaken within an optimal seasonality window. (MCCM now targets completion of rehabilitation in spring, allowing late spring rainfall to support germination of cover crops, providing both surface protection and increased infiltration across the constructed slopes).

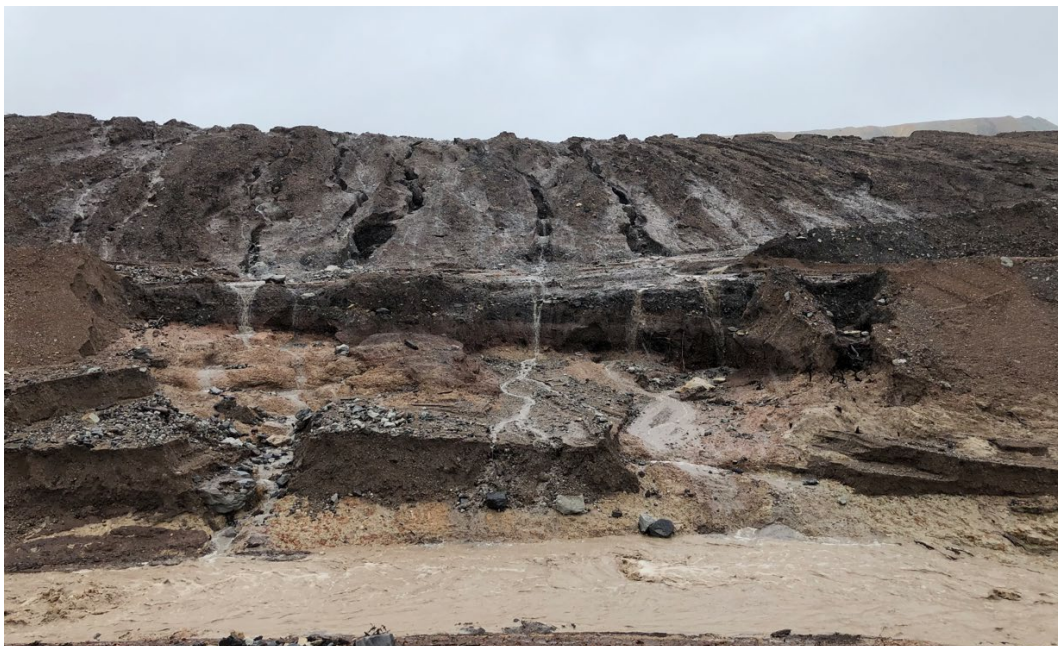
Compaction of drainage structures was difficult to achieve, as the dry spoil materials were more difficult to compact into a suitably stable foundation. To compensate, operators undertook multiple passes. However, this resulted in further breakdown of soil structure rather than improved compaction, resulting in poorly bound and unstable surfaces. When high-intensity rainfall events occurred, these surfaces rapidly lost cohesion, resulting in severe erosion and, in some cases, failure of the drainage structures.

Compounding the spoil issues, the topsoils were also affected by the drought conditions. The clay-based soils had dried and hardened. When re-spread over shaped landforms, they formed a dense surface layer that reduced infiltration; which resulted in more water reporting across the slopes and to the drainage structures. This exacerbated the strain on the drainage structures, with water using any variations within the landform as a preferential flow path. As a result, not only the drainage structures were under pressure, but the slope itself saw multiple instances of rill erosion from the movement of water (Figure 6).

**Figure 6 Erosion across the constructed geomorphic landform (following 8 February 2020 rainfall event)**

Following the initial extreme weather event (January 2020), slopes became saturated and unsafe for equipment access, preventing rectification works from being undertaken. As a result, the already damaged slopes and drainage structures remained exposed. Prior to repairs being completed, the February 2020 summer storm occurred, further exacerbating the existing damage and significantly increasing erosion and structural degradation across both the slopes and drainage network.

The size of rehabilitation campaigns has also been reduced. Smaller catchment areas are easier to manage in terms of overland flow during high-intensity storm events (as commonly experienced in the Gunnedah Basin). Rehabilitation areas have been reduced in size, with individual areas being no more than 30–50 ha. This has resulted in reduced upslope surface run-off requiring routing across the rehabilitated landform and, consequently, reduced risk of erosion.
