# Internally draining rehabilitation: lessons from several decades of experience at Newlands Coal Mine

*Newlands Mine, a large-scale open cut and underground coal operation in central Queensland Australia, operated from 1983 to 2023. Over its operational life, multiple landform design strategies were trialled, creating a valuable long-term record of rehabilitation performance and evolution.*

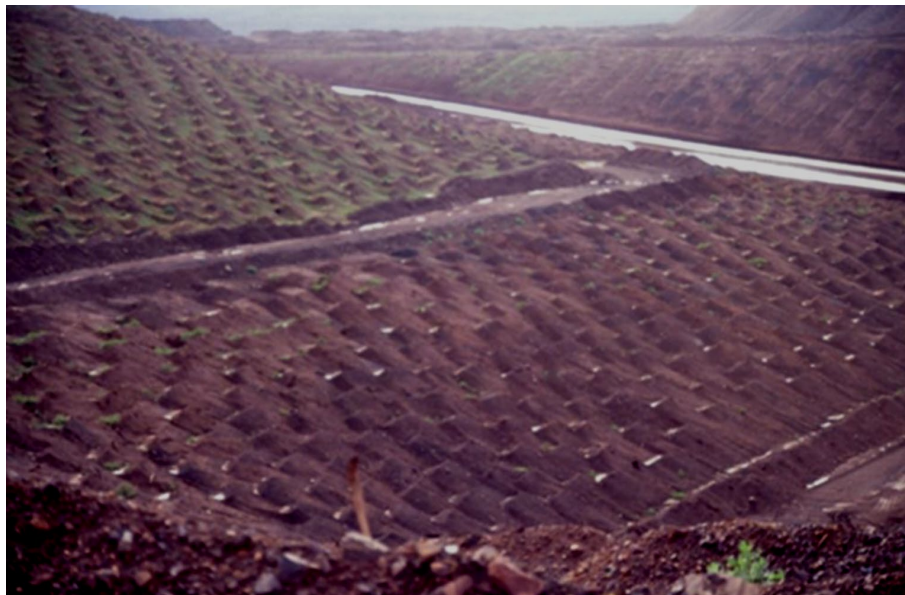
**Figure 1** Successful moonscaping in Western Australia, iron ore mine, after a major cyclone (Note: Photo taken by H. Jones in 1978 as presented in Jones et al. [2012])

The concept of moonscaping is conceptually similar to IDR referred to at Newlands. Moonscaping controls rainfall run-off in a manner that minimises erosion and maximises rainfall infiltration to assist in the development of a sustainable vegetation cover. Moonscaping was implemented through the formation of scallops in the landform as depicted in Figure 1. This photograph was taken following a cyclone and apparently performed very well.

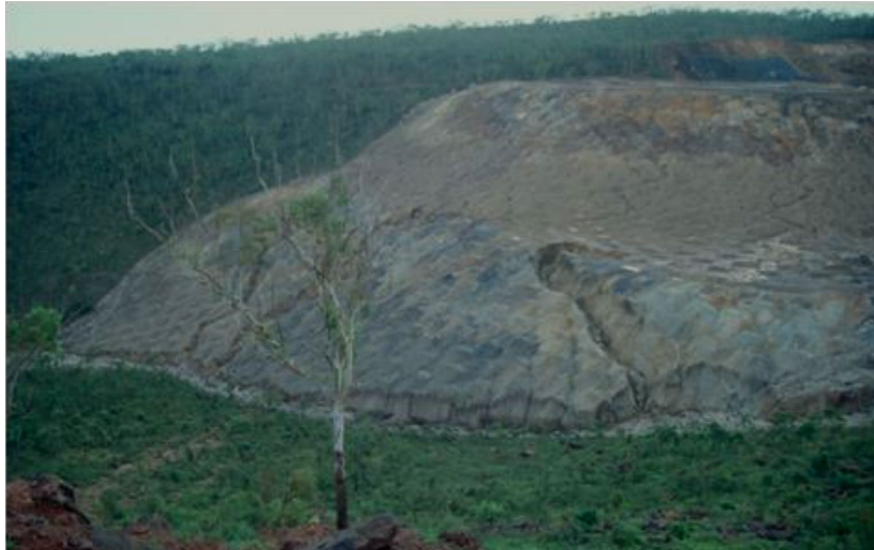
There are examples from Western Australia where moonscaping approaches have not been successful. The example presented in Figure 2 shows a cascade failure that occurred in 1998. The failure was attributed to different physical properties of the waste materials and the more intense rainfall over a long period which resulted in major damage.

**Figure 2 Failed moonscaping in northern Western Australia in the first wet season after construction, iron ore waste dump (Note: Photo taken by H. Jones in 1998 as presented in Jones et al. [2012])**

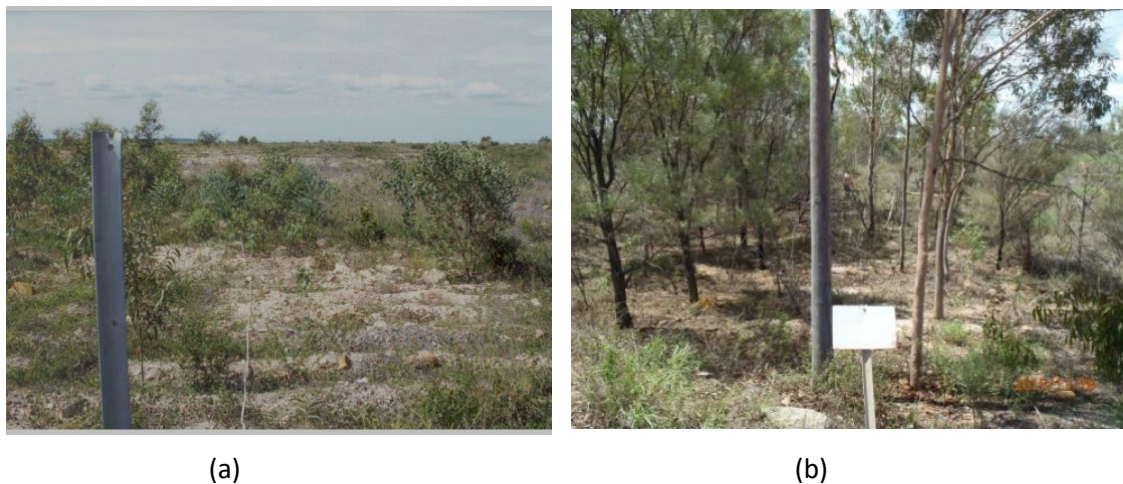
**Figure 9** Photograph of LFA 13 taken (a) December 2000; (b) November 2015
