Decommissioning Alcoa's First Bauxite Mine in the Jarrah Forest of Western Australia — Cradle to Grave

C. Grant *Alcoa World Alumina Australia, Huntly Mine, Australia*

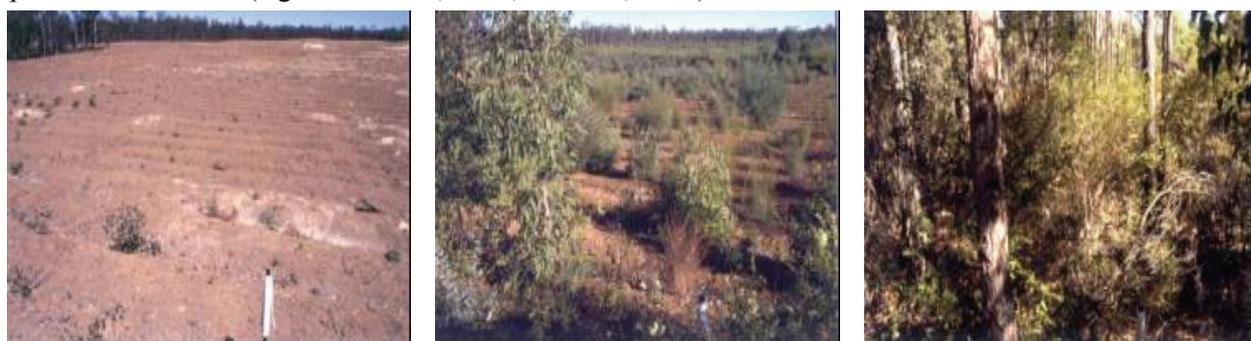
Figure 2 Time sequence photos of one restored site at 1 (left), 2 (middle) and 13 (right) years of age

The restoration process starts with shaping the mine pit, returning the soil and ripping to 1.5 m deep using a bulldozer with a winged tine. Logs and rocks are returned to provide habitat for native fauna. Seeds of local plants are spread, and nursery-grown plants are planted for species where seed is not a viable method of establishment. A fertiliser mix is then applied in late winter or early spring using a helicopter. Establishment of vegetative cover is rapid (Figure 2). A more detailed description of the restoration process is provided elsewhere (e.g. Ward et al., 1996; Gardner, 2001).

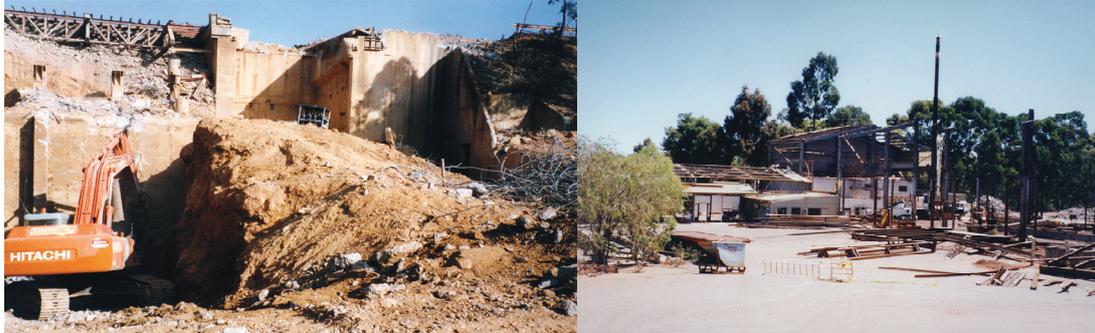
Figure 3 Removal of the crusher footings (left) and dismantling of the workshops (right)

All infrastructure such as buildings, workshops, fuel bays, power lines, water pipes and pumps, the sewage and waste water treatment plant was dismantled and removed from site (Figure 3). Two auctions were held at the mine, one for the crushing plant and another for the workshops, stores and other minor buildings. An Environmental, Health and Safety Inspection was undertaken in each area prior to any dismantling or demolition work to ensure safety and environmental issues were identified and managed. For all dismantled or demolished infrastructure, the following objectives were developed:

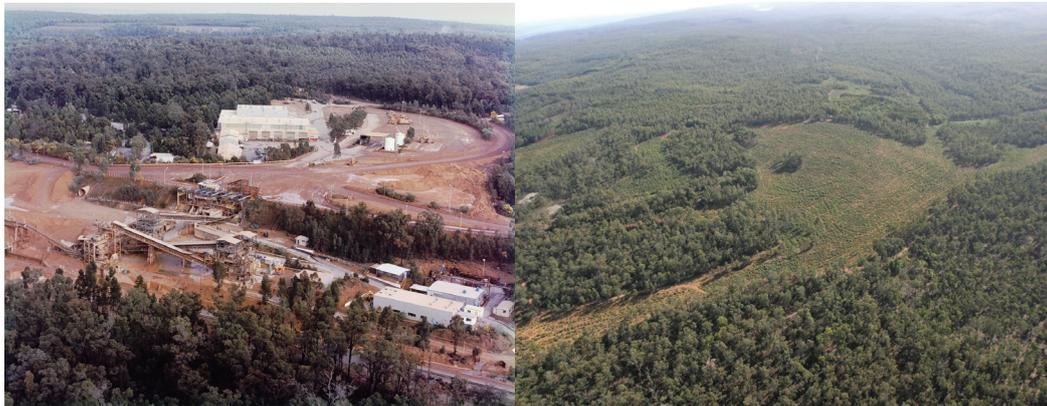
Figure 4 Aerial photo of crusher and workshop area at Jarrahdale during operations (left), and after decommissioning and rehabilitation (right)

The Jarrahdale Mine was regulated under the Mine Safety and Inspections Act (1994). As the mine was no longer operational, Alcoa requested clearance from the Department of Industry and Resources (DoIR) indicating that its requirements relating to mine safety had been met. Following a site inspection, a letter was received from DoIR in 2004 outlining that all infrastructure had been removed and the site had been left in a safe condition (Figure 4).

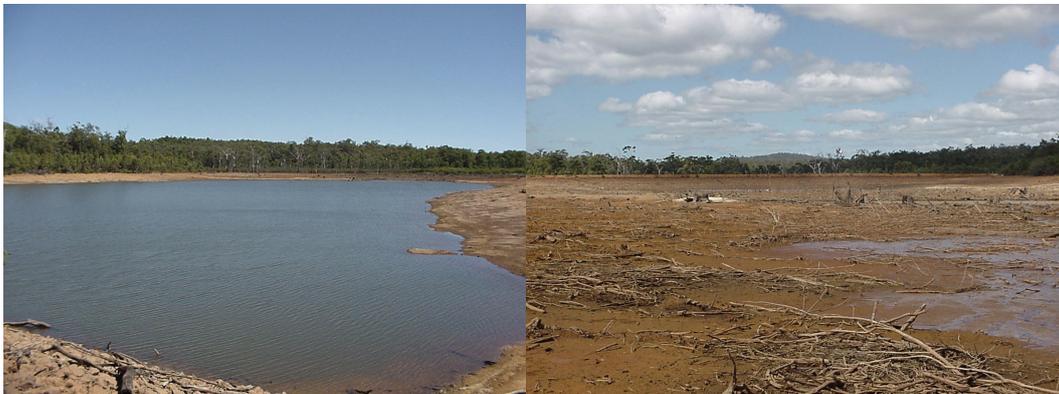
Figure 5 Chandler Dam during siphoning process (left) and at the completion of the process in April 2000 (right)

After the winter rains had finished in 1999, siphons were used to lower the water level of the dam (Figure 5). The water was siphoned into the stream zone area below the dam. Once the water level was sufficiently low, the dam wall was removed and the fill material placed around the edges of the dam and landscaped to blend into the existing terrain. The edges of the dam were ripped and seeded with tree and understorey species native to the area. Through the middle of the original dam floor, the pre-existing stream zone was established. This consisted of a permanently and a seasonally wet area. These areas were seeded with local species to encourage the establishment of vegetation to minimise the movement of sediment material. Monitoring of turbidity levels was undertaken downstream of the dam for three winters and the results indicated that the rehabilitation of the dam had been successful in minimising mobilisation of sediment.

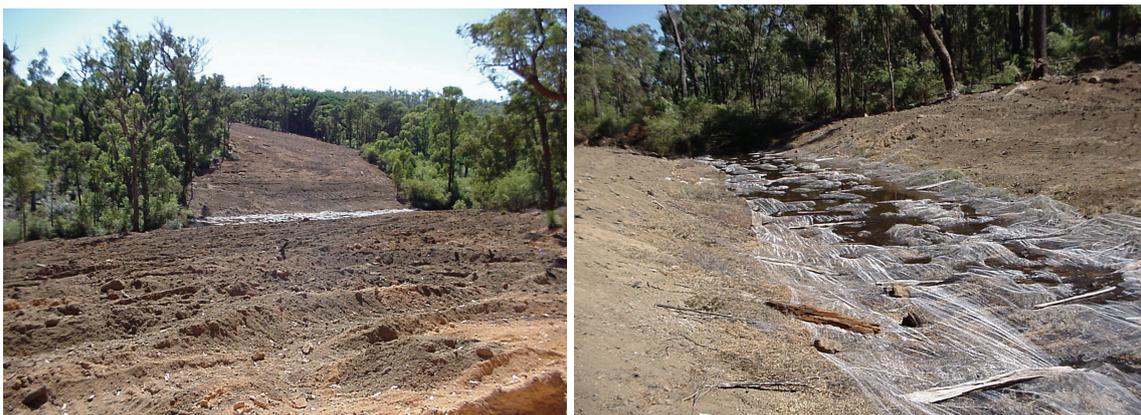
Figure 6 Rehabilitation of a haul road stream crossing: from a distance (left) and close-up (right)

- Removal of haul roads in stream areas during the latter part of the summer months when stream and underground water levels are at their lowest.
- Removal of all fill material from the stream zone and landscaping the area to blend with the pre-disturbance stream formation.
- Removal of all geofabric placed on top of the stream bed when the haul road was constructed.
- Placing tea tree brush in the stream zone and on the edges of the stream. The tea tree was held in place by biodegradable mesh onto which rocks and logs were placed (Figure 6). This helped to prevent erosion in the stream area and also encourage the quick establishment of tea tree plants to stabilise the site.

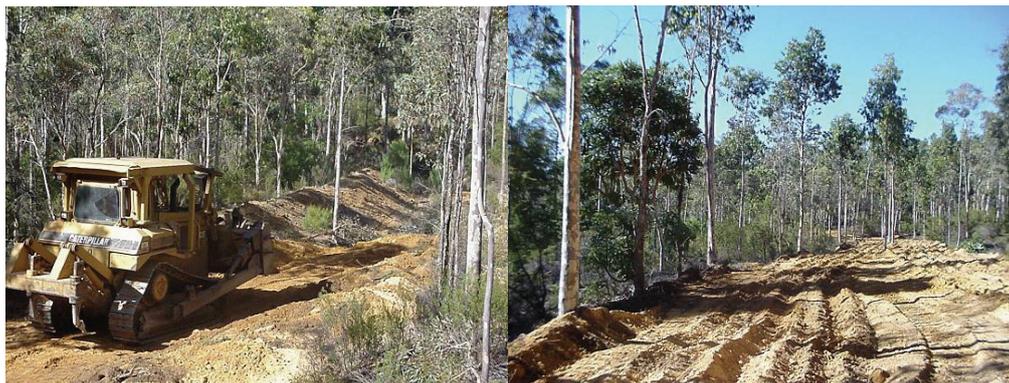
Figure 7 Removal of a contour bank from a pre-1988 rehabilitation pit (left) and subsequent re-rehabilitation of the area (right)

The assessment determined whether the site was exhibiting sustained growth and development. If a site received a low score it was reviewed with CALM to determine the need for corrective action and the extent of rework required to improve the site. Re-work prescriptions aimed to favour the re-establishment of jarrah forest species and suppress the re-establishment of non-native species. Areas that did not meet the standards due to the presence of significant infrastructure, such as pit faces, were automatically reviewed with CALM regardless of growth on the site (Figure 7). Following these inspections, a total of 133 ha was identified as requiring further rehabilitation. These areas were rehabilitated according to the post-1988 rehabilitation completion criteria and monitored accordingly. While all re-rehabilitated areas eventually met the appropriate criteria, the quality of the rehabilitation in these areas was uniformly lower than areas being rehabilitated for the first time. This emphasises that further disturbance of rehabilitated areas should be avoided wherever possible as the end result may be even worse than the existing current condition. Remedial action of the existing vegetation rather than complete removal of it should be the preferred option.

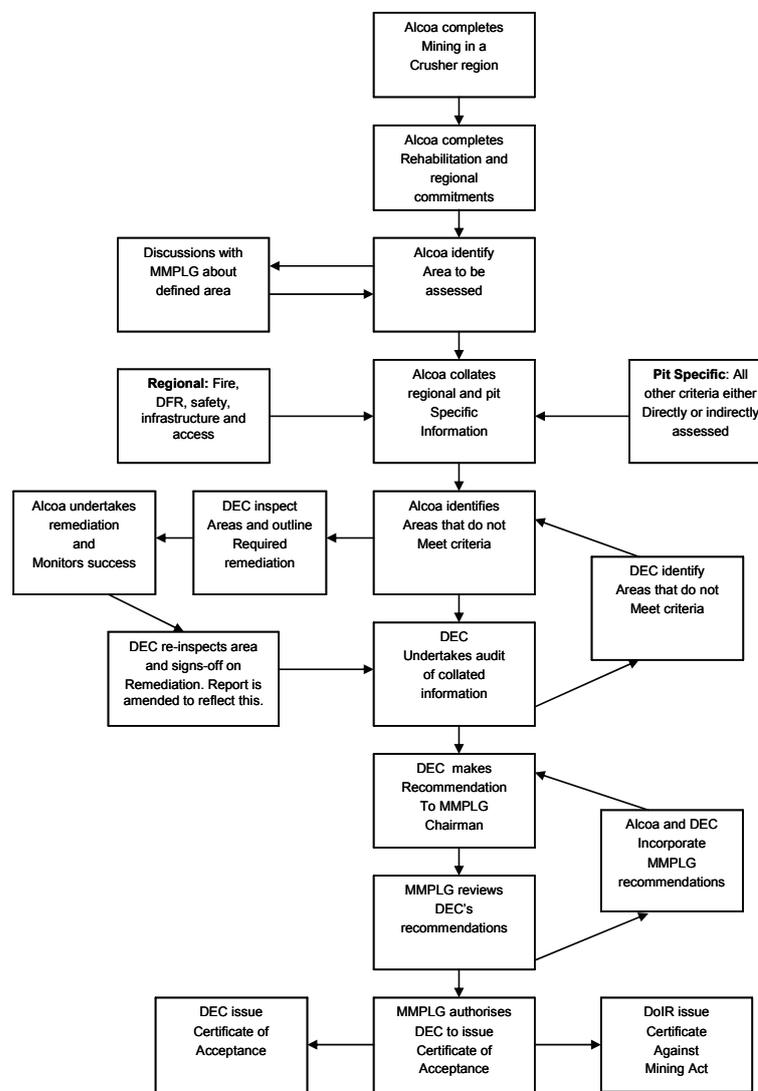
Figure 8 Detailed process for sign-off against completion criteria

Alcoa's completion criteria contained broad guidelines as to how responsibility for an area of rehabilitation would be relinquished and a certificate of acceptance issued, but no detail about how this would be administered. A detailed process was drafted in 2004 and eventually signed-off by the MMPLG in 2005 (Figure 8). An area containing 975 ha of rehabilitation at the Jarrahdale Mine was identified as the first one to be submitted to the MMPLG to ultimately receive a certificate of acceptance. The Water Corporation is proposing to undertake thinning and burning operations in the rehabilitation and surrounding unmined forest to increase water run-off into the adjacent Wungong Reservoir. This was one of the drivers for putting this particular area up for sign-off. A submission was made to the MMPLG in February 2005 and the first certificate of acceptance for a significant area of mining rehabilitation in Australia was issued in November 2005 (Figure 9).
