# A Reflection and Analysis of the Waste Rock Dump Closure Strategies at Kidston Gold Mine

**D.J. Williams** *The University of Queensland, Australia*

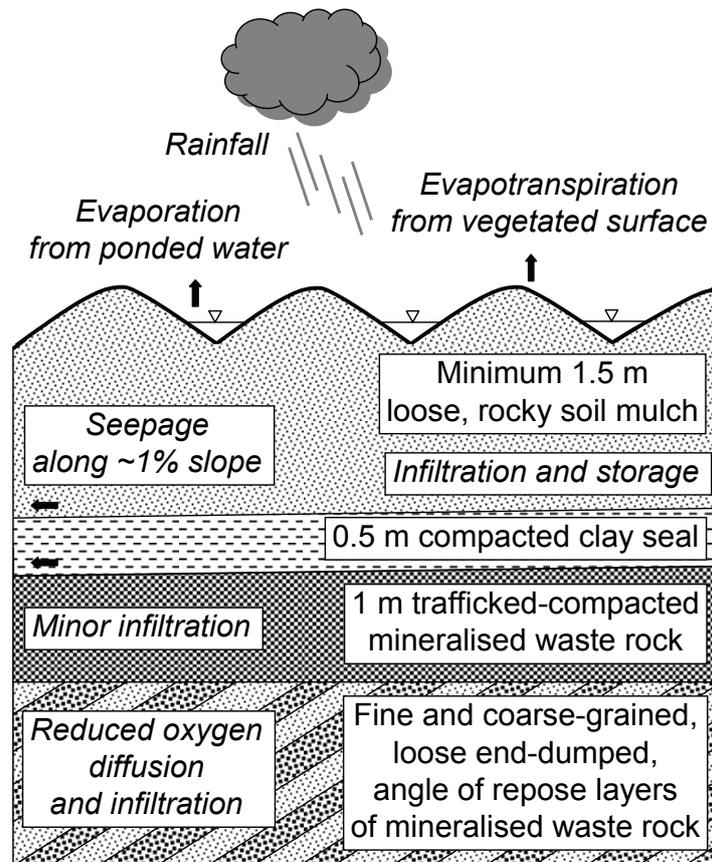
A schematic of the original store/release cover system used for the 23 ha South Waste Rock Dump trial cover is shown on Figure 1. Prior to the construction of the store/release cover, the top of the rock dump was sloped to prevent the ponding of any water that penetrates the cover. A near-saturated 0.5 m thick compacted clayey (fine-grained oxide waste rock) sealing layer was then placed, overlain by a loose rocky soil mulch (coarse-grained oxide waste rock) layer a minimum 1.5 m thick, which serves as the store/release layer and protects the underlying compacted clayey sealing layer.

**Figure 1** Schematic of original store/release cover system used for South Dump trial

The initial South Waste Rock Dump trial store/release cover referred to in Section 2.2 (and as shown in Figures 1 and 2) was aerially seeded in October 1996 with a mix of native and exotic species, and enrichment planted on the top of the mounds with tube stock over the following three years. Fertiliser (CK55 at 200 kg/ha) was applied at the time of sowing, with a further application of 200 kg/ha in June/July

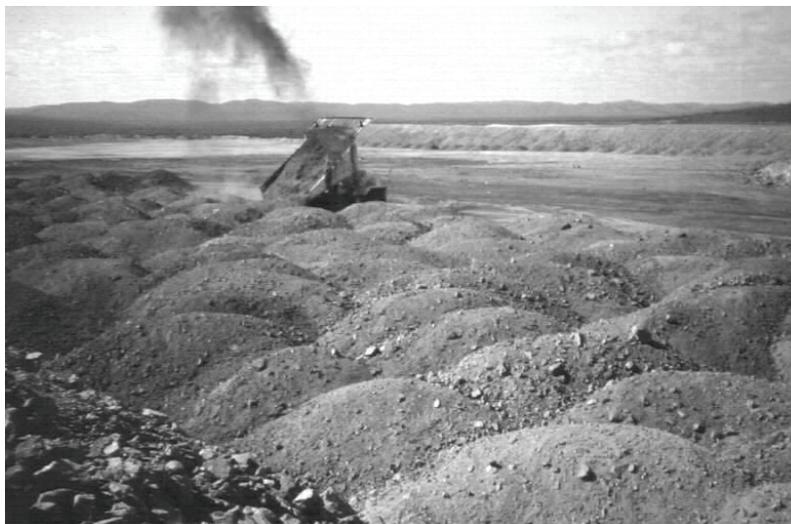
Figure 2 shows the placement of the rocky soil mulch layer by loose paddock dumping on the compacted clayey layer on the South Dump. The revegetation comprised grasses planted from seed, plus planted acacias and eucalypts, and volunteer acacias. Two years after planting, the grass growth was somewhat diminished due to the consumption of the initial fertiliser application, and acacias were the only other species that survived. More fertiliser was subsequently added to ensure sufficient ongoing consumption of stored water through transpiration, so avoiding the gradual wetting up of the cover over time. However, this additional fertiliser was also exhausted over time and the state of the vegetative cover was further diminished by the prevailing extended dry conditions. While the dry conditions would limit the potential for infiltration through the cover, the lack of a good vegetative cover could also limit the release of infiltration stored in the cover should a wetter than average period occur.

**Figure 2** Placement of rocky soil mulch layer on South Dump cover trial

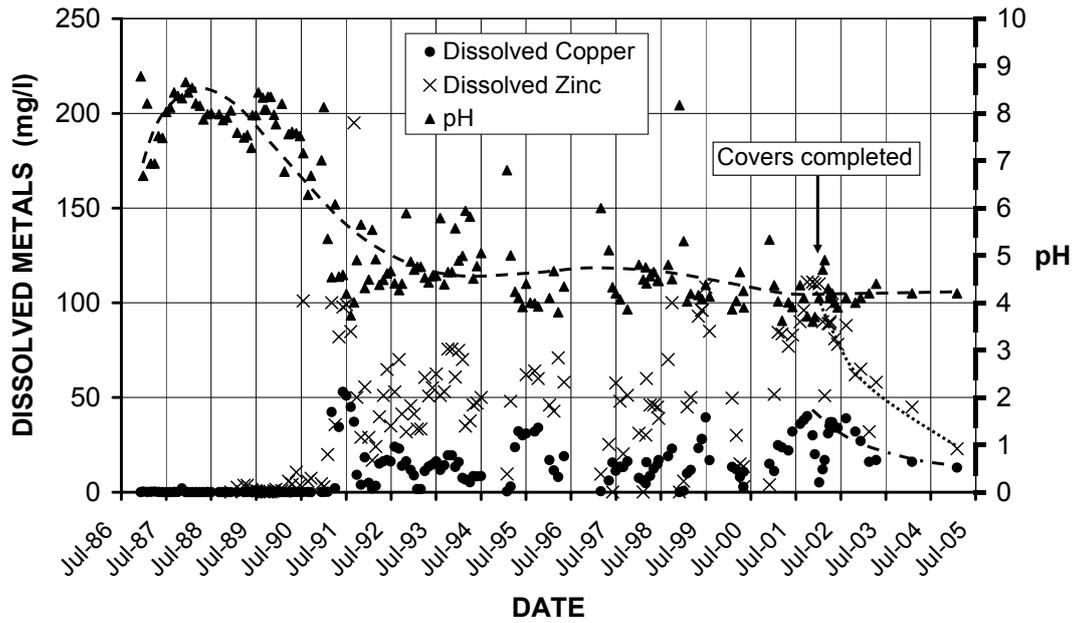
Water quality in the main toe seeps from the South and North Waste Rock Dumps has been monitored since late 1986. The monitored water chemistry parameters have included pH, electrical conductivity, sulphate, and a number of metals, including aluminium, arsenic, cadmium, copper and zinc. Dissolved copper and zinc concentrations and pH levels for the main toe seep from the South Waste Rock Dump are plotted against time on Figure 3, together with some trend lines.

The 1 in 140 year 1990/91 wet season, which followed a low rainfall 1989/90 wet season, generated spikes in pH (to a low of 3.2) and dissolved metals (dissolved copper to over 50 mg/l and dissolved zinc to over 100 mg/l). Over the next 10 years, the pH remained at about 4.5, and the dissolved copper and dissolved zinc concentrations averaged about 25 mg/l and 50 mg/l, respectively. Following the completion of the store/release covers over the entire flat top surfaces of the dumps by late 2001, the removal and processing in 2001 of the low grade ore stockpiled within the South Waste Rock Dump footprint, and the diversion to Wisers Hill Pit of mine water that previously flowed through the South Dump, the water chemistry of the dump seepage began to improve significantly, apart from the pH, which not unexpectedly has remained constant. The dissolved copper and dissolved zinc concentrations have reduced to 15 mg/l and 25 mg/l, respectively.

**Figure 3** Dissolved copper and zinc concentration and pH levels for main toe seep from South Dump versus time

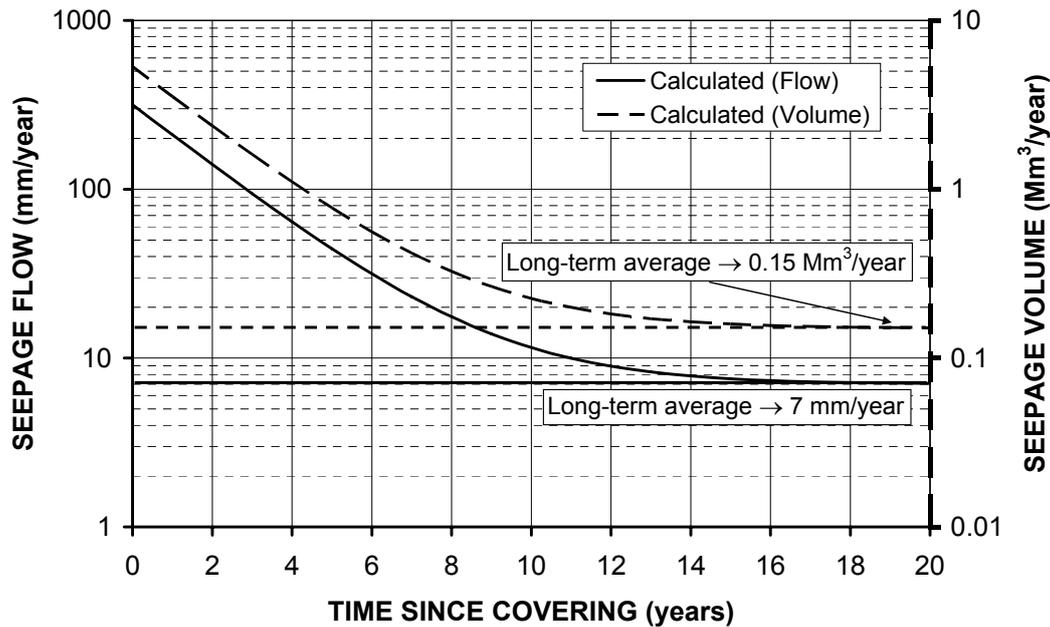
Figure 4 shows both the predicted seepage flow rate (left hand vertical scale) and the predicted seepage volume (right hand vertical scale). After about 17 years (end of 2018), the seepage flow rate is predicted to approach that percolating through the cover (about 7 mm/year) and the seepage volume will be limited to that percolating through the side slopes, which comprise 10 to 15% of the surface area of the dumps, amounting to ongoing relatively clean seepage at a rate of perhaps  $0.15 \text{ Mm}^3/\text{year}$ .

**Figure 4** Predicted decline in toe seepage from waste rock dumps

V-notch weirs were installed at the main toe seeps from the South and North Waste Rock Dumps at Kidston in October 2002 and have shown an exponential decline in seepage flow rate over time due to the minimal additional rainfall infiltration since the dumps were covered. Based on the estimated wetting up of the dumps due to rainfall infiltration during the 15-year operation of the mine (Williams and Rohde, 2006), and the measured exponential decline in seepage flow rate since the dumps were covered, the ongoing decline in seepage from the toe of the waste rock dumps shown on Figure 4 was predicted. This prediction was based on the determination of the unsaturated hydraulic parameters of the waste rock comprising the dumps.

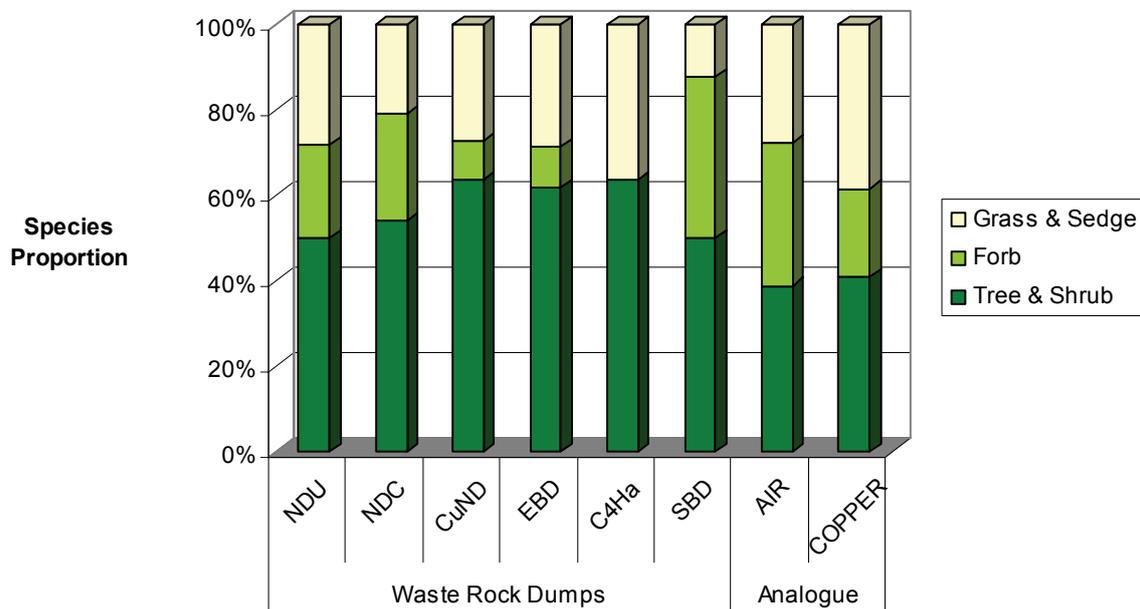
A summary of some of the vegetation characteristics for the waste rock dump sites and comparisons with two unmined “analogue” sites (the Airstrip and Copperfield sites) are presented on Figures 5 and 6. Figures 5 and 6 show the often quite rapid development of structural similarities between the mined and unmined sites. While the species richness and diversity levels of the analogue sites is not yet being detected through the monitoring programs on the rehabilitation areas, the surface roughness and the increasing amount of leaf litter that is now accumulating in the landscape of even the youngest sites, does provide the opportunity for these sites to progress towards meeting agreed end-point criteria.

**Figure 5** Proportions of species in each life form for waste rock and analogue sites

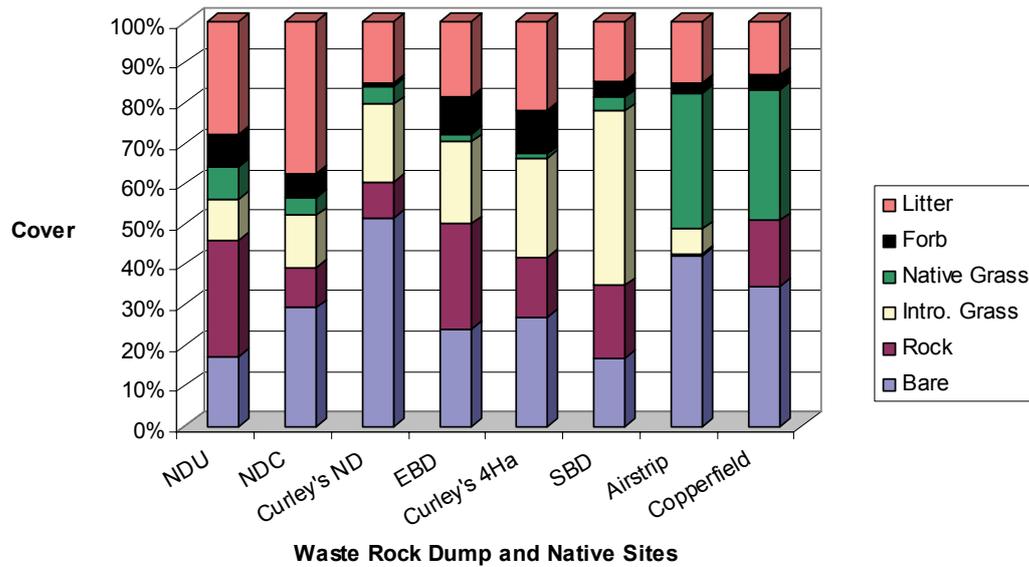
**Figure 6** Cover proportions for waste rock dump sites compared to analogue sites

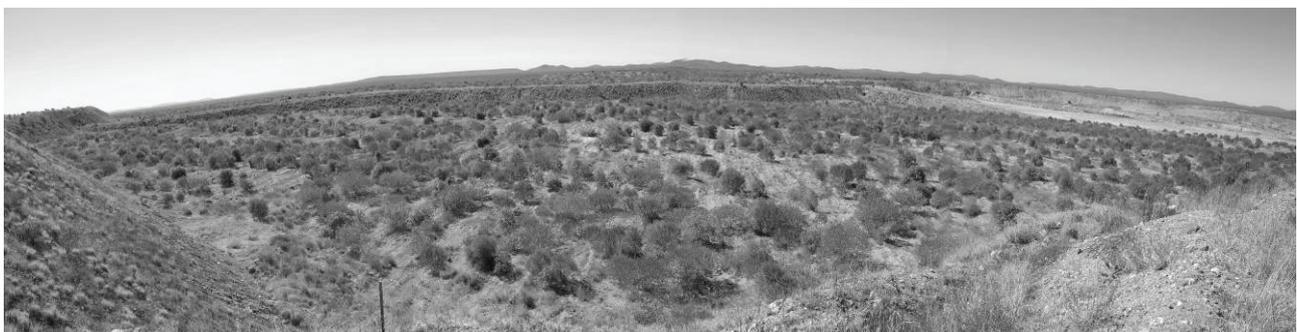
**Figure 7** A view across top of North Dump, 2 years after shrub and tree seeding

The vegetation characteristics for the North Dump in 2005, established 3.5 years, are summarised in Table 1, and the state of the shrub and tree development after 2 years are shown on Figure 7.

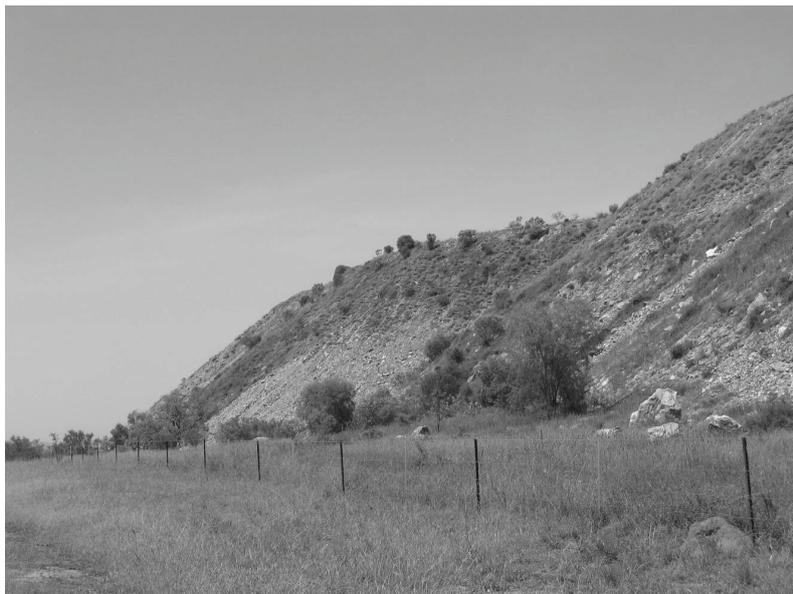
The outer batter slopes have been monitored both through measurements of erosion pin sets at the foot of various sections of the dump, and a photographic record maintained on an annual basis since 2001. The nature of the oxide deposition process from the crest of the dump meant that the loose unconsolidated material over the barren waste rock would run down the slope with rainfall events, but the proportion that is held up within and between the crevices of the blocky rock beneath has created a very effective sink for fines and other resources that provide the basis for encouraging a persistent vegetative cover. Figure 8 illustrates the effectiveness of this strategy, and over time, evidence suggests that vegetative colonisation of the batter slopes will proliferate.

**Figure 8** Revegetation of outer batter of East Dump within 3 years of seeding
