A GIS-Based History of Gold Mine Residue Deposits and Risk Assessment of Post-Mining Land-Uses on the Witwatersrand Basin, South Africa

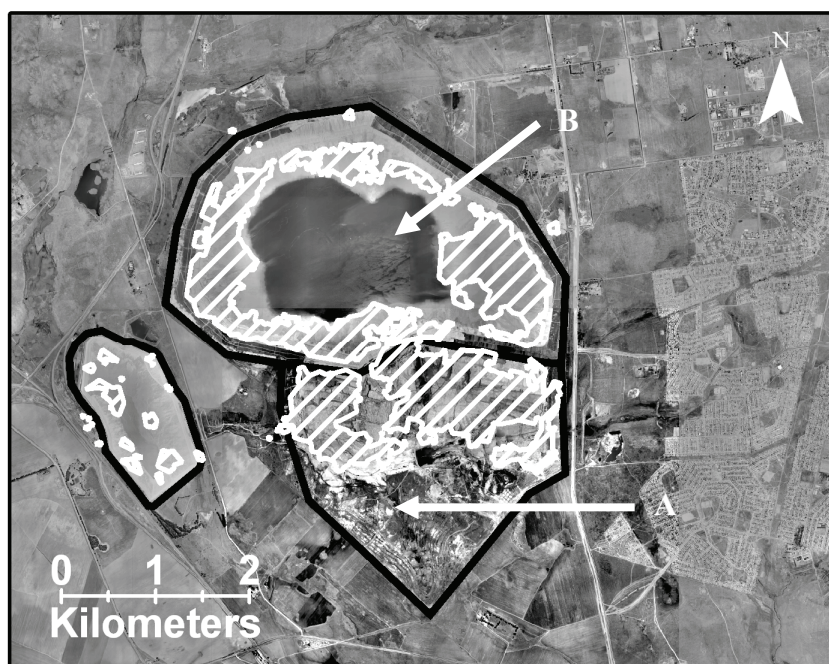
Figure 3 Aerial photograph of a partially removed slimes dam showing the presence of residue on the ‘cleaned’ part of the footprint (arrow A) whereas ASTER only detects minerals, including uranium-bearing minerals (white stripes), on the un-cleared part. Arrow B shows how water masks detection of minerals

We found positive associations ($p < 0.0001$) between four of the five minerals detected by ASTERS and all gold mine tailings (i.e. MRDs and spillage) detected from aerial photographs; the exception being chlorite (Table 5). Associations were greatest for slimes dams (i.e. active, dormant and being reworked). There was a positive association only between uranium-bearing minerals and slimes dam footprints ($p < 0.0001$) with two other minerals that are known to be present having a negative association (jarosite at $p = 0.0127$ and copiapite at $p = 0.0116$). Thus the aerial photographs appear to be a more reliable indicator of residual tailings material than ASTER thematic imagery of minerals (Figure 3, arrow a).

After removing the influence of MRDs, positive associations were found between spillages and all minerals except chlorite. These relationships were weak, with less than 2% of spillage associated with any of the minerals detected by ASTER. Since most of these minerals are known to be present, this indicates that the ASTER sensor is either not sensitive enough for these particular minerals at low concentrations, or that the minerals were not detectable as a result of the influence of water (i.e. primary minerals are masked by moisture, while many secondary minerals only form as precipitates (Figure 3, arrow b).

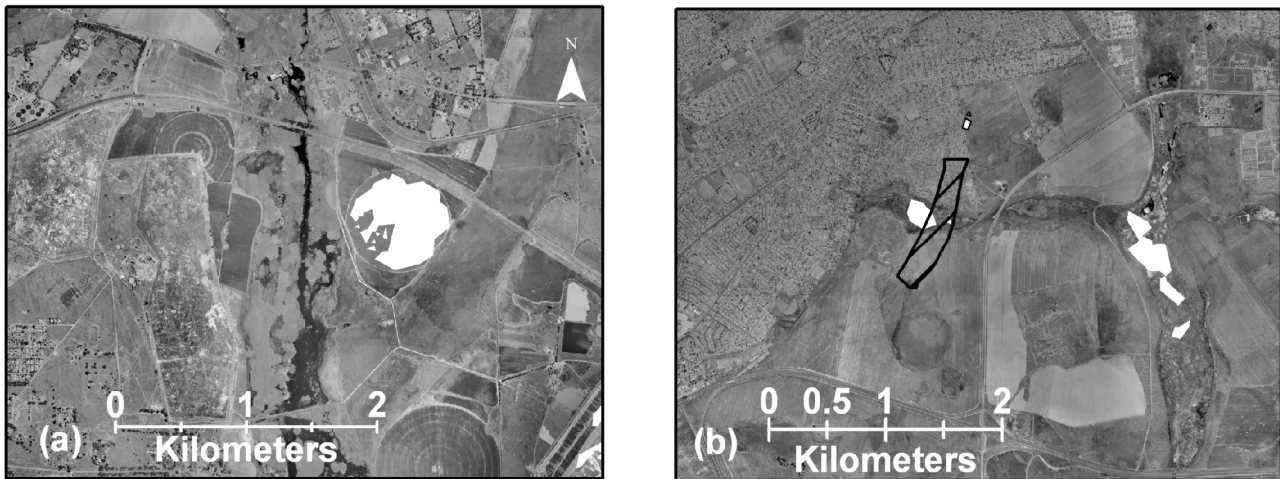
Figure 4 Aerial photographs (2003) with thematic overlay showing uranium-bearing minerals (solid white) on (a) irrigated agricultural land (a crop pivot) and (b) Black Reef outcrop (black stripes)

We found that uranium-bearing minerals were only detectable on irrigated agricultural land, and not on rain-fed agriculture, with over 6% of irrigated land showing uranium-bearing minerals (Table 6). The odds ratio of there being uranium-bearing minerals on this irrigated land was 960.21 times greater than for rain-fed, indicating that the possible uranium source was the irrigation water used for crops (Figure 4a). Irrigation water in the region comes from rivers and groundwater; both of which could be in receipt of natural uranium sources (e.g. reef outcrops or aquifers intersecting uranium-bearing reefs) as well as mining sources (e.g. dewatering or AMD). Our findings support those of Tutu et al. (2005) and Winde et al. (2004), both of whom found substantial evidence for the accumulation of various uranium-bearing minerals in areas of high evapotranspiration along rivers and streams across the Witwatersrand Basin. Mineral signatures that we considered typical of gold residue deposits and AMD, such as jarosite and uranium-bearing minerals, were also associated with reef outcrops (Figure 4b).

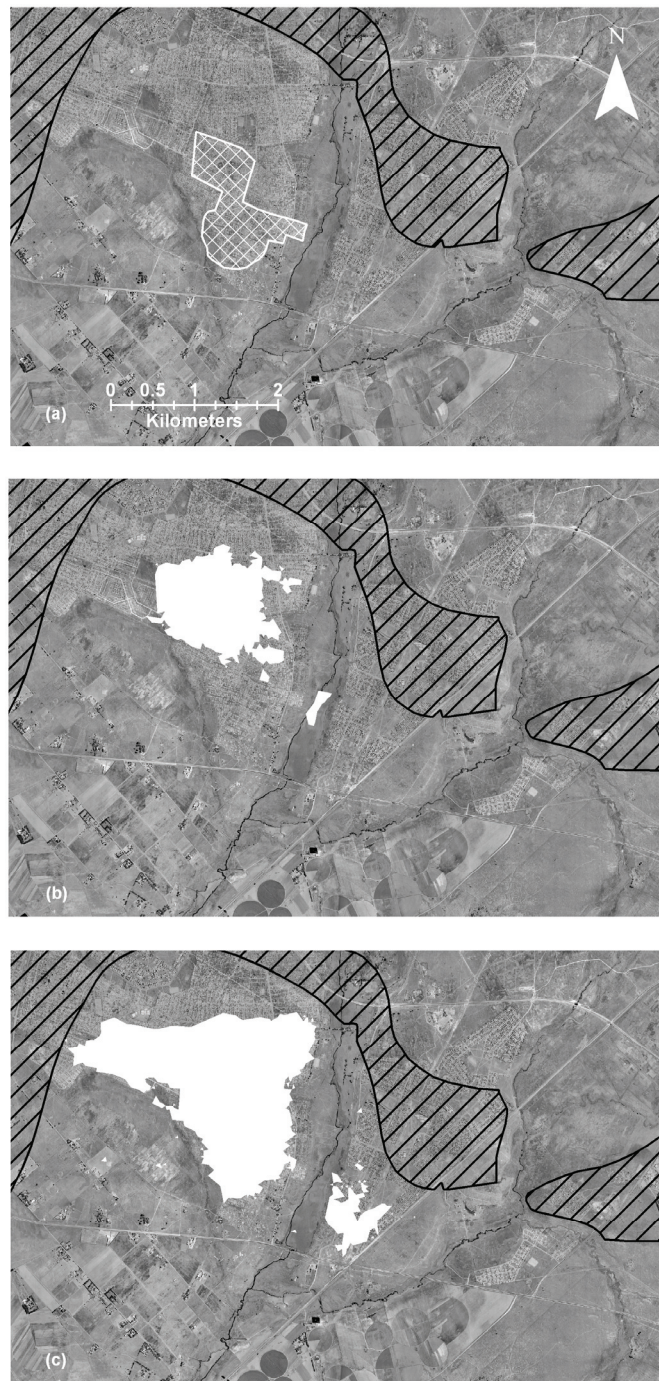
Figure 5 Aerial photographs (2003) of (a) former agricultural holdings (now residential) (white cross stripes), with ASTER thematic overlays in solid white for (b) jarosite and (c) uranium-bearing minerals. The presence of the black reef is indicated in black stripes

We found ASTER imagery useful for identifying previously unknown “hot spots” remote from likely sources. These included the irrigation pivots mentioned earlier, contamination downstream from sources, reef outcrops and a formal residential area some 13 km from the nearest gold mining activity. This residential area was associated with significant areas of uranium-bearing minerals and jarosite, possibly as a result of former land-use (irrigated agricultural land), and/or proximity to the Black Reef (Figure 5).
