# Rockfall Management at the Savage River Mine

**B.J. Hutchison** *Australian Bulk Minerals, Savage River Mine, Australia*

## Abstract

*Rockfall hazards are an everyday risk in most open cut mines. This paper describes the management techniques used to assess and mitigate rockfall hazards at the Savage River Mine located in the high rainfall environment of the west coast of Tasmania.*

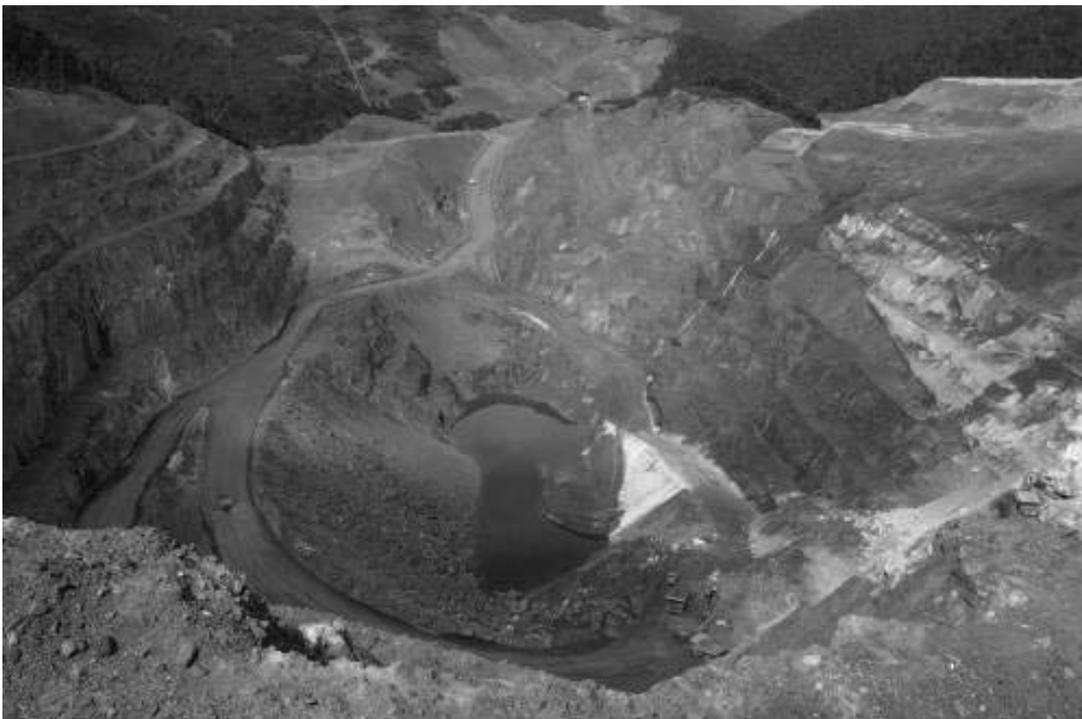
**Figure 1** Savage River mine's north pit

The Savage River Mine (Figure 1) on the west coast of Tasmania has been in operation since 1966 with a one year hiatus in 1995 during which an ownership change was made. The mine is located in a semi-temperate rainfall environment which experiences approximately 2000 mm of rainfall a year. The majority of the heavy falls occur during the winter and spring but all months of the year can experience significant rainfall.

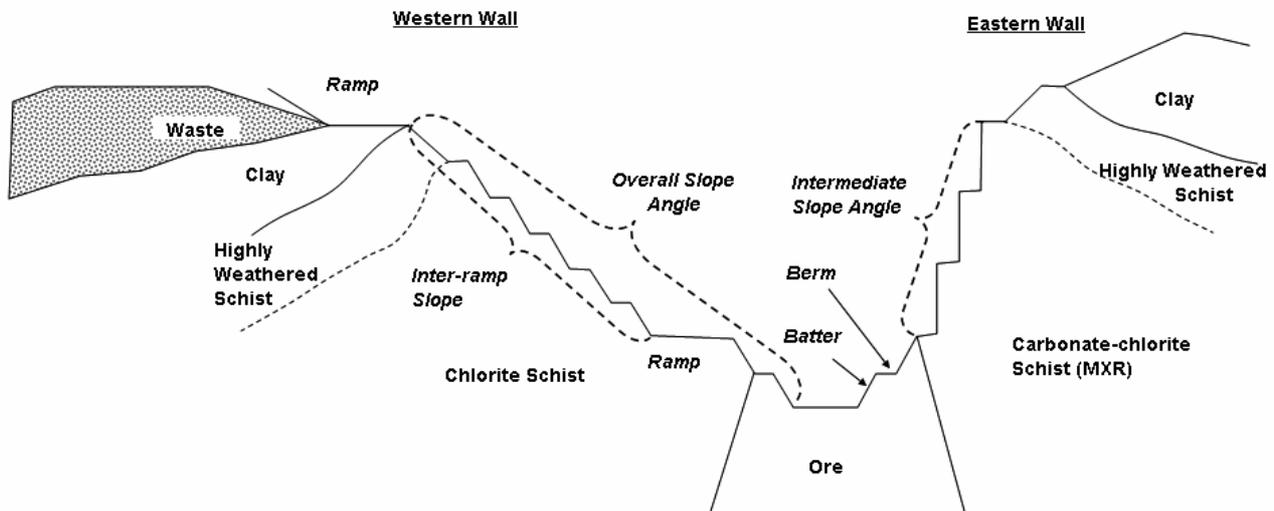
**Figure 2** North Pit geology and slope terminology

The northern, western and southern walls of North Pit are comprised of the weak chlorite schists and sheared magnetite ore bodies. A series of slowly developing topples and circular failures have been experienced over the years in these walls but rockfalls have generally not been a problem. These walls have been designed at 37 to 45° overall slope angles, with 50 to 60°, 20 m high batter slopes, as depicted in Figure 2, to cope with the potential large scale problems.

As ABM progressed their mining operations through a series of cutbacks the eastern wall intermediate slope angle in the MXR rock has been steepened from 47 to 63°. The photo in Figure 1 and the cross section in Figure 2 show the stark slope design contrast between the eastern and western walls.

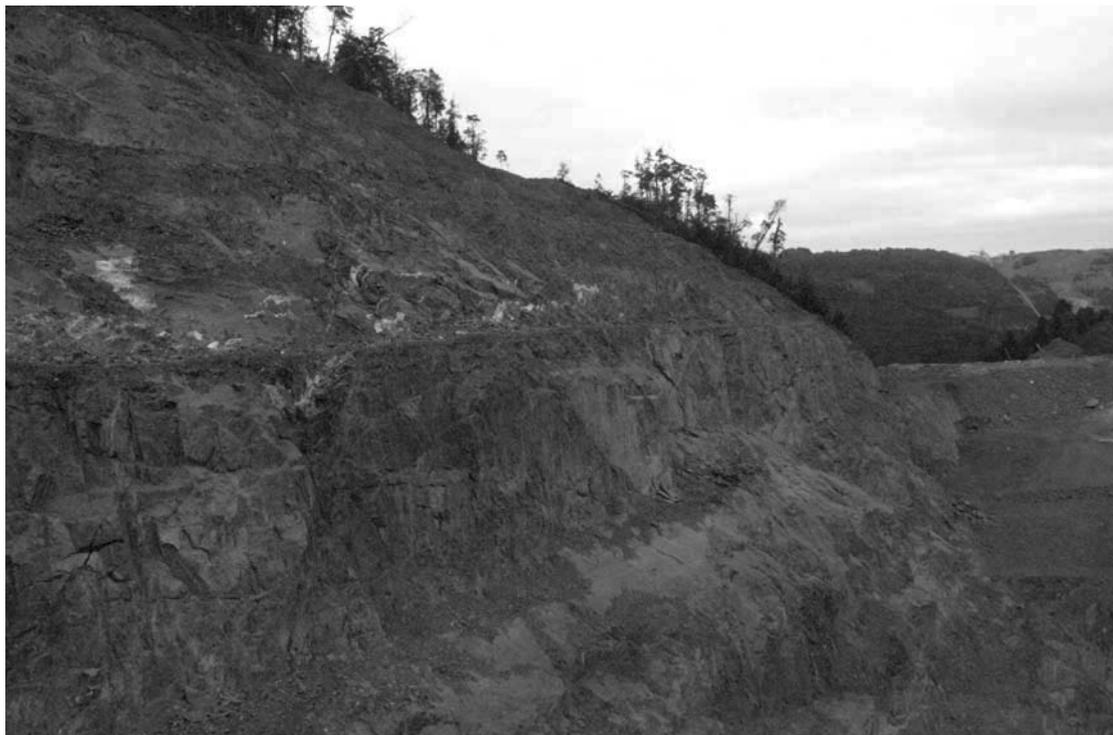
**Figure 3** North pit extension 3 berm loss due to unfavourable jointing

The latest extension 3 cutback design had a series of 20 m vertical presplit batters with 10 m berms to give the 63° intermediate slope angle. Unfortunately when the eastern wall was cut further back into the east wall, unfavourably oriented jointing was encountered over significant portions of the wall. These 40 to 60° westerly dipping joints caused the partial or complete loss of some of the 10 m wide catch berms, as shown in Figure 3, creating ski jumps for potential rockfalls.

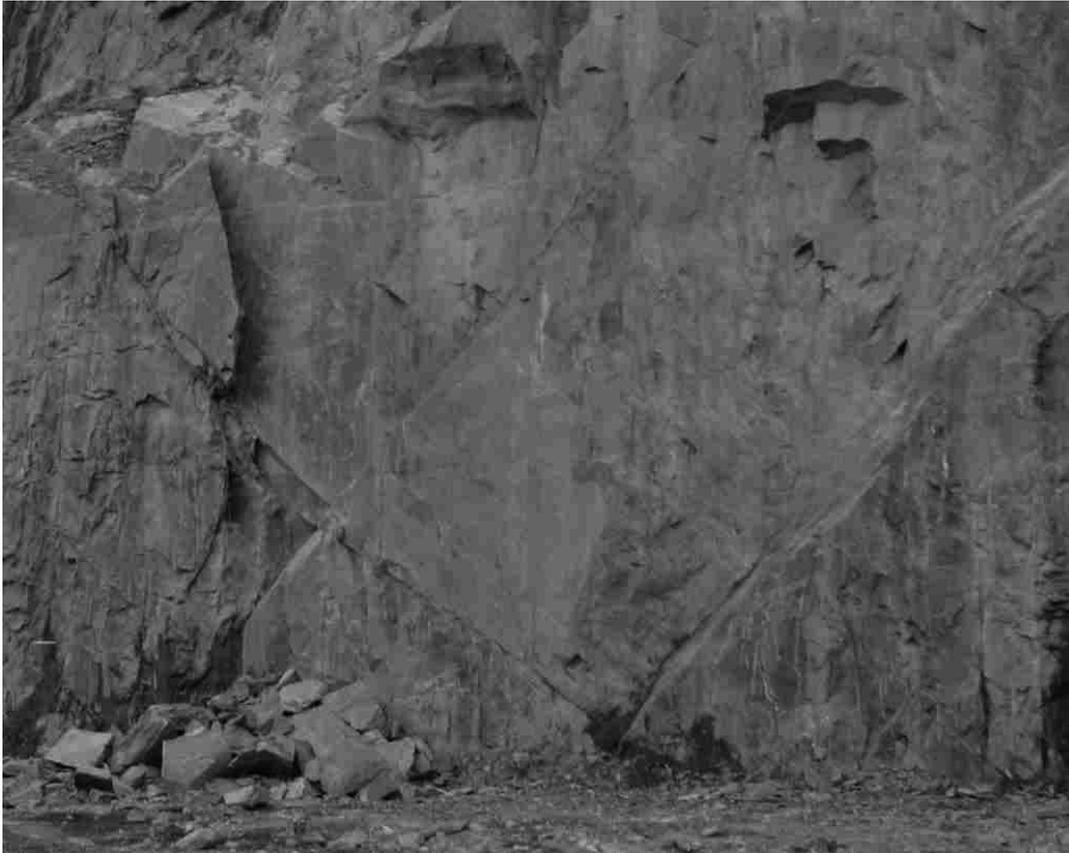
**Figure 4** Rock block failure instigated by blasting

Rockfalls from the east wall of North Pit are generally of two types. The first involves the loosening and toppling/sliding of large blocks or wedges from the batter face, refer to the example in Figure 4. These failures have often been instigated by blasting and several have been noticed within the first few minutes of a blast when the shot firers have been clearing the shot. In some cases the loosening of large blocks occurs over a long period of time and these can and have been identified by geotechnical inspections, for example Mat's Block, shown in Figure 5.

Occasionally rock block failures, such as that shown in Figure 4, occurred, but most were in unbolted ground. The bolting was carried out by mine site personnel. The drilling of the cable bolt holes was carried out remotely as described in Section 4.5. To reduce the risks to the grouting crew, geotechnical inspections were made before each grouting session, a GroundProbe Slope Stability Radar was also used to monitor rock movements (see Section 5) and the mobile rock catch fence was placed between the rock face and the men and equipment.

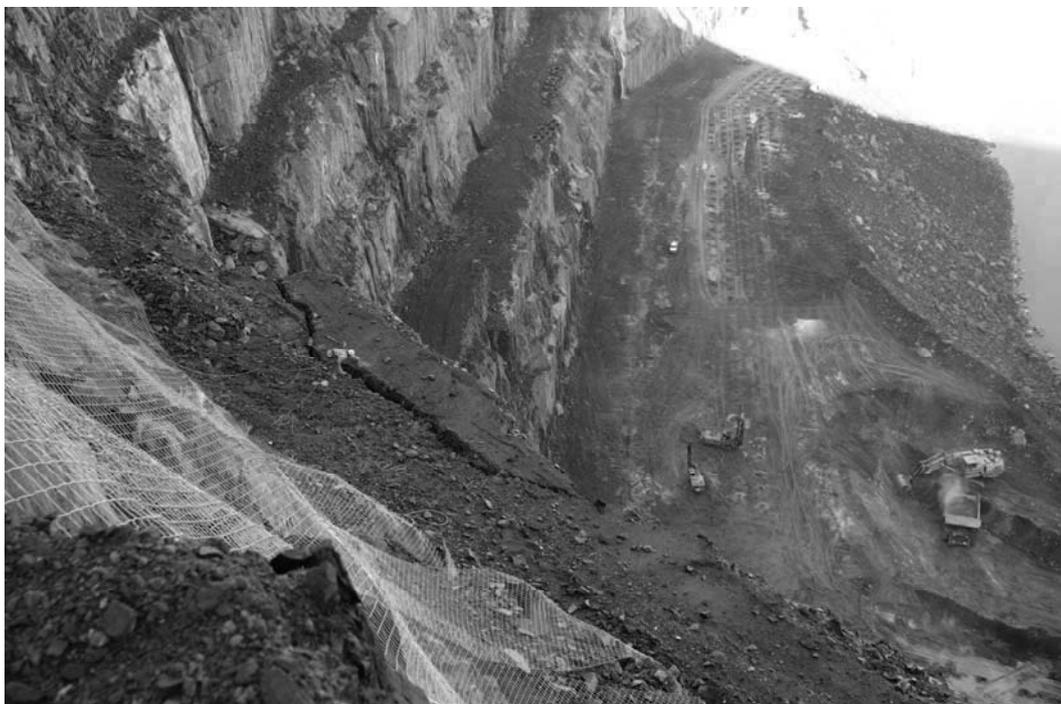
**Figure 5** Long term loosening and toppling of Mat's Block (110 m above work area)

ABM has also made an unsuccessful attempt at trying to employ rock climbers to effectively remove small loose blocks of rock from crest and batter areas. Due to access and base anchor placement problems this proved to be inefficient from both a cost and scheduling view point. Mat's Block, shown in Figure 5, was however successfully removed by blasting, see Figure 8, and then draping curtain mesh over the resulting face, see Figure 9. The block was approximately 20 m long, 2 m wide and 10 to 15 m in height. The job was complicated by a lack of access directly onto the block, with only walking access to the berm 15 m above. The block had been monitored for over a year, using photographs taken from the berm above to estimate changes in the crack development. The photographs were taken at intervals varying from daily to weekly depending on weather and blasting under the block.

Although there was no evidence of imminent failure the decision was finally taken to remove the block. After gaining access down onto the block via ropes and ladders it was deemed too risky to drill blast holes directly in the block itself, for fear this could destabilize the block during the drilling process. The explosives therefore needed to be packed directly into the crack; so there was the possibility of having a very disturbed back scarp following blasting. “Rocklink” curtain mesh was therefore deemed necessary to allow any loose and dislodged rocks to be directed down onto a berm 40 m below.

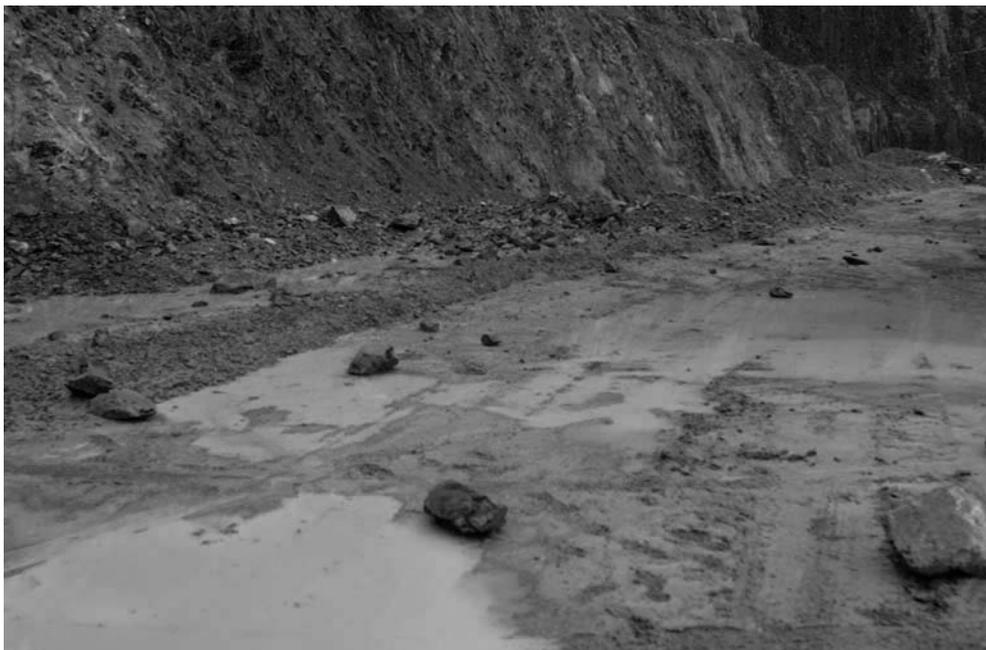
**Figure 6** Rainfall induced rockfalls

The second type of rockfall at Savage River involves small blocks of rock that get loosened by the blasting or are washed off the face during high rainfall events, refer to Figure 6. The source of these smaller blocks is often material from the batter crests where the rock gradually opens up along the steep foliation due to relaxation.

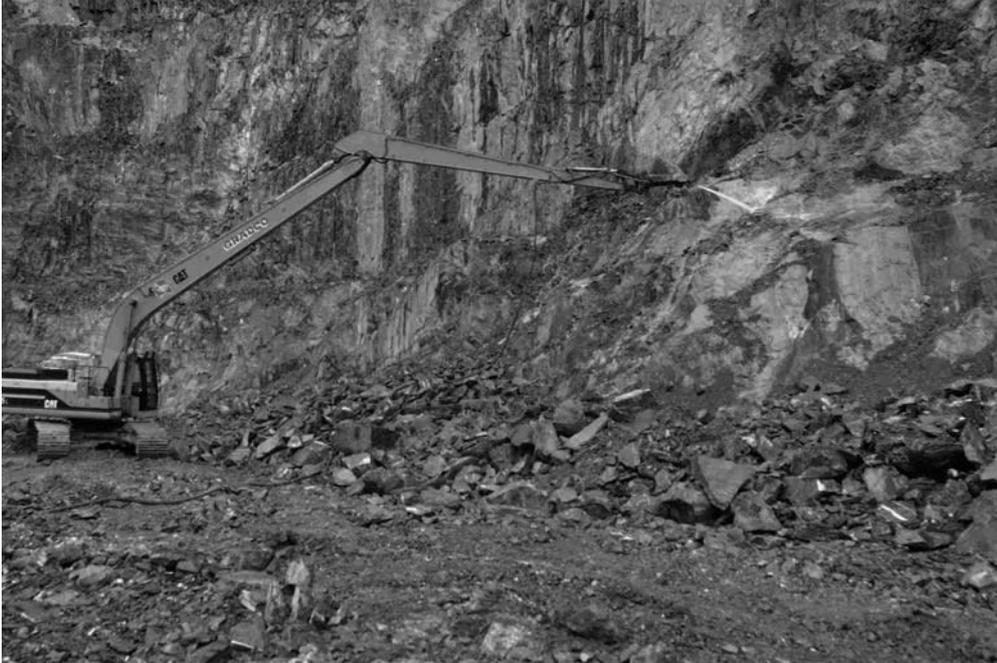
**Figure 7 Longreach excavator with washing attachment**

ABM have an intensive machine rock scaling programme that utilises an array of excavators from their main production machines (O&K1200 and Cat 5130) down to specialist long reach excavators, such as the Cat 325L shown in Figure 7. In this figure a water cannon had also been attached to the excavator scaling bucket to wash loose rock from the face. This technique was trialled when a long dry spell was encountered that reduced the natural washing normally experienced by rainfall. Although it was relatively successful it has not yet been adopted as a standard procedure.

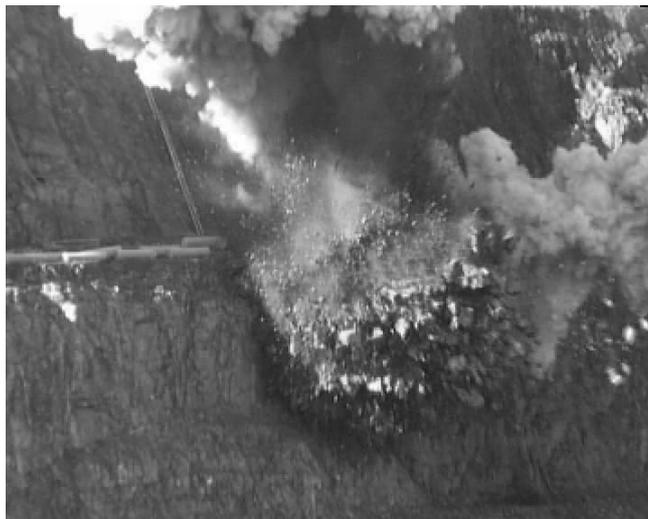
**Figure 8 Blasting of Mat’s Block**

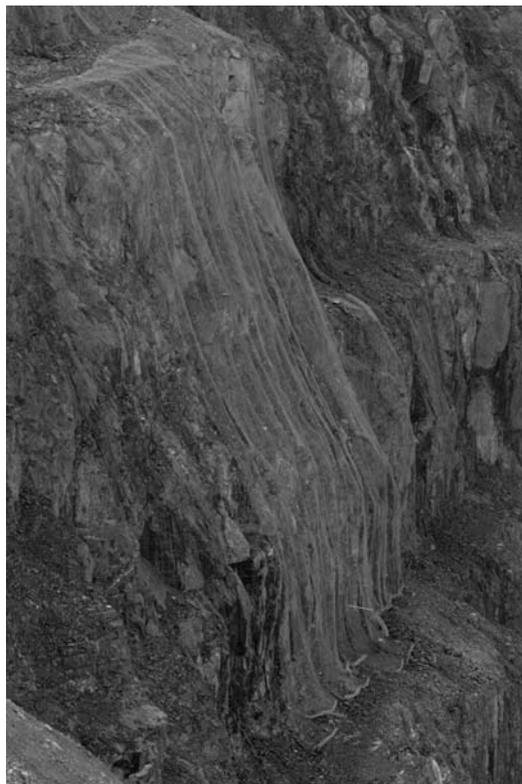
**Figure 9** Mesh draped over remnant of Mat's Block

A helicopter was utilized to transport the mesh material and a pneumatic drill was used to place pins on the berms to hold the mesh. This work was supervised and carried out by Rock Engineering Pty Ltd with assistance from Earthtec Constructions Pty Ltd and site personnel. The curtain mesh was attached to the back of the berm and left rolled up before the explosives were loaded and fired. The 50 m long rolls of mesh were then released and stitched together by Earthtec personnel whom rappelled down over the mesh. The removal of Mat’s Block was successfully carried out but at a cost of approximately A\$200,000.

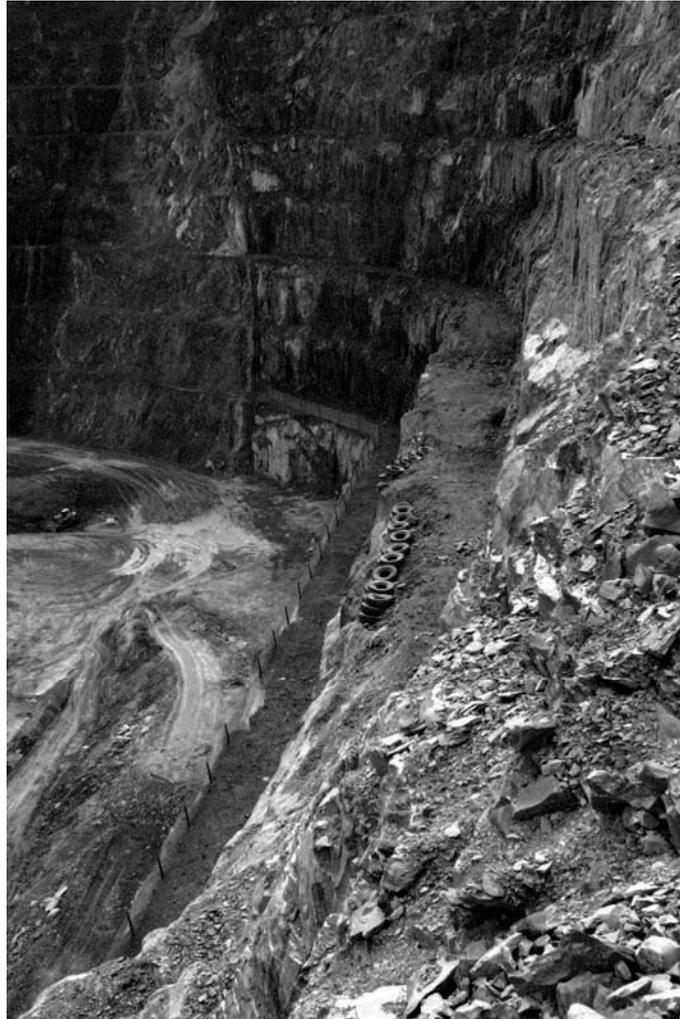
**Figure 10 RL 200 catch berm (with tyre wall) and RL160 rock fence below**

It started to become obvious that significant lengths of the 10 m wide berms were not standing up, and the catch capacity of the east wall was no longer adequate to protect workers at the bottom of the pit. In an attempt to improve catch capacity, a 20 m wide catch berm was designed at the 200RL. To achieve this, the catch benches above (220RL) and below (180RL) were both reduced, to 5 m widths, effectively creating double batters above and below. It was intended that the 200RL berm should have a 2% grade towards the south to control the runoff water that washed down the east wall. This was partially successful, at the northern end of the bench, as shown in Figure 10, but unfavourable jointing at the southern end of the bench resulted in the loss of the crest and thus the controlled drainage. In one section used haul truck tyres were pinned and cable bolted then backfilled to make an artificial crest, refer to Figure 10. This has since captured several small rockfalls.

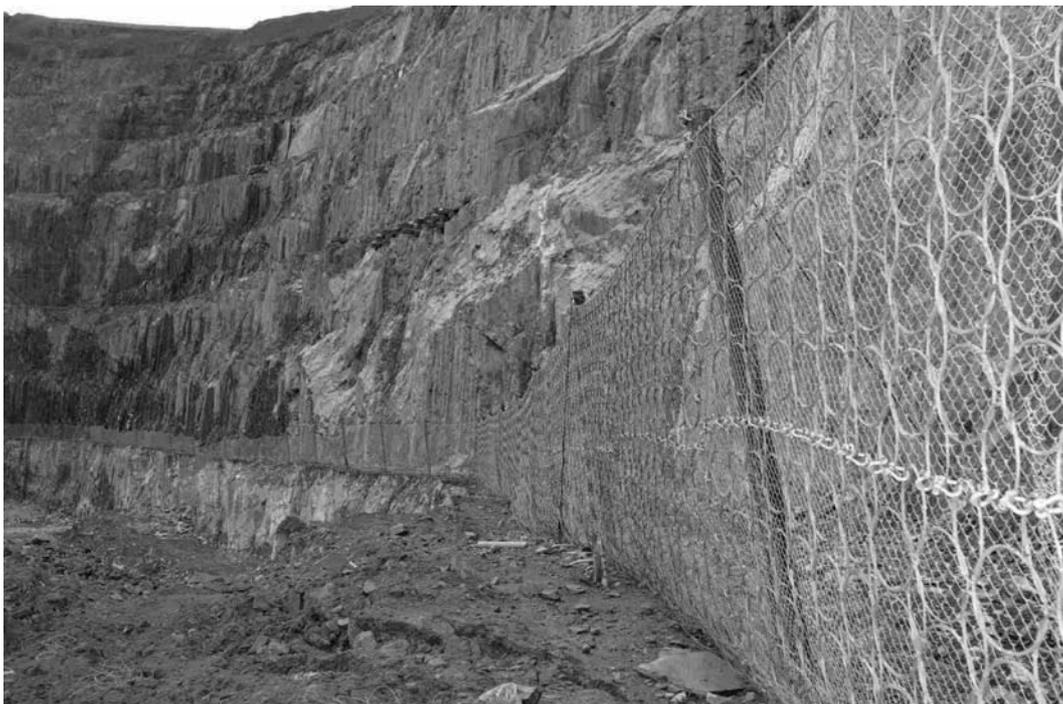
**Figure 11** 250 KJ Geobrugg rock catch fence

These fences are often used on highways to prevent rocks cascading out of ditches and across the road surface. In the mine, they are required to be placed as far from the wall as possible, but not too close to the crest to be effected by the next presplit blasting and underlying batter. A 15 m wide berm was designed and 3 m deep postholes were drilled 7 m behind the lower presplit crest, on 10 m centres. To protect the crests, 8 m single strand passive cable bolts were drilled at 45° into the berm, 3 m back from the presplit line. This configuration was very successful over 330 m of the initial 450 m of fence, refer to Figure 11.

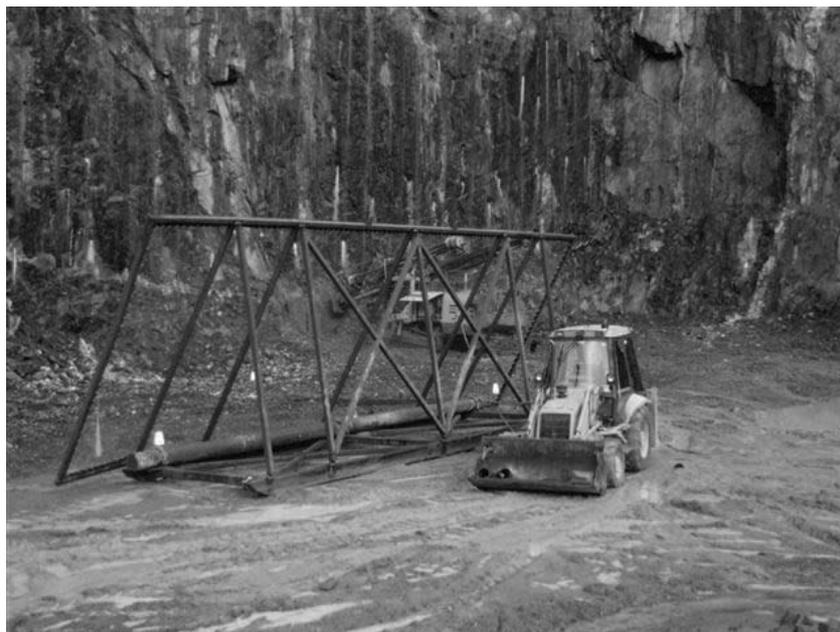
**Figure 12 Mobile rock catch fence in use during remote drilling**

In ABM's quest to create a 20 m wide exclusion zone at the base of the high wall they first addressed the drilling task, as a significant period of time was required to drill the presplit holes as close as 2 m to the toe of the batters. When ABM was incapable of finding an off-the-shelf remote drilling rig capable of meeting their requirements they funded the local drilling contractor Maxfield Drilling to adapt one of their Atlas Copco L8 drill rigs. Radio remote controlled equipment usually has approximately a dozen remote functions but the L8 had up to fifty nine functions that needed to be remotely controlled. The contractor therefore adopted low tech, less expensive cable remote technology, which allows for a multitude of functions, governed only by the amount of data that can be passed through the cable. The cable system was designed so that it could be plugged/unplugged as required, using up to 60 m lengths of multi-core cable to enable the operator to be a safe working distance from the high wall. The operator now sits in an air conditioned, small backhoe unit with the control panel as shown in Figure 12.

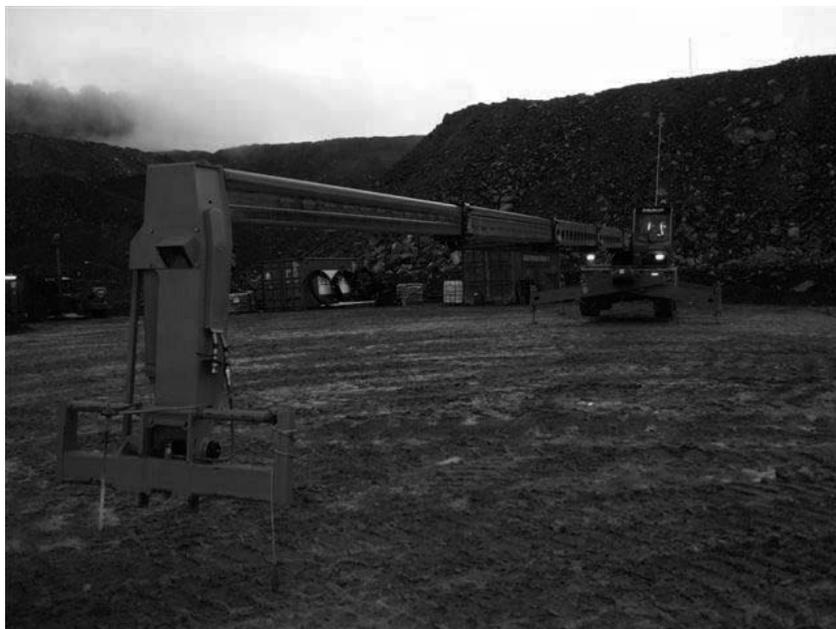
**Figure 13 Merlo Roto 40:25 for remote explosive loading**

After assessing various alternatives and pieces of equipment, the project is now directed at developing a series of four attachments to a Merlo Roto 40:25 slewing handler (Figure 13) to allow these tasks to be carried out from outside the 20 m exclusion zone. This machine has a total reach of 22 m with a 150 kg load.

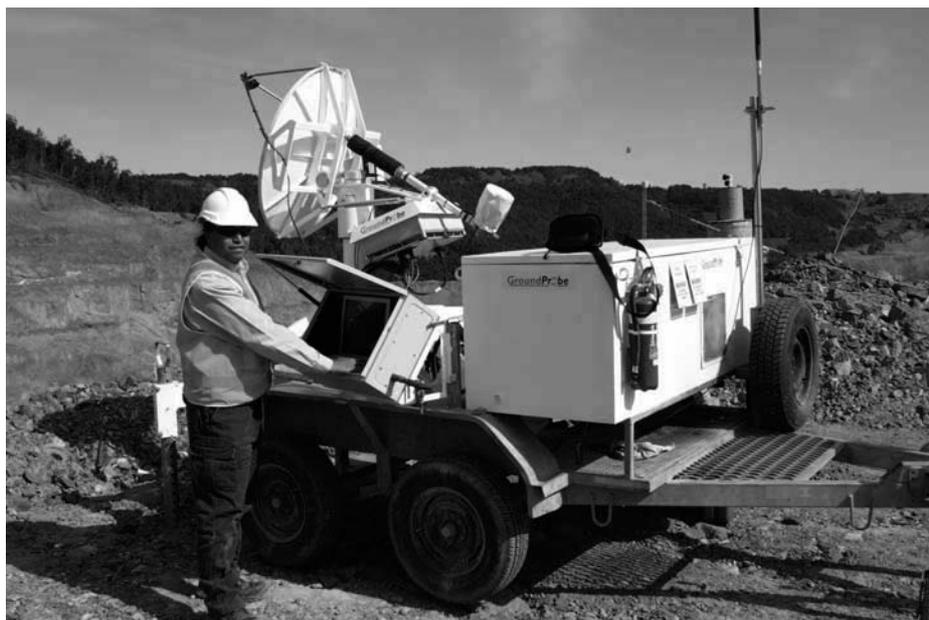
**Figure 14** GroundProbe's slope stability radar

GroundProbe's Slope Stability Radar (SSR), see Figure 14, with its sub 0.2 mm movement accuracy and alarm capabilities, was therefore trialled to see if it could identify potential rockfall areas. The radar was retained beyond the trial date due to its ability to monitor minute movements over a medium to large area in real time. The biggest limitation with the radar has been that it could not monitor movements of smaller blocks ( $<4$  m<sup>2</sup>) that might fall from the wall at the distances that the radar could most practically be deployed.

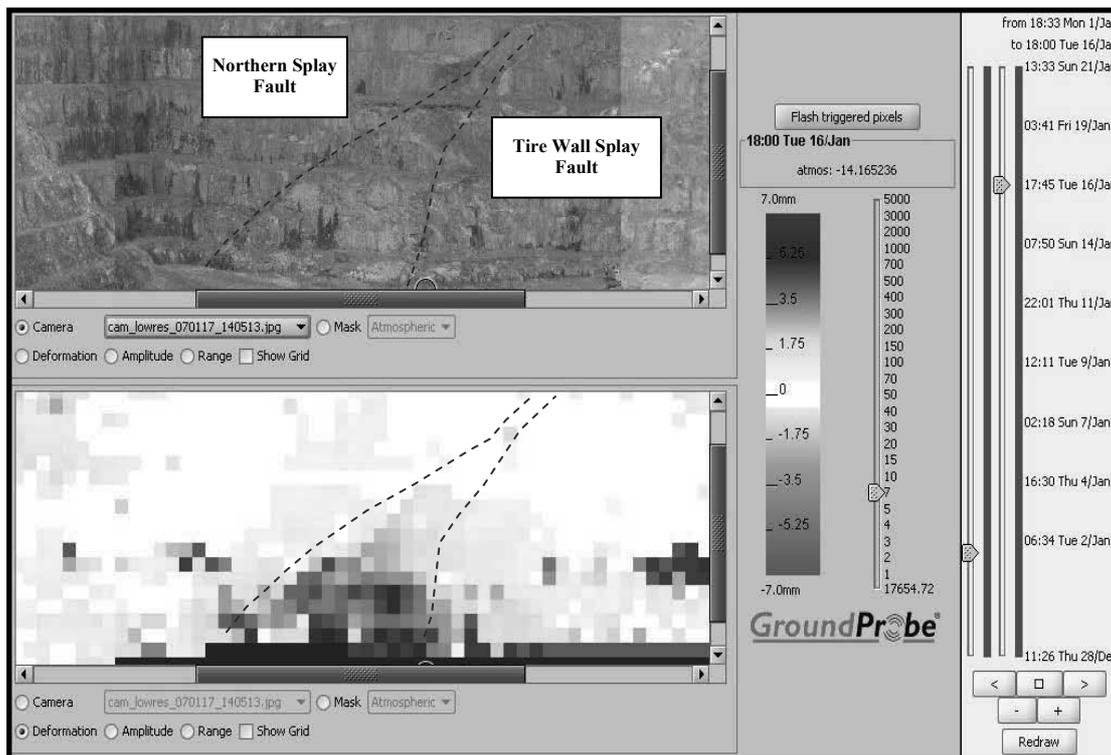
**Figure 15 East wall splay fault movement area**
