# Understanding the Bigger Picture — Interpretation of Geological Structure in Open Pit Rock Slope Stability

R.C. Oldcorn *MWH, New Zealand*

R.D. Seago *SRK Consulting, UK*

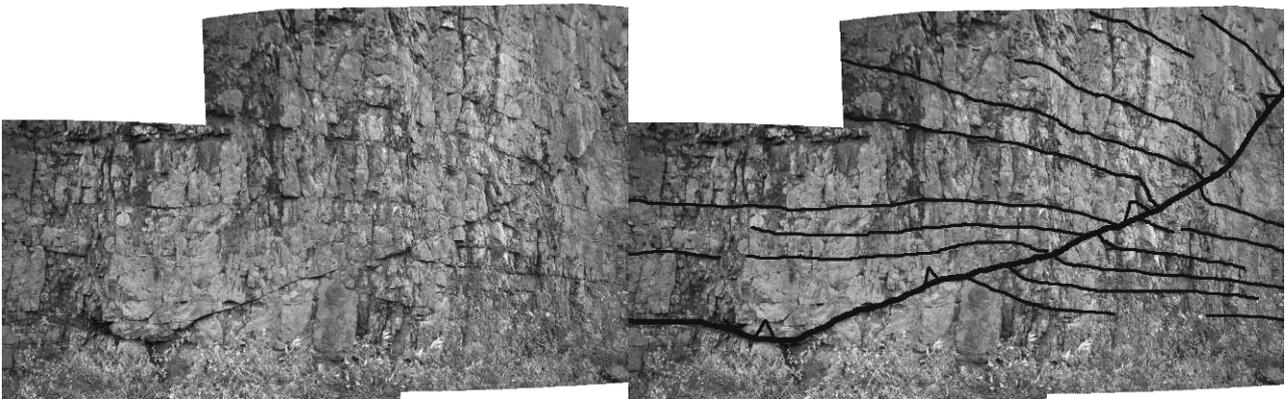
**Figure 10** Close-up of lateral ramp in South Wall of quarry. Movement is to the south and into the face. Thrust dips out of the face and is parallel to bedding on the left side of the image

The main fault at the quarry is the Pen-y-Garn Thrust, which cuts the northern limb of the Castell Coch Anticline and can be traced through part of the north wall of the quarry. All other thrust faults can be considered minor in terms of structural displacement of strata but can still have a significant impact on the pit wall stability, depending on their location relative to the existing and planned slopes, and also depending on their specific geotechnical characteristics. Other structures consistent with the folding and the low angle thrust tectonic model were observed around the quarry. Low angle listric shaped faults, which become bed parallel with depth are common and tip-folds, lateral ramps and pop-ups are present, as shown in Figures 9 and 10 below.

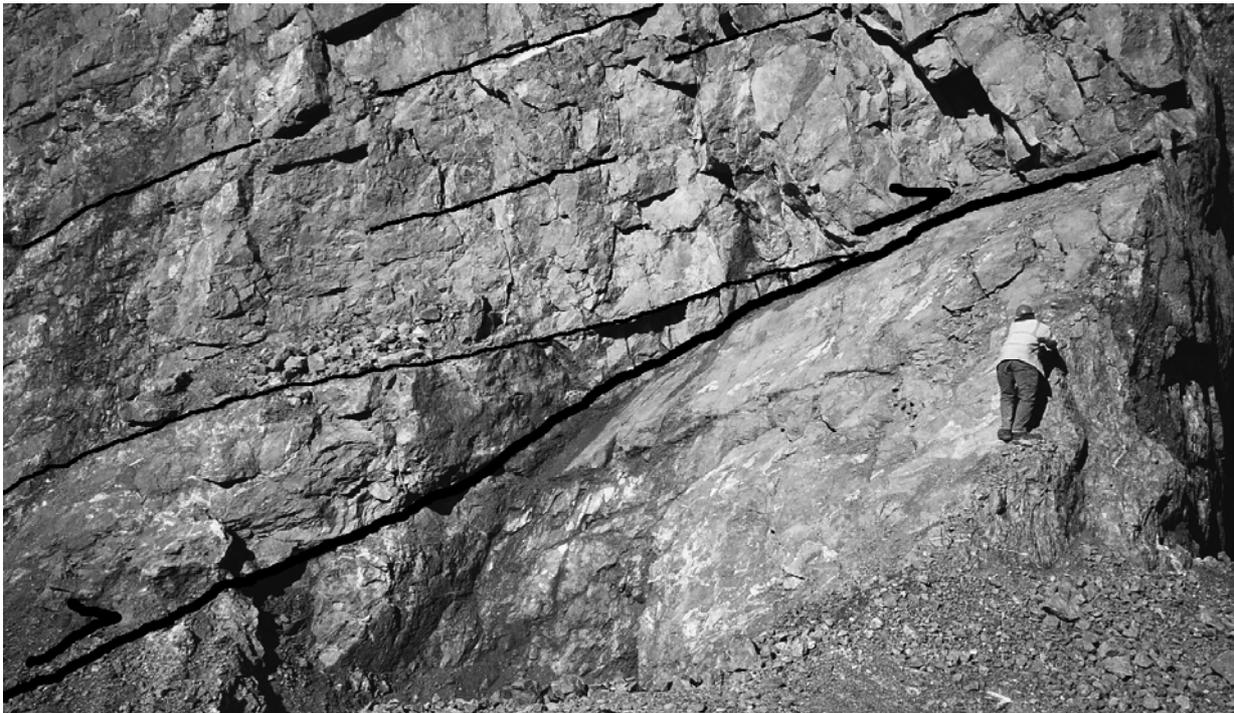
**Figure 11 Thrust showing low angle truncation of bedding**

The thrust faults related to the main anticline-syncline structure of the quarry, as identified by the structural review, were of great significance to quarry planning, especially during a phase of quarry expansion and with the experience of a previous failure along the quarry wall. The structure of the quarry was oversimplified in existing models and local pit wall scale faults were not understood in sufficient detail, such as the fault shown in Figure 11.

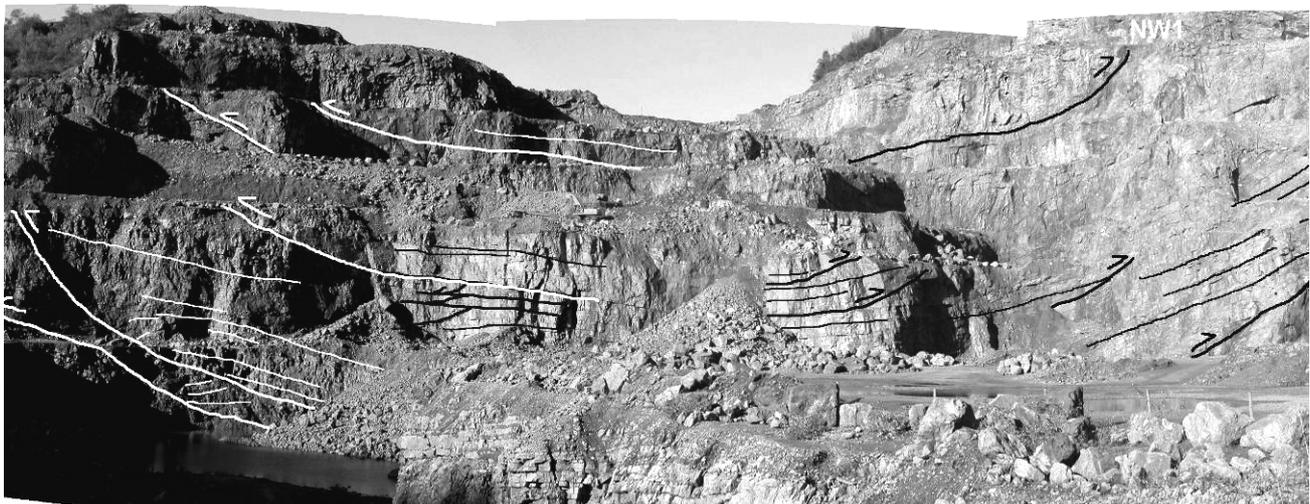
**Figure 13** Looking west at the syncline in the NW corner of the excavation, showing the presence of south dipping thrusts on the south-dipping limb and north dipping thrusts on the north-dipping limb. Arrows show the movement directions of the thrusts

Also observed in the southern limb of the Tongwynlais Syncline are numerous north dipping thrusts, which emerge from the syncline (see Figure 13). This was also extremely important for quarry planning, since development of the northwest corner of the excavation would result in north facing slopes as well as the south facing slopes in the north wall. North facing cuts would potentially expose multiple thrust faults dipping out of the slope. The configuration of these faults in this wall was the main structural control in the 2005 failure.
