Stress Issues at Pajingo Mine

R.K. Whiting *Newmont Pajingo Limited, Australia*

Abstract

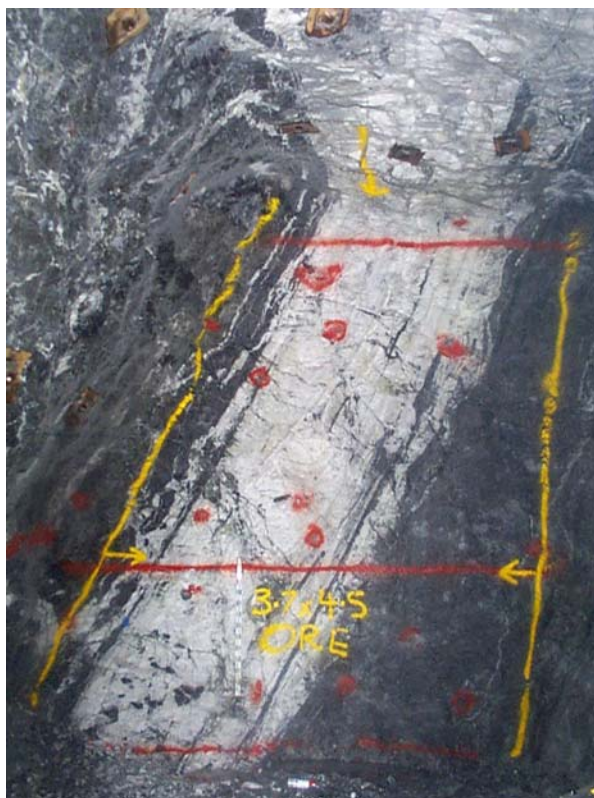
Figure 2 Typical narrow vein

Quartz veins are generally bound within discrete faults and range from vertical to approximately 60 degrees dip. An increase in jointing and faulting is commonly observed in both the hangingwall and footwall of the ore veins and orientated sub-parallel to them thus influencing stope stability and dilution control (Figure 2).

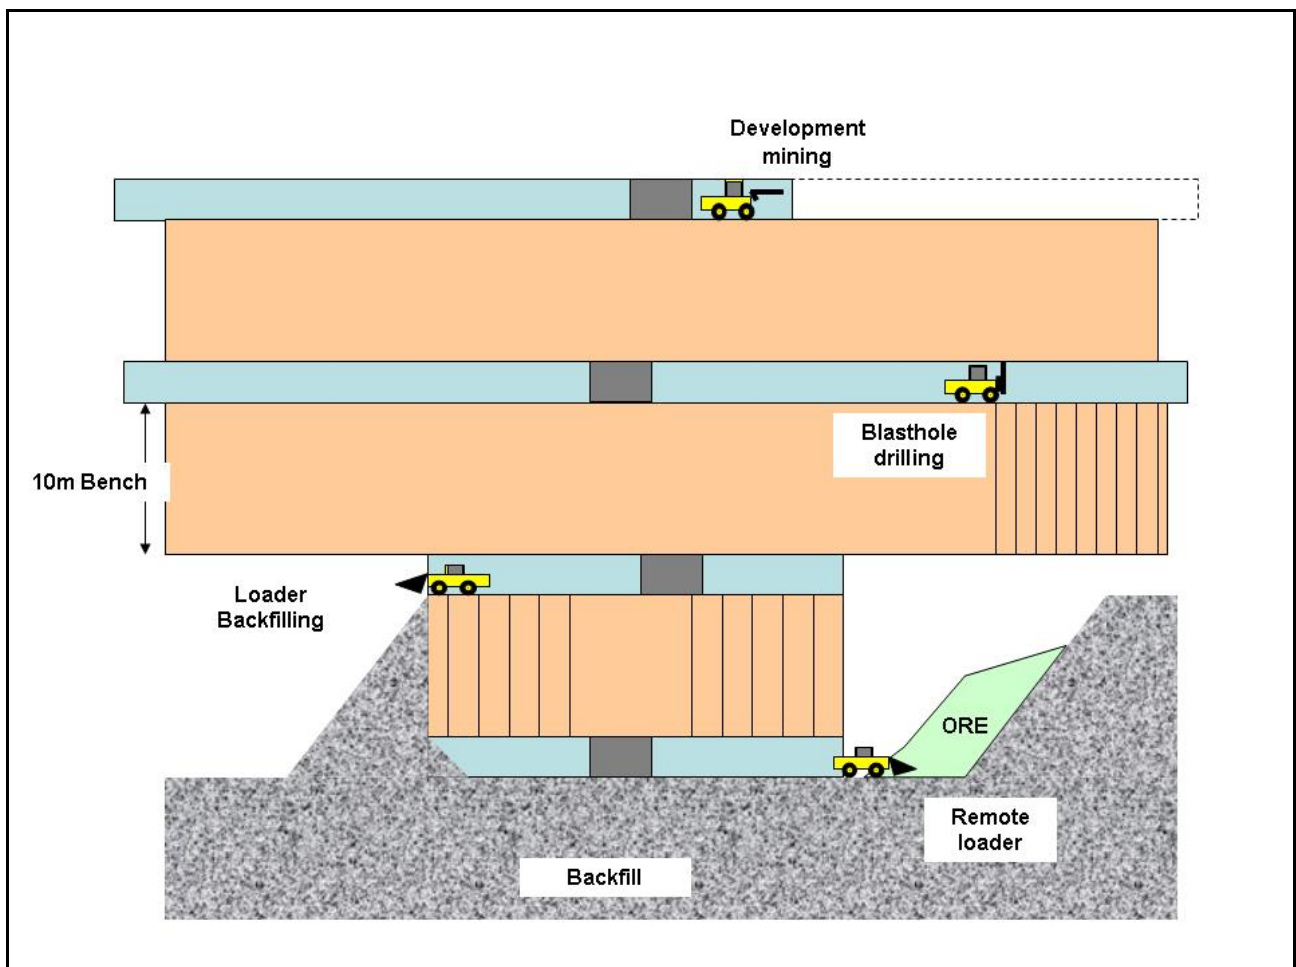
Figure 3 Schematic section of modified Avoca mining method

Mining on site has traditionally been based on a bottom up benching technique with retreat to a central crosscut. A modified Avoca sequence is used with run of mine unconsolidated waste rock periodically placed to backfill stopes as the bench is mined from each end toward the centre (Figure 3). The backfill material then forms the floor as the next level is extracted. For the majority of mining undertaken at Pajingo this method has been highly effective with open strike lengths of up to 200 m (without backfill) achievable in highly competent areas of the orebody.

The ore between successive levels is mined by drilling and blasting downholes back to the centrally located cross-cuts. Mining of stopes follows a bottom-up sequence with mined out stopes being backfilled with waste from the upper level. The backfilled waste then forms the floor of the next stopping horizon.

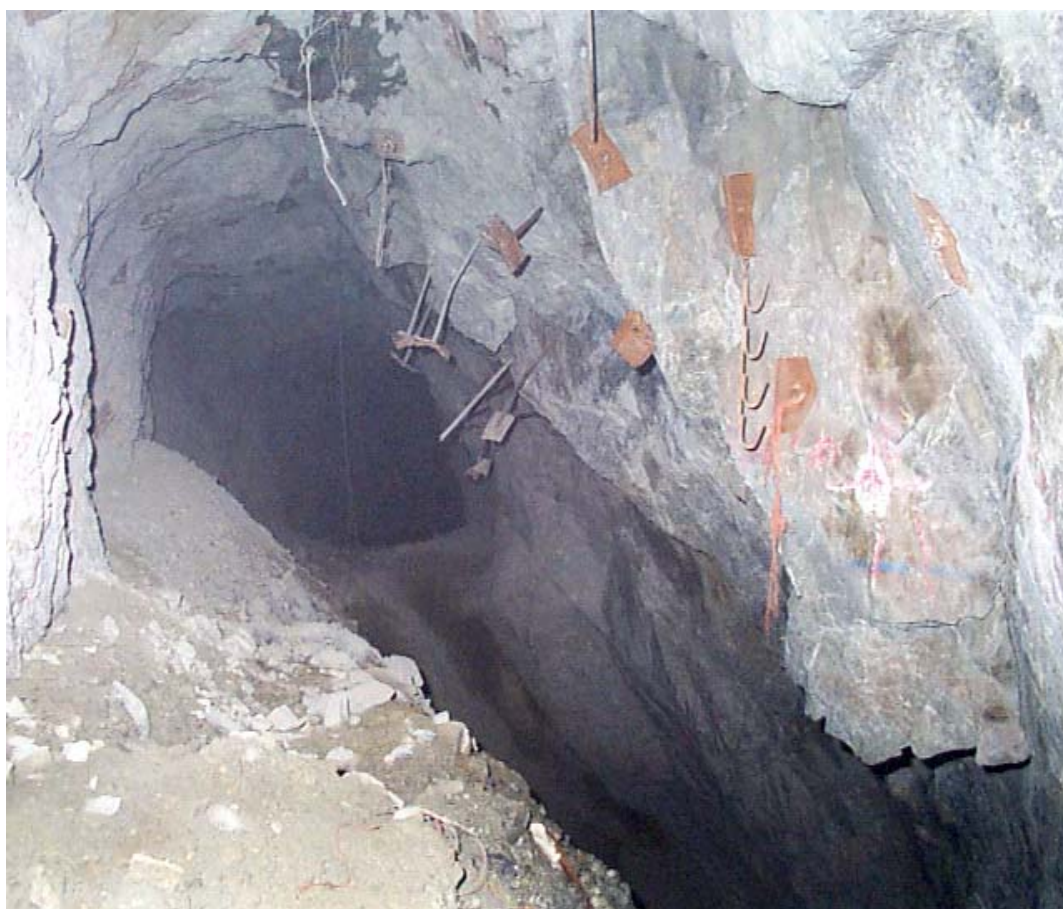
Figure 4 Typical narrow vein stope performance in the Vera orebody

Conditions in the Vera orebody (maximum 300 m below surface) were so good that stoping was commonly retreated all the way back to the cross-cut on both sides without any backfill (up to 200 m of stope strike length). The last stope across the intersection was then ‘mass’ fired. In some cases this caused minor damage to the cross-cut above with cracks forming in the cross-cut pillars. The pillars were scaled but were managed without the need for rehabilitation. There were no reported stress related issues with the mining of these ore bodies at higher elevations within the mine. A typically good performing narrow vein stope within the Vera orebody is shown in Figure 4.

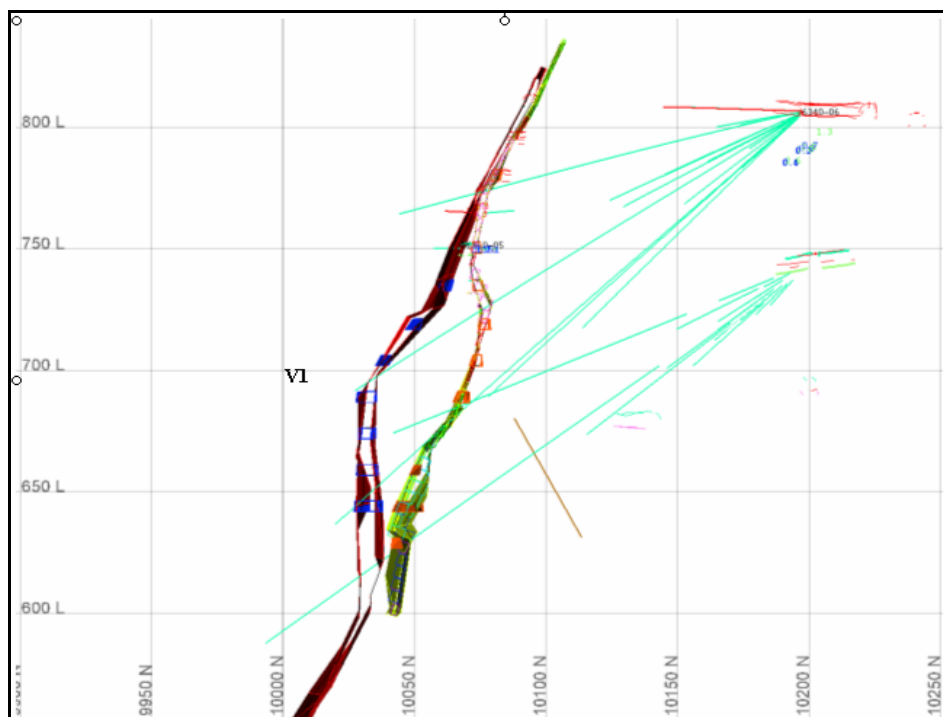
Figure 5 Cross section through sub parallel Jandam lode structures

The Jandam orebody is the deepest of the Pajingo lodes (maximum depth 670 m) and is characterised by two sub-parallel vein structures (Figure 4). The veins form a series of steeply dipping ore shoots with a number of linking structures and splays along the main fault trace (Figure 5). Rock mass quality is generally within the ‘good’ class of rock and the orebody conditions are notably better quality rock than the material comprising the footwall and hangingwall. Initial ground support used during development was split sets and mesh.

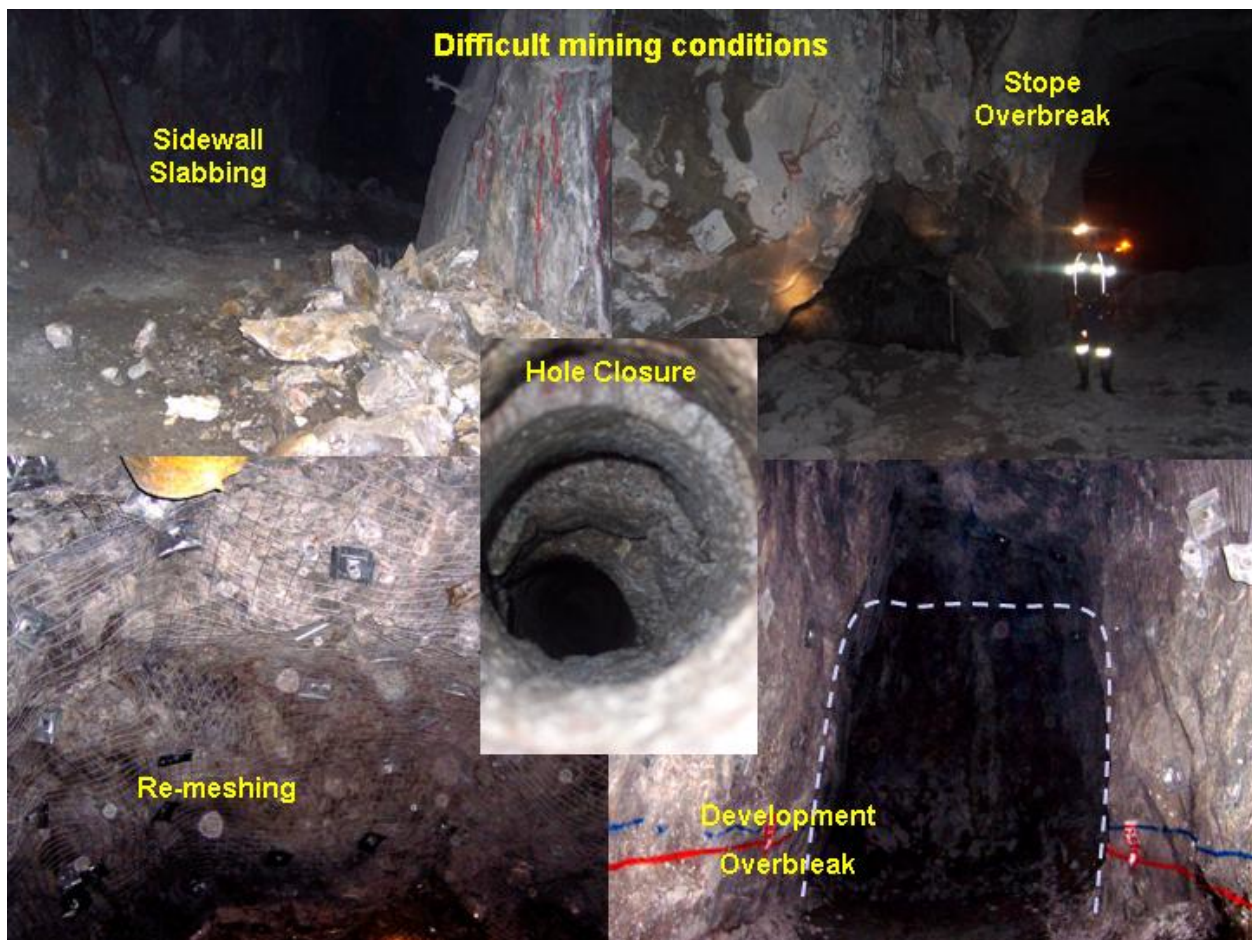
Figure 7 Examples of stress induced damage in the Jandam orebody

As extraction of the orebody increased, the modified Avoca sequence which had worked so well for Pajingo for many years started to show more signs of stress induced damage. Ground conditions in advance of the mining front started to deteriorate and a number of mining steps which were standard procedure started to become unachievable making mining conditions difficult such as (Figure 7 and 8):

- Spontaneous falls of ground.
- Hole closure causing redrills, no drilled stocks.
- Extensive rehabilitation in advance of stoping front required.
- Ground movement/ displacements not controllable with standard ground support.
- Slow mining with major interruptions to mining schedule.

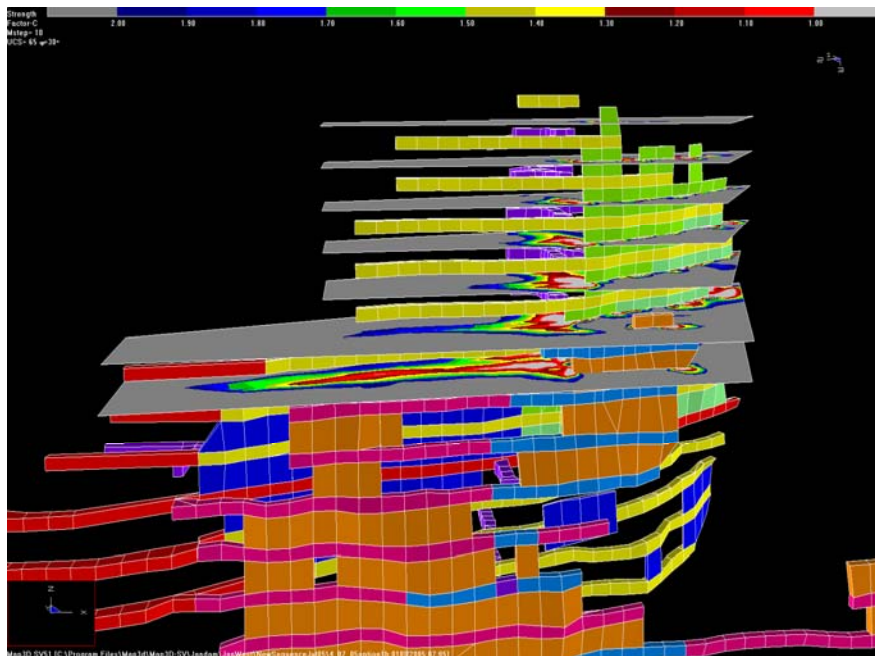
Figure 9 Map 3D model showing safety factor plot of the proposed Jandam extraction sequence (after Ascott, 2005)

Numerical stress modelling completed after the onset of the difficult mining conditions in Jandam indicated that mining induced stress conditions were the likely driving force behind the deterioration. The high stress conditions were exacerbated by the central retreat mining sequence which concentrated stresses within a shrinking pillar centred on the cross-cut area. Continuation of the standard central retreat extraction was likely to incur major ore loss by creating unmanageable conditions in critical areas such as cross cuts which placed at risk the recovery of substantial volumes of the mining resource (Figure 9).

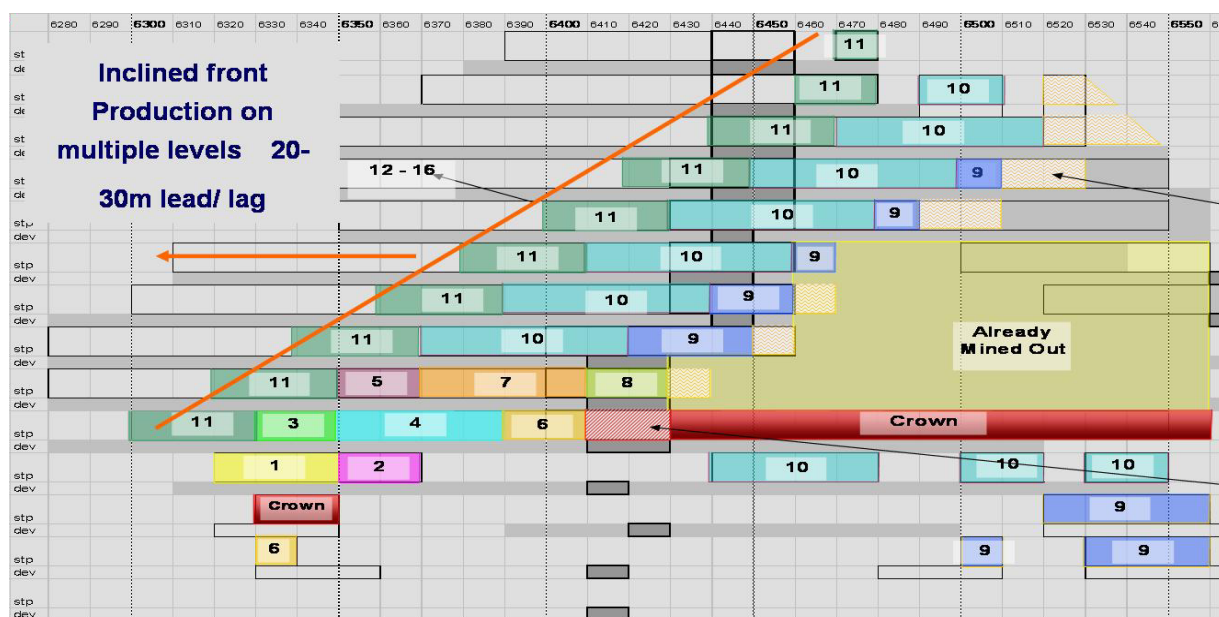
Figure 10 Schematic long section of Jandam inclined mining front and end access extraction. Numbered blocks represent order of extraction (after Ascott, 2005)

The need to manage mining induced stresses forced the development of an alternative method which proposed to construct end accesses to the orebody and extract using a modified Avoca method using inclined front (Figure 10). The inclined mining front operates on multiple levels with a 20-30 m lead-lag distance and sheds stress to the stope abutments rather than concentrating stress on a shrinking central pillar. This allowed mining to continue from the centre of the orebody out toward the extremities. A true Avoca mining and backfill operation was achieved while access was available from the central cross cuts which then reverted to a modified Avoca after backfilling had passed the central access. Upgraded ground support prescribed to control the stress damage and dislocation along structures included debonded cable bolts throughout the length of ore drives and fully grouted split set bolts.

The design modifications had the added bonus of dramatically improving the extraction ratio (>16000 Oz) as well as accelerating access to high grade ore through the introduction of multiple production levels. Damage at stope brows is still evident but restricted to within the lead-lag distance of stopes. It is now at a much more manageable level as are pre-drilled production hole closures and deformation/dislocation magnitudes.

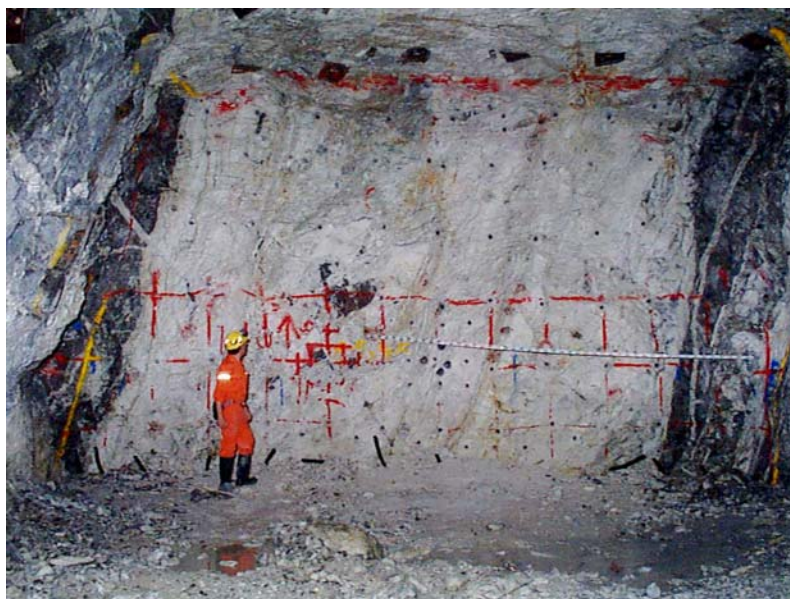
Figure 11 Typical wide quartz vein

Vera South Deeps mine has extracted the majority of the V1 vein structure along strike to the East of the Jandam orebody. It extends to a maximum depth of 570 m below surface with the bulk of the mineralisation within veins of up to 18m width between 520–400 m depth (Figure 11). Ground conditions are within ‘good’ quality class of rock and standard primary ground support is split sets and mesh.

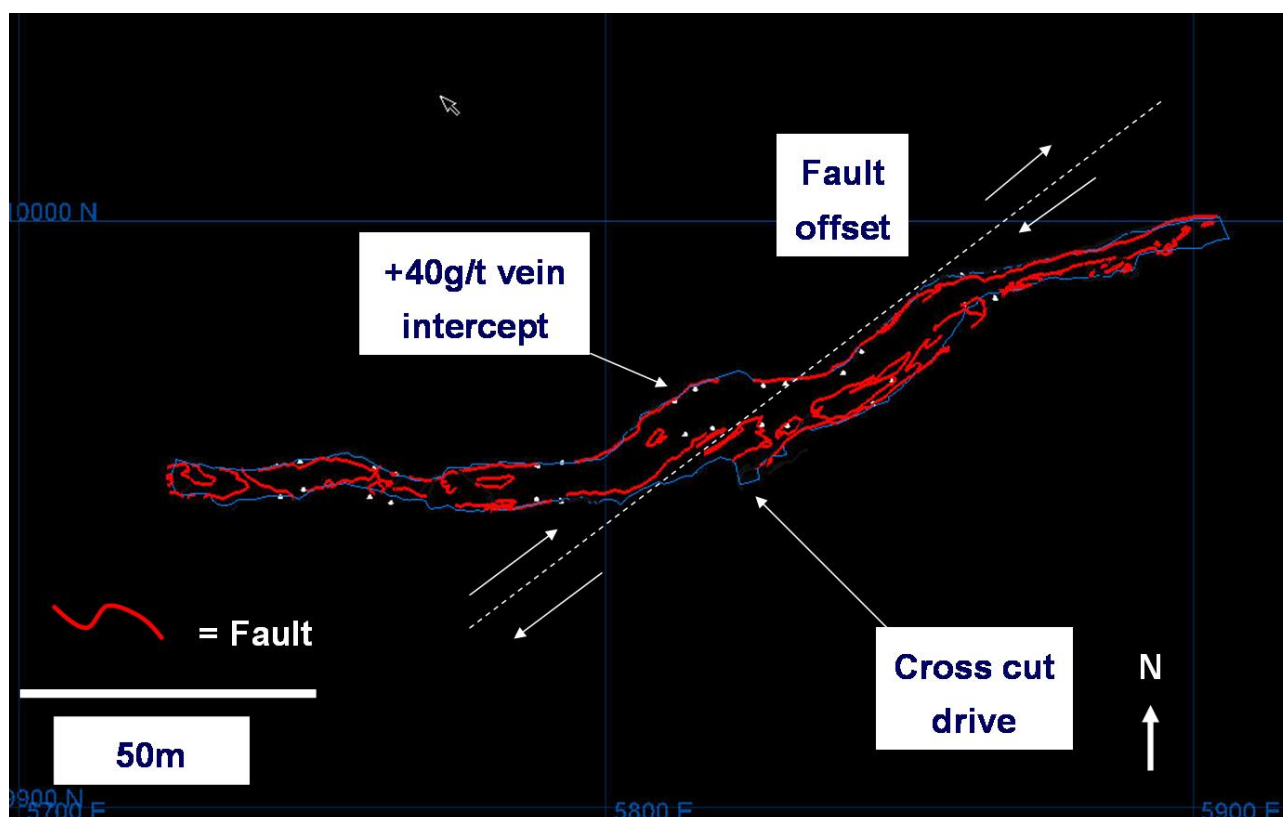
Challenges also existed where cross-cut drives intersected the ore veins at locations where a number of conditions coincide to create unfavourable mining conditions. These include (see Figure 12):

- Widest point of ore vein – This existed because of fault offset and duplication of the ore structure.
- Heavily structured area – cross cutting faults common in crosscut area.
- Highest grade.
- Highest mining induced stress conditions due to central retreat extraction.

Figure 12 Plan view of Vera South Deeps 840 level fault mapping. This shows x/cut intersection coinciding with the highest grade, most structure and widest span of the ore drive which would be subjected to the highest stress loading
