Canadian and Australian Ground Support Practices in High Deformation Environments

Abstract

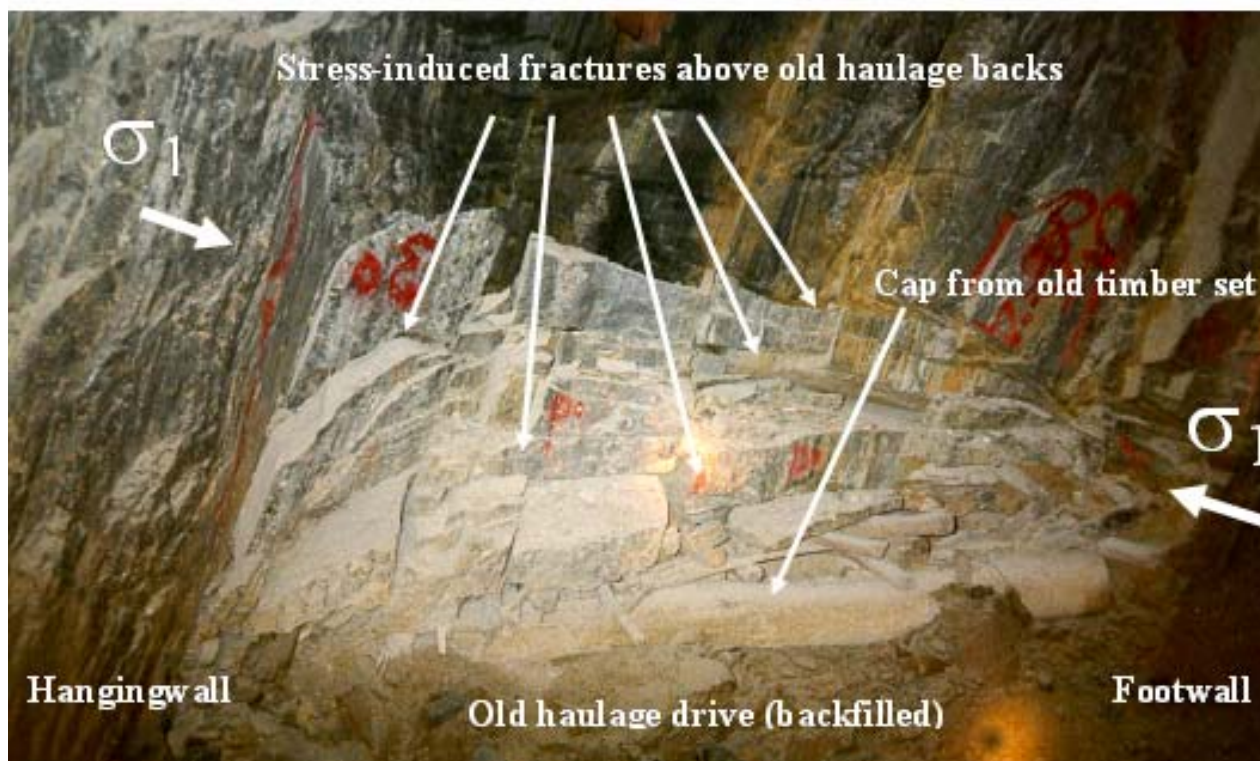
Figure 1 Stress-induced fracturing above the backs of 1950s haulage drives at Big Bell

The lead author's understanding of the mechanisms controlling deformation in foliated ground was initially based on observations at the Big Bell gold mine in the mid-1990's (Sandy and Player, 1999). At that time, the underground mine was being redeveloped, having closed in 1955. By chance, some of the new trackless levels were developed at elevations that allowed the backs of the old rail haulages to be scrutinised (Figure 1). This provided a relatively rare opportunity to examine the fracturing styles and intensity of stress-induced damage.

From these observations, it was clear that intense, stress-induced fracturing had developed above the backs of the haulage drives. Shearing on the stress-induced fractures had been accompanied by significant dilation or 'bulking'. The fractures had developed initially parallel to the drive backs, but then 'rotated' somewhat

presumably as the failed ground had shed stresses deeper into the backs. Stress-induced fracturing had 'stabilised' once fractures had developed parallel to the local major principal stress (σ_1).

- Stress-induced fractures sub-parallel to the drive backs and floors, leading to significant 'bulking' as the fractures shear and dilate (Figure 1). This in turn results in deformation and closure between the floors and backs of the drives, and contributes significantly to the shearing in the walls.

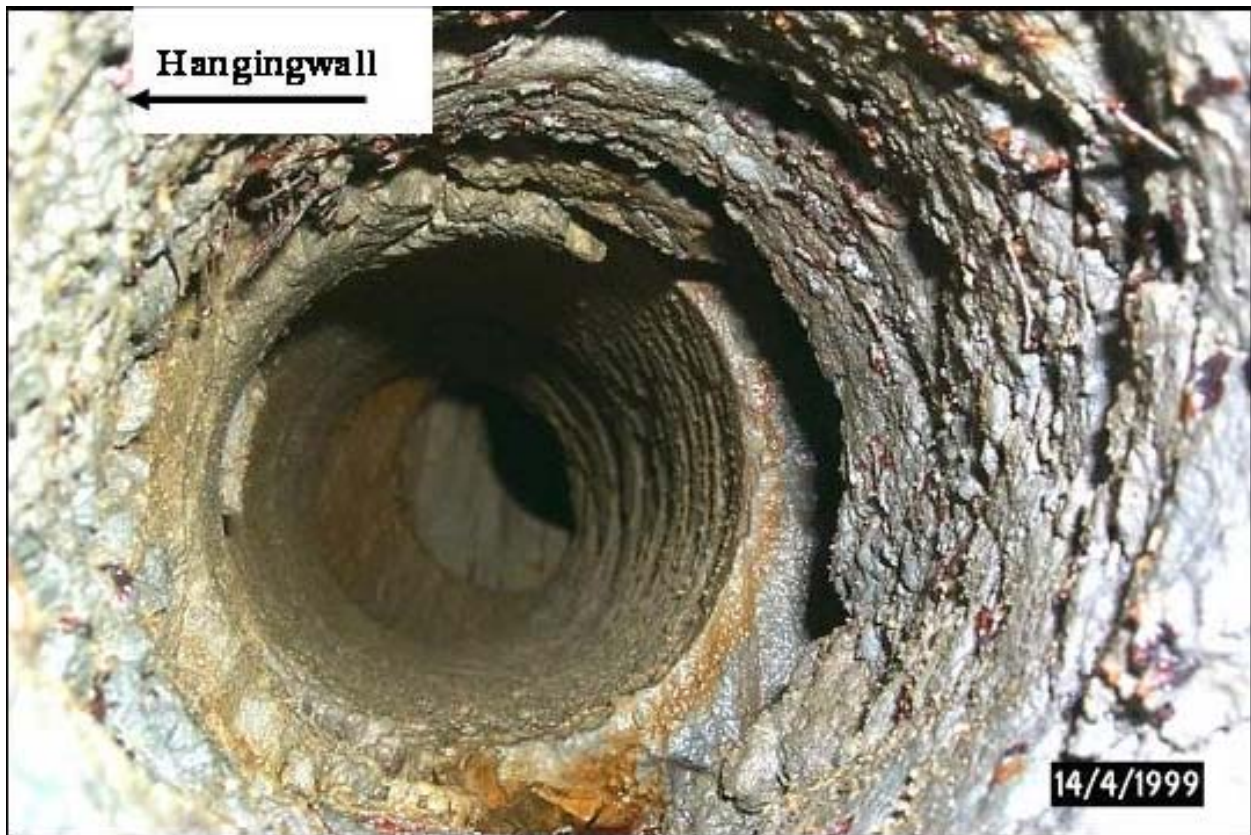
Figure 3 Shearing of 89 mm diameter blastholes in the oredrive backs (Big Bell)

Offsets observed in blastholes drilled through the backs confirmed that significant shear was occurring on the stress-induced fractures (Figure 3). Similarly, shearing was observed in sludge sampling holes drilled in the ore drive hangingwalls and footwalls (Figure 4). Observations showed consistent indications of the sense of shear, as shown in Figure 2.

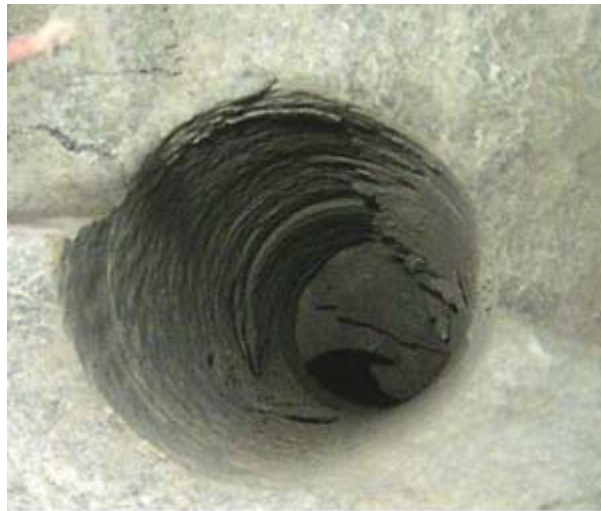
Figure 4 Shearing of 89 mm diameter sludge sampling holes in ore-drive hangingwall

- Shearing of foliation in the drive footwall and hangingwall leading to offsets in drillholes (Figure 4) and 'guillotining' or truncation of the support elements (Figures 5 and 6).

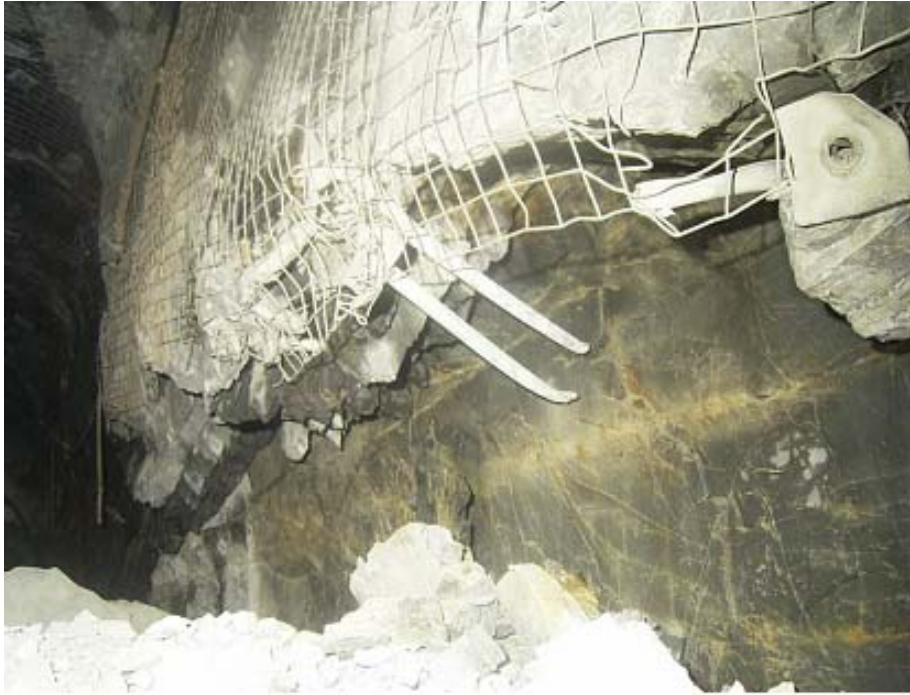
Figure 5 Guillotining of friction bolts installed in the footwall. Note the sense of shear indicated by the damage to the bolts

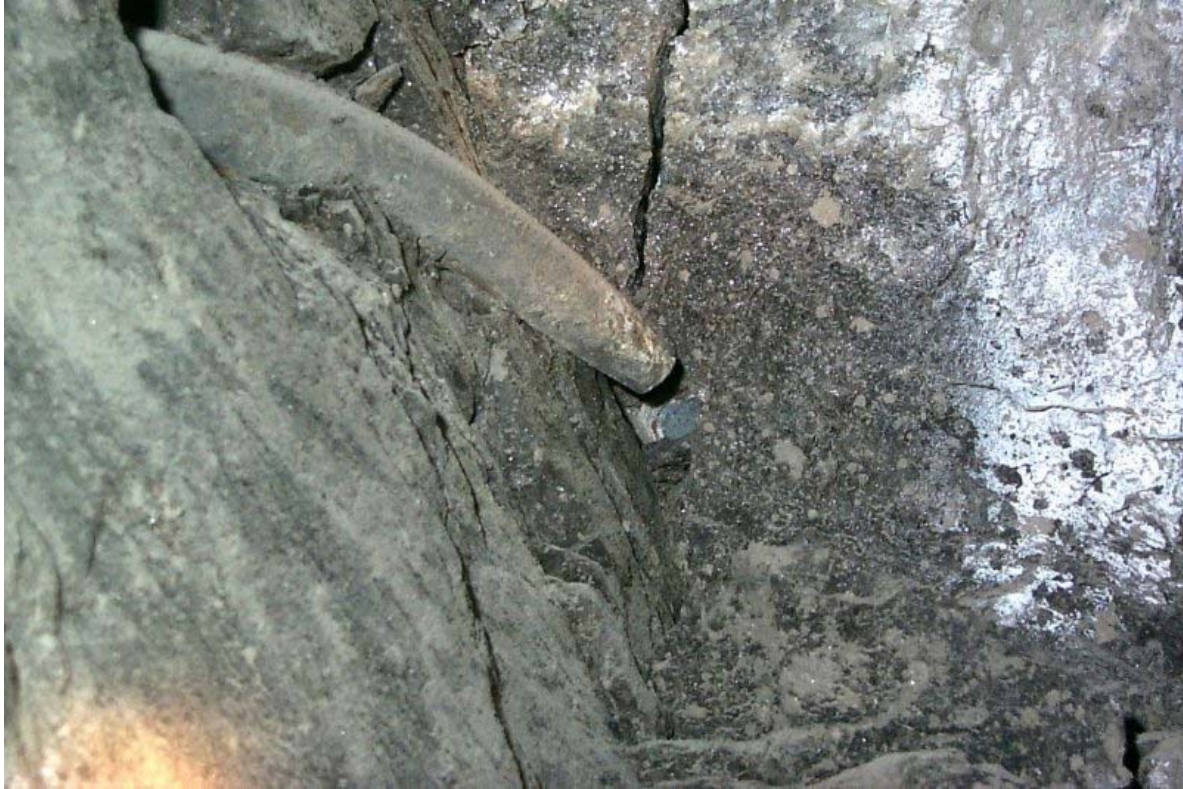
Figure 6 Necking and guillotining of friction bolts installed in the hangingwall. Note the sense of shear indicated by the damage to the bolts

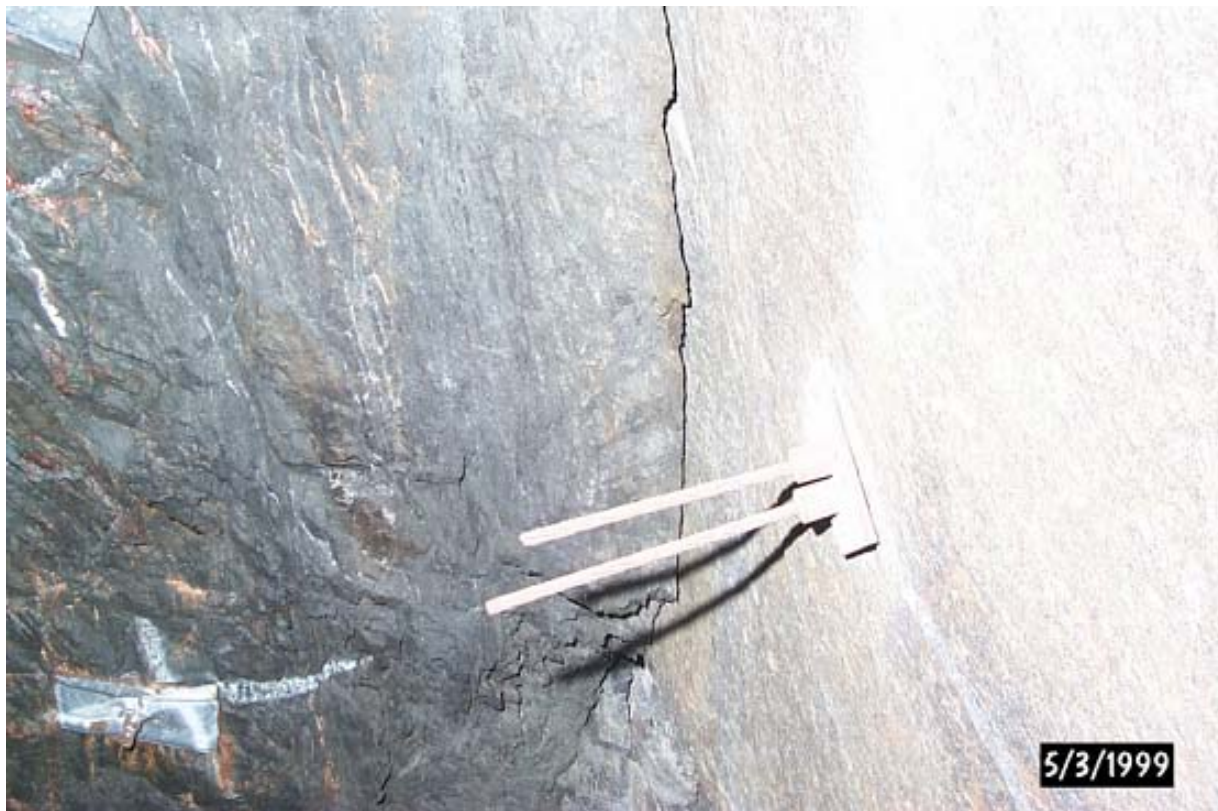
Figure 7 Initial indication of high deformation – dilation/shear of the hangingwall/back contact

- The initial indication of significant bulking above the backs is usually the development of an open crack where the backs meet the hangingwall (Figure 7). Support elements in this location are often the first to become trapped in shear, indicated by the loss of the faceplate. Where meshing or fibrecreting are employed, the development of this crack may be difficult to observe.

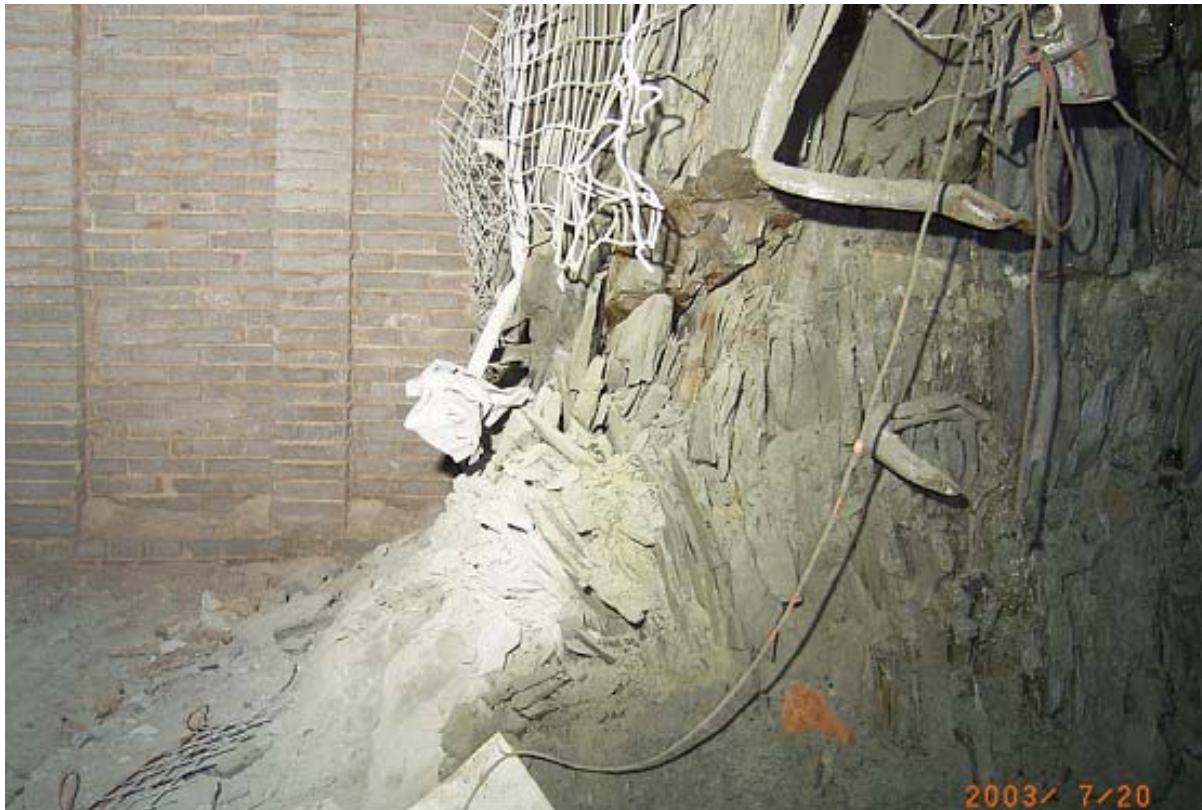
Figure 8 Buckling of the lower footwall

- Buckling of the drive walls may occur if shearing is prevented. As a result of the confinement provided by the drive floor and the beneficial effect of reinforcement in the upper part of the walls, buckling tends to be most commonly developed in the lower part of the footwall (Figure 8).

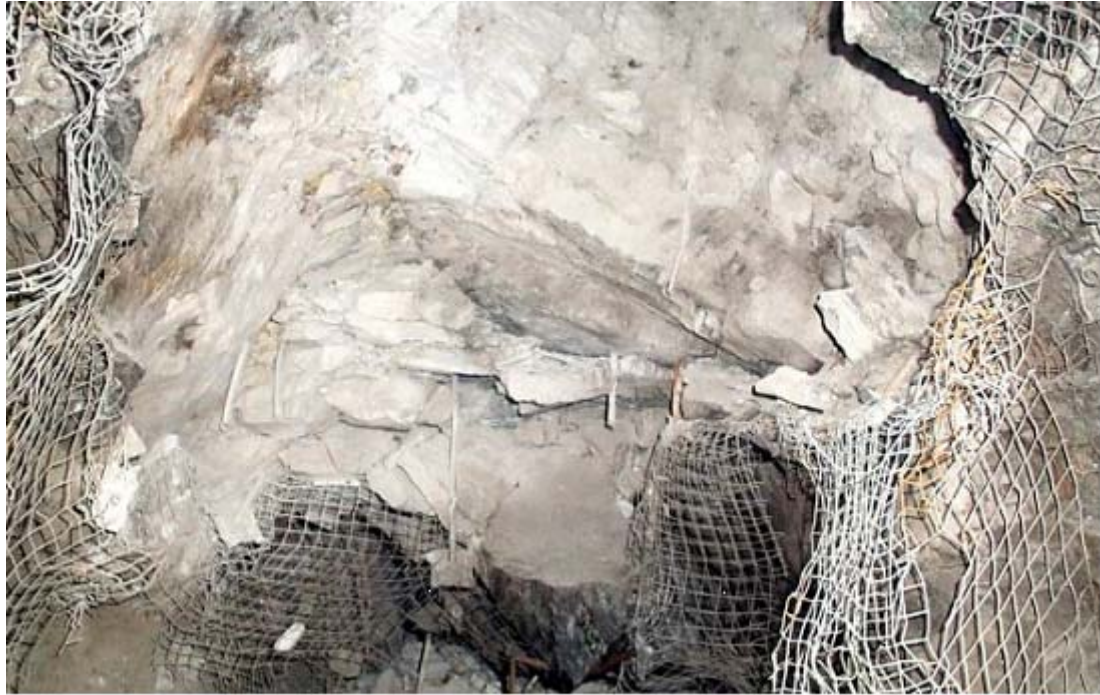
Figure 10 Stress-induced fracturing above the backs of an ore drive at the Yilgarn Star gold mine

A more recent example of observations of fracture development above the backs of an ore drive is presented in Figure 10. An example of a drive exhibiting an advanced stage of deformation, in which serviceability has been compromised, is shown in Figure 11.

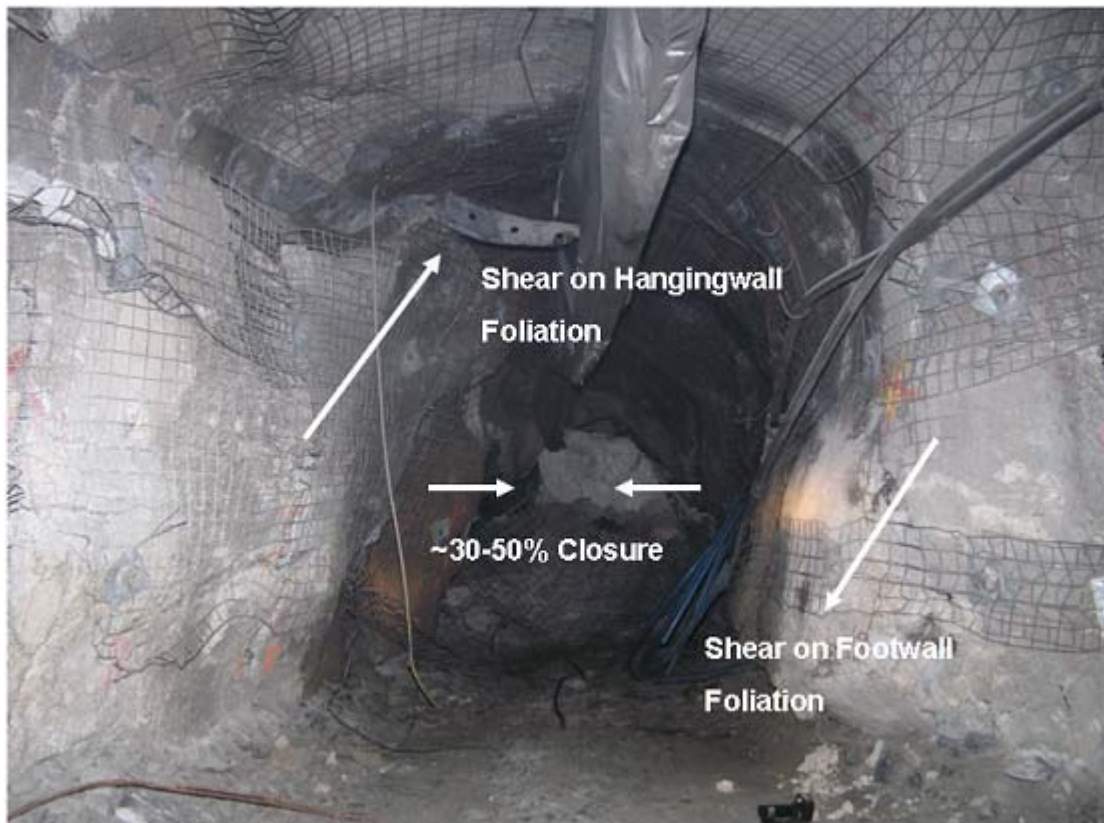
Figure 11 Drive exhibiting advanced stage of wall deformation. Serviceability has been lost

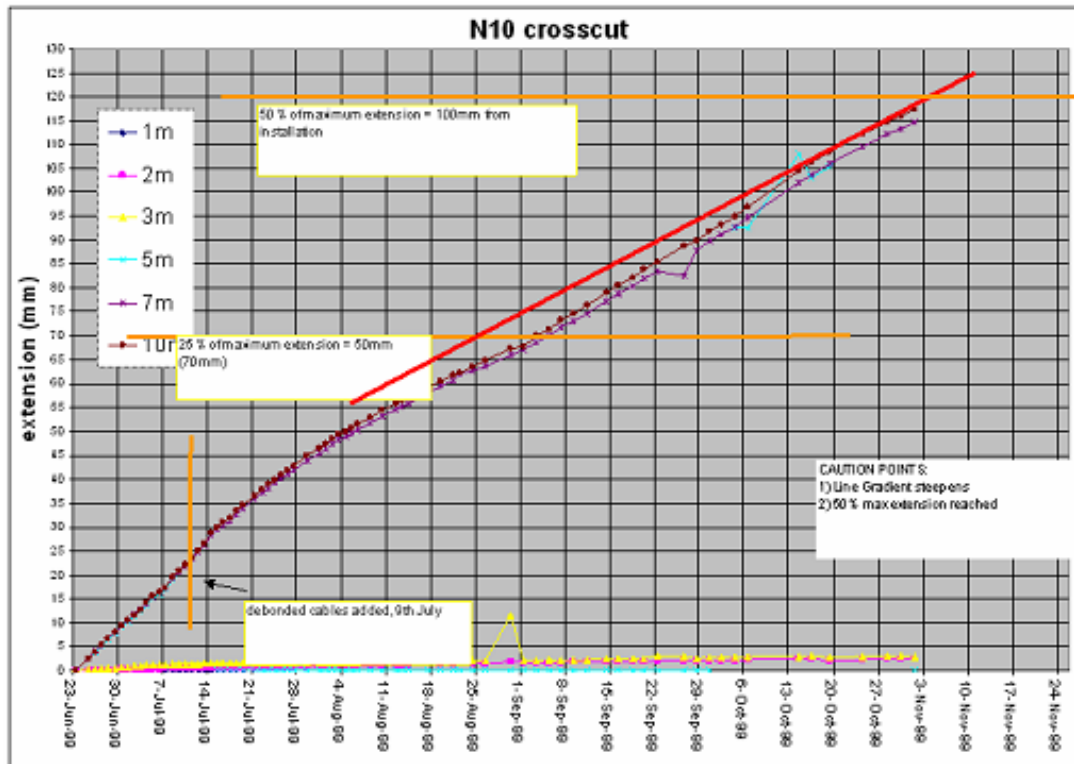
Figure 17 Extensometer results from Yilgarn Star show deformation continuing over many months

Some Australian mines have relocated development either further from the orebody (increased stand-off distances) or into stronger rocks to reduce the level of deformation experienced and lower the costs of rehabilitation. With significant ongoing or ‘time dependent’ deformation apparent in operations such as Yilgarn Star, as indicated by extensometer monitoring results (Figure 17), scheduling development as late as possible in the mining cycle can also reduce rehabilitation requirements (Valent and Haywood, 2002).
