# The Weakest Link — Ground Support Observations at Some Canadian Shield Hard Rock Mines

**B.P. Simsen** *Craig Mine, Xstrata Nickel Ltd, Canada*

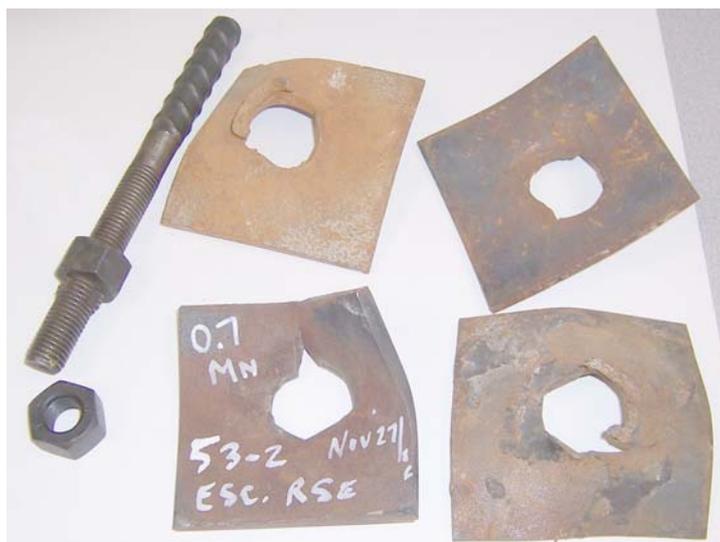
One of the more common resin rebar failure modes in hard brittle ground is the plate ripping over the bolt nut or the nut breaking at the bolt threads. For 22 mm diameter rebar with hexagonal nuts (reverse spin – see Figure 1), a characteristic scar is often seen in the plates after blasting or strain bursting blows the plate over the nut. For example at Craig Mine 5 x 5 inch (125 x 125 mm) flat steel plates have been used. They were switched from ¼ inch thick to 3/8 inch thick (6.35 mm to 9.53 mm) to reduce the nut punching problem. Fewer incidences have been observed since this change but it generally is still easier to have the plate pop off than to break the rebar (for near surface deformations). The mine is also planning to increase the plate size to 150 x 150 mm, which is the practical maximum for the mechanised bolting machine being used.

**Figure 1** 125 mm<sup>2</sup> rebar plates after dynamic loading. Left is end of 22 mm diameter rebar with hexagonal nut. Top left plate is 3/8" (9.53 mm) blown off rebar by wall slash (development blast), bottom left 3/8" plate blow off after Mn 0.7 seismic event locating ~14m away, top and bottom right ¼" (6.35 mm) plates blown off after strain bursting. Note Mn = Nuttli Magnitude (Kaiser et al., 1996)

Although the tests were only exploratory in nature they help illustrate some key points. The first drop simply ripped the plates over the rebar nut, in a very similar fashion to the underground observations noted in Figure 1. Increasing the plate thickness prevented this. The rebar steel is rated for about 13% elongation, however the bars failed at the threads after approximately 5% elongation (calculated as permanent deformation/free length of bar). Strain localisation at the threads didn't allow the full utilisation of the potential steel strength. Externally threaded bars can help eliminate this problem.

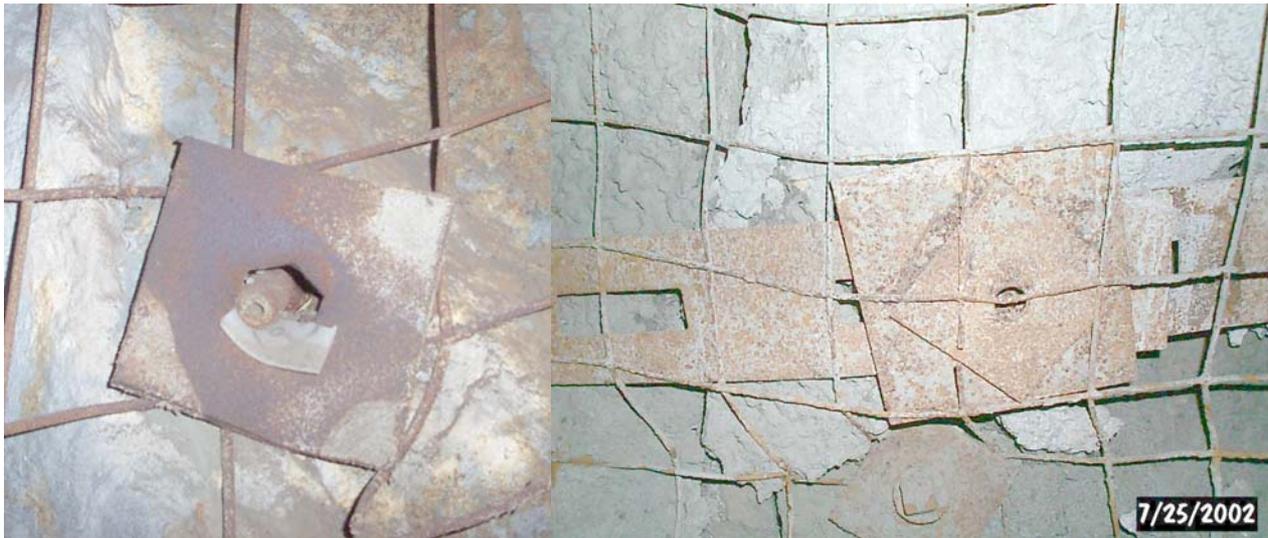
Similar observations have been made with other bolt types/plate combinations and also under "static" loading conditions. Where dome nuts are used on smaller diameter 20 mm rebar, they sometimes pop off and break the bar at the threads rather than the having the plate punch through the nut (Figure 2, right side).

**Figure 2** Left – 22 mm rebar in schist – bulking caused by schistose layers delaminating under load. Right – 20 mm rebar in meta-sediments, layered ground delaminates under high load causing heavy bulking. In this case the ground support included shotcrete covered by steel strapping and twin plates (7" x 7" with 5" x 5" plate over top). The 20 mm rebar was installed with a dome nut which popped off (rockbolt seen below rebar plates, 100 mm aperture weld mesh in both photos)

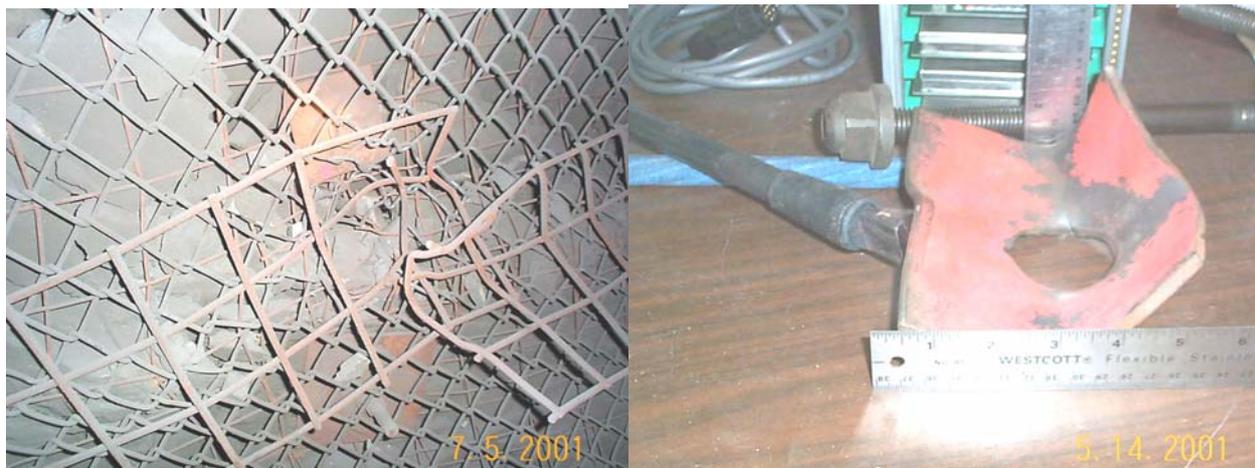
**Figure 3** Modified cone-bolt plate failure. The ¼" thick plate shown in the right photo was found 6 m horizontally from the photo on the left against the opposite wall of a drawpoint. It is quite possible that the bar had seen substantial shearing and the cone wasn't able to plough. Both the cone and mixing paddle as well as the dome nut are shown in the right hand photo (similar type of dome nut as 20 mm rebar example above)

Figure 3 also shows some broken mesh strap strands (7.7 mm diameter 00 gauge mesh) which the sharp edge of the plate helped guillotine (Figure 4 below also shows example of mesh getting cut by plates). It should be possible to make bevelled edged plates (Ortlepp, 2002) to reduce this effect, although the complications of manufacturing would likely increase the cost. Some mining camps use double plates, where a relatively thin large area plate is covered by the 'conventional' style plates shown above. Rubber backed plates (Li, 2001) or timber backed plates have been used to both dampen peak loads and reduce the cutting into the mesh. Generally speaking, the addition of the mesh strapping (Simser et al., 2006) has greatly improved the support by increasing load transfer to the tendon and it is rare to see the strap strands broken.

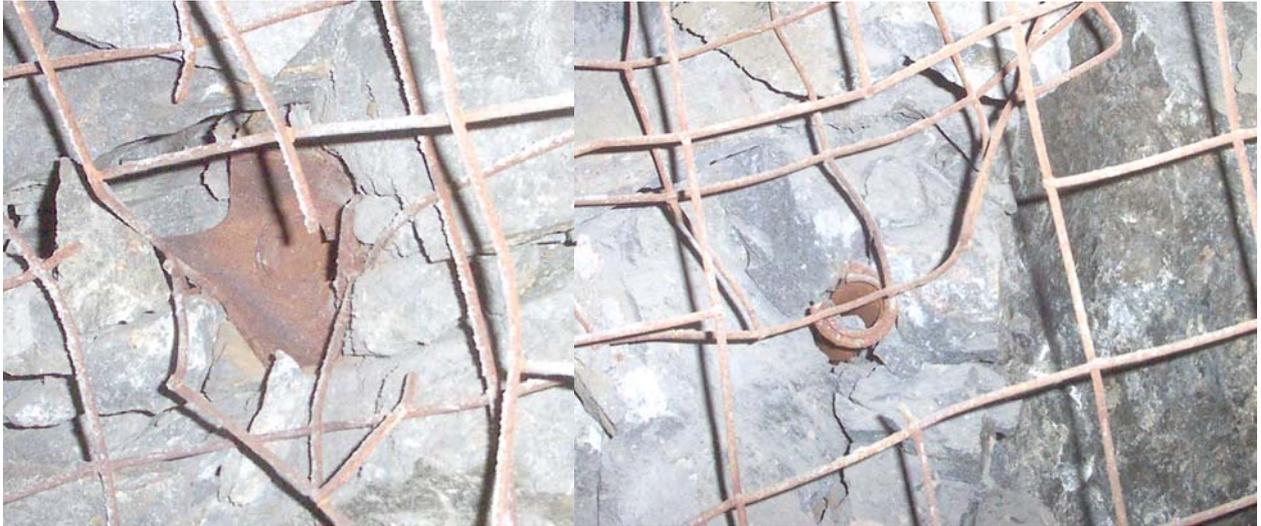
**Figure 4** Left – 35 mm friction set (splitset style bolt) with folded plate and broken No. 7 gauge mesh strands (wire strand capacity about 0.9 t, 4.5 mm diameter). Right – same wall – friction set with plate torn off. Mesh strands also broken. A slip plane can be seen in right half of photo. This chloritised structure caused localised movement on the wall, pinching the bolts not allowing them to yield. Mesh is 100 mm aperture for scale. Bolt length is 1.8

The use of yielding tendons can reduce the premature plate failure problem. In Figure 4 the splitsets likely could not yield due to shearing along the structure offsetting the bolts. Similar problems are common in laminated ground and at La Ronde Mine (Mercier-Langevin and Turcotte, 2007) they have introduced rebar inside the splitsets to enhance both the pull out resistance and the shear strength. This method also increases corrosion resistance of the splitsets and the rebar nut/plate over the splitset plate reduces the impact of this weak link.

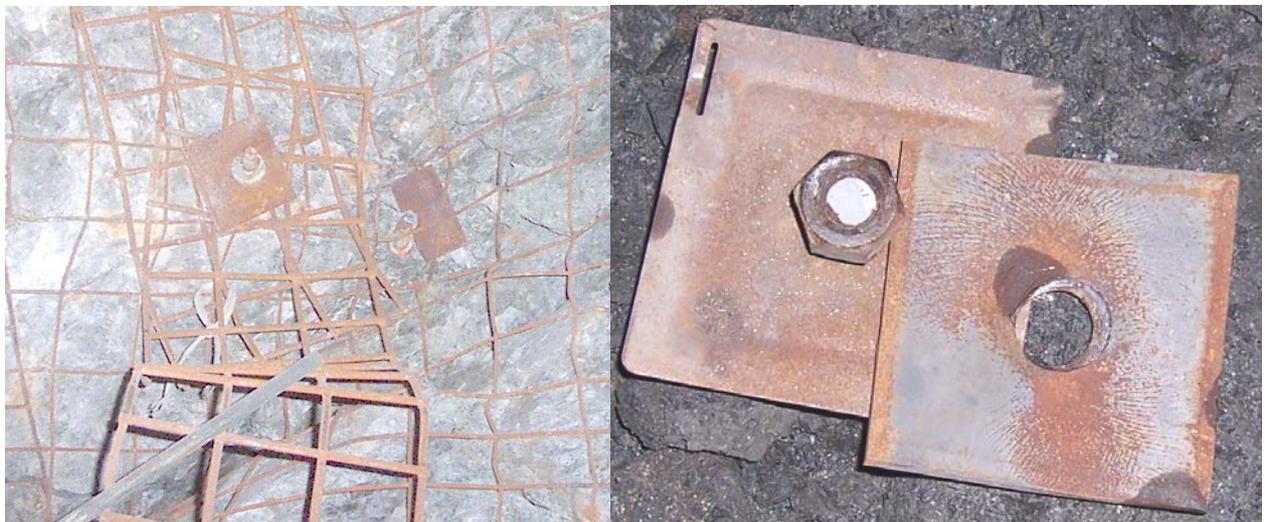
**Figure 5** Left – rebar plate ripped in half immediately to the right of cone bolt (yielding tendon) over 00 gauge strap. This area experienced dynamic loading from a M<sub>n</sub> 2.6 event approximately 15 m away. Right – No.7 rebar snapped at threads. A small amount of rust can be seen on the otherwise fresh bar break probably due to eccentric loading/bending of the bar (push plate seen on bottom, rebar plate on top)

In Figure 5 above (left side) modified cone bolt plates over top of heavy mesh straps survived a relatively large magnitude event, but the stiff rebar (without the loading spreading strap) had its' plate ripped in half. The right side of Figure 5 shows a close-up of a 22 mm rebar broken at the threads. In this case careful

examination of the bar shows a bit of rust on the otherwise fresh break. With the pre-existing crack in the bar it was easier to break at the threads rather than punch through the plate.

Getting the exact plate strength to match the bar strength may not be practically achievable because of irregular rock surfaces and un-even plate loading. The 3/8" plate punching resistance appears to be relatively close to the 22 mm rebar strength but still tends to bend prior to failure allowing a simple visual (qualitative observation) for bolt loading. The 1/4" plate also allows a good visual sign of bolt loading but arguably punches through too easily.

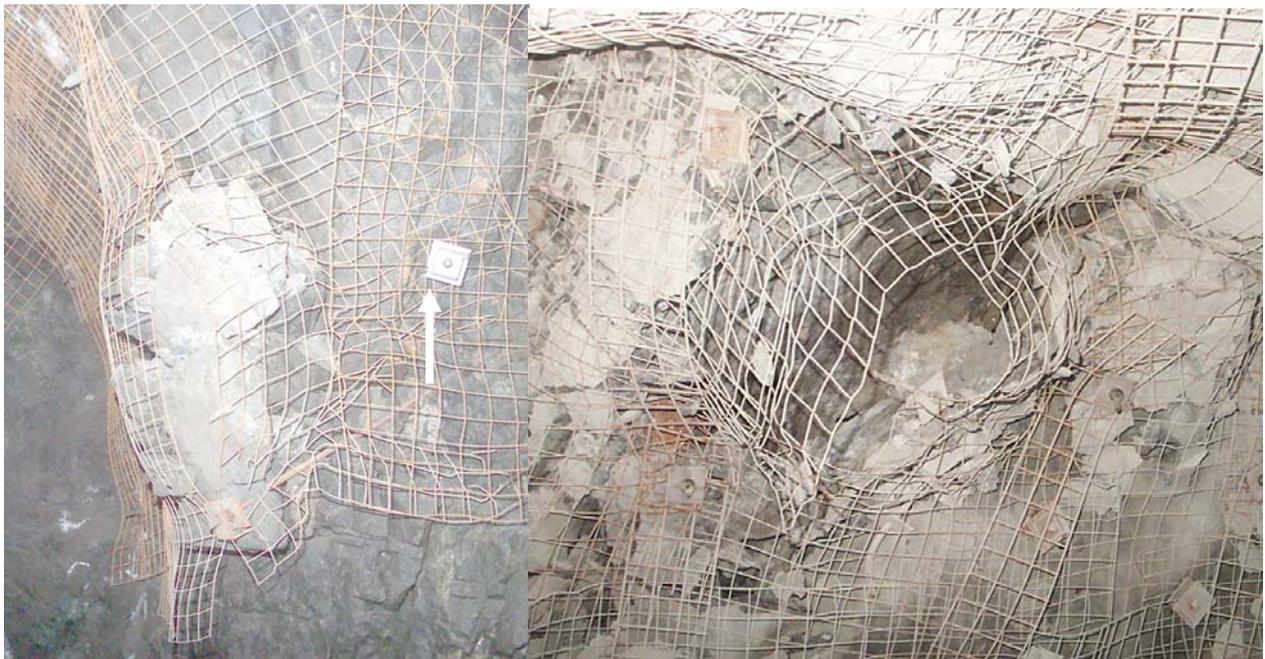
The use of weld mesh sheets (screen) is popular in typical Canadian Hard Rock Mines. Different wire thicknesses are available, with most operations balancing ergonomics (weight of a sheet with respect to manual handling), cost and performance. In some operations #9 gauge has been found to be "light" and prone to blast damage and premature failures, and switching to #6 gauge led to less re-work. Xstrata Sudbury operations generally use #7 gauge. Better performance comes from heavier mesh, however peeling apart along the screen sheet edges is often the problem rather than the wire strength. Even with 2 to 3 square overlaps (200 to 300 mm) the seam can split open more easily than breaking a line of wire strands (Figure 6).

**Figure 6** Left – bulking in blocky ground. Wall screen is splitting at seams; a push plate is denoted by the arrow. Right – back screen between straps and cone bolts after Mn 2.0 event approximately 10 m away (about 1.5 tonnes of loose spilled out)

Push plating (Figure 5 right, Figure 6 arrow) is often used to attach the next development advance mesh to the previous advance. The plates are designed to go over the rebar threads with a pull off strength a bit stronger than the mesh strength. They are placed over the main rebar plate so aren't that well coupled to the rock surface and don't often pull off under load. The mesh bagging is rarely sufficient to pull off the push plate as it would break the wire strands first and for strain bursting, the rebar plate gets hit first.

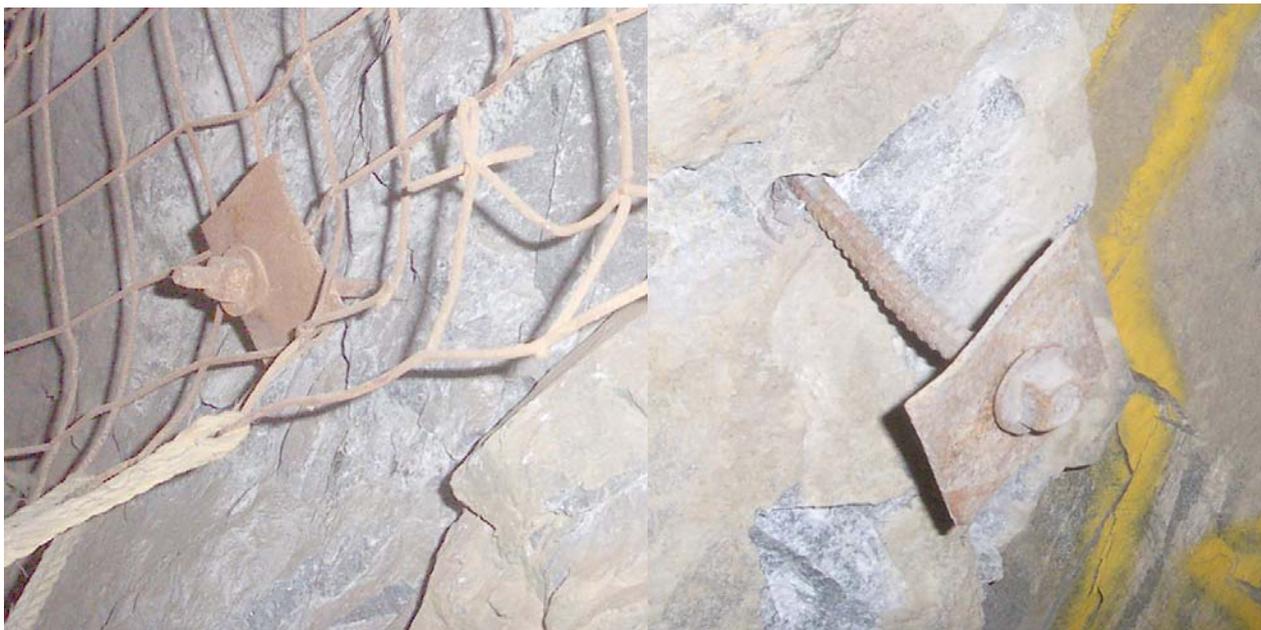
**Figure 7** Left – Zero capacity bolt – mechanically anchor rockbolt in wall – plate is vertically aligned allowing minor spalling to fall out more easily due to gravity – once the plate has lost contact, the end anchored bolt is no longer supporting anything. Note also lowest wall screen can allow small material to spill out (open ended between bolts). Right – forged head rebar – spalling caused plate to lose contact (similar to left photo) but at least there is a fully bonded ripple bar in the hole still acting as ground support. The forged head arguably avoids the inherent weakness conventional rolled or cut threads cause (although forging changes steel strength) but the plate can only be held tight to the rock during installation, not tightened up later as threaded bar allows

Plate size is sometimes dictated by equipment, especially with some mechanised bolters using a carousel configuration that won't fit large plates. Thicker plates (e.g. 3/8" versus 1/4") do not pull off as easily but don't give as clear a visual sign of ground support taking load (less bending). Good coupling to the rock can also be an important factor, although threading the bar can introduce a weakness, it does allow an inexpensive way to get the plate tight to the rock. Some friction style bolts (e.g. swellex) have to rely on a bit of bolt "shrinking" as it is expanded to get the plate tight. The lack of tight coupling with the rock may actually avoid the potential weak link of the welded bushing or a plate ripping over the bushing. Externally threaded bar (e.g. dywidag) offers an obvious improvement, again usually at higher cost.

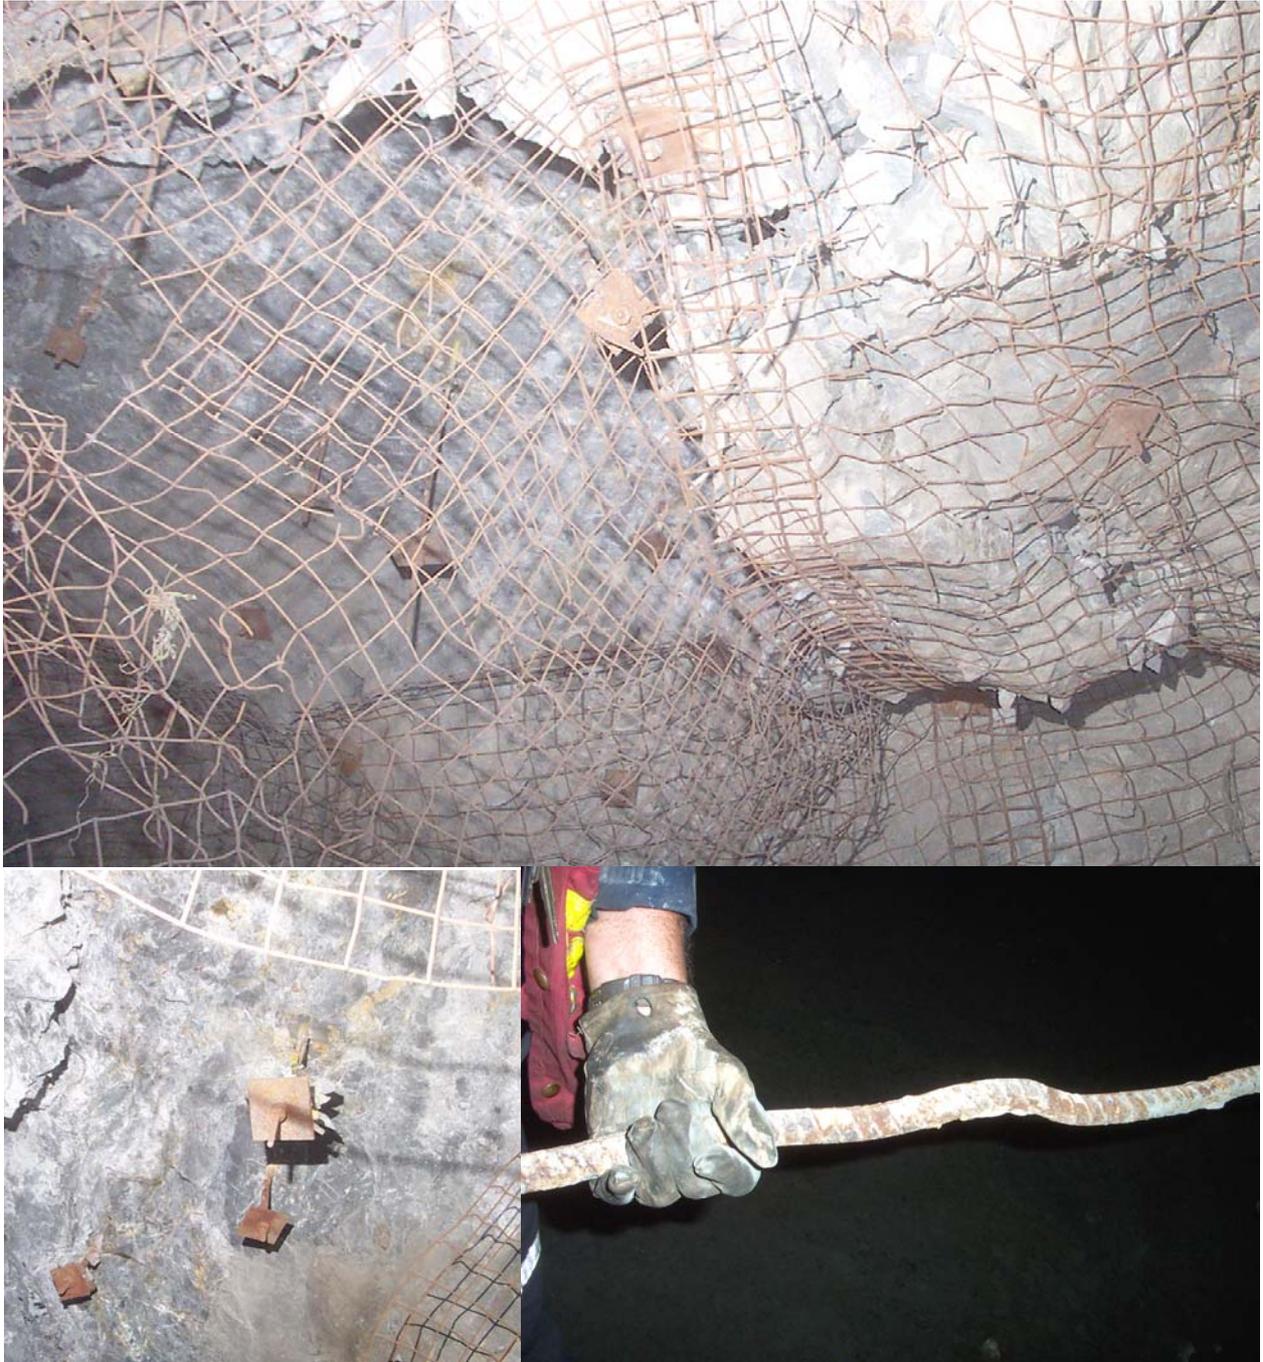
Figure 8 shows a rockburst in the back of a blasthole overcut that likely occurred with the blast. It became accessible after filling the panel several weeks later. The failure occurred after the last line of modified cone bolts and straps where only rebar/screen and cables were installed. Experience has been that the load spreading straps help prevent the rock from shattering out around the bars, which is as important as the use of yielding tendons (modified cone bolts installed through the straps in this case) for rockbursting conditions. The bottom right photo shows two intact rebar, one intact cable, and two screen seams. Although some rebar and screen failed (e.g. bottom left photo), most of the fallout was allowed by retainment loss (screen peeling open at seams, rock shattering out around tendons).

**Figure 8** Back burst in blasthole overcut after floor mined out

The heavily sheared rebar shown in Figure 8 illustrates several points. Although the end was sheared off (not in photo) the bar deformed at several locations along its axis resulting in substantially more deformation capacity than a simple pull test would imply. For example a typical rebar pull test might have failure displacement in the order of 20 to 30 mm. If the bar displaces along multiple portions (for example in stress fractured ground with multiple fractures dilating) it may be able to deform to much greater total amounts.

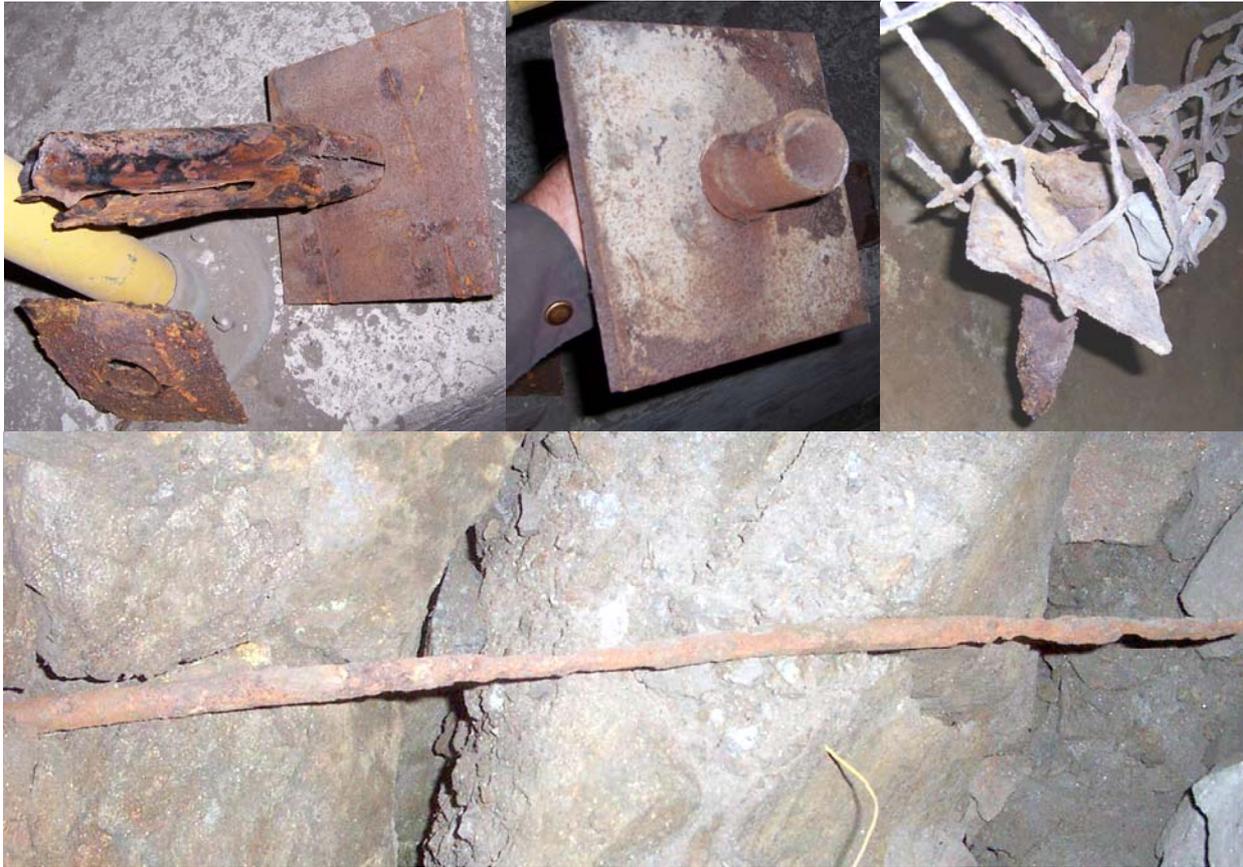
Thin walled friction bolts and mechanically anchored rockbolts are well known to be prone to corrosion problems. In theory a mechanically anchored rockbolt could perform quite well, being able to accommodate movement between the shell and the plate. In practice slip or failure of the mechanical shell often occurs prior to breaking the bar, and the entire assembly is prone to corrosion. It is not always possible to detect severe corrosion problems by visual assessment alone, examples of rockbolts and friction style bolts corroding in the hole with an apparently “good” protruding portion occur as per Figure 9 below.

**Figure 9** Upper Left – Super swellex bolt approximately 6 months old after being exposed by a small fall of ground. It was installed in a wet area in massive sulphide material (corrosive). Centre – same swellex bolt viewed from plate side with apparently only moderate corrosion. Upper right – friction set (split set) after approximately 2 years in an area with limited ventilation (high humidity). Bottom – mechanically anchored rockbolt with variable corrosion along its length (installed in massive sulphide material > 5 years, was exposed during rehab)

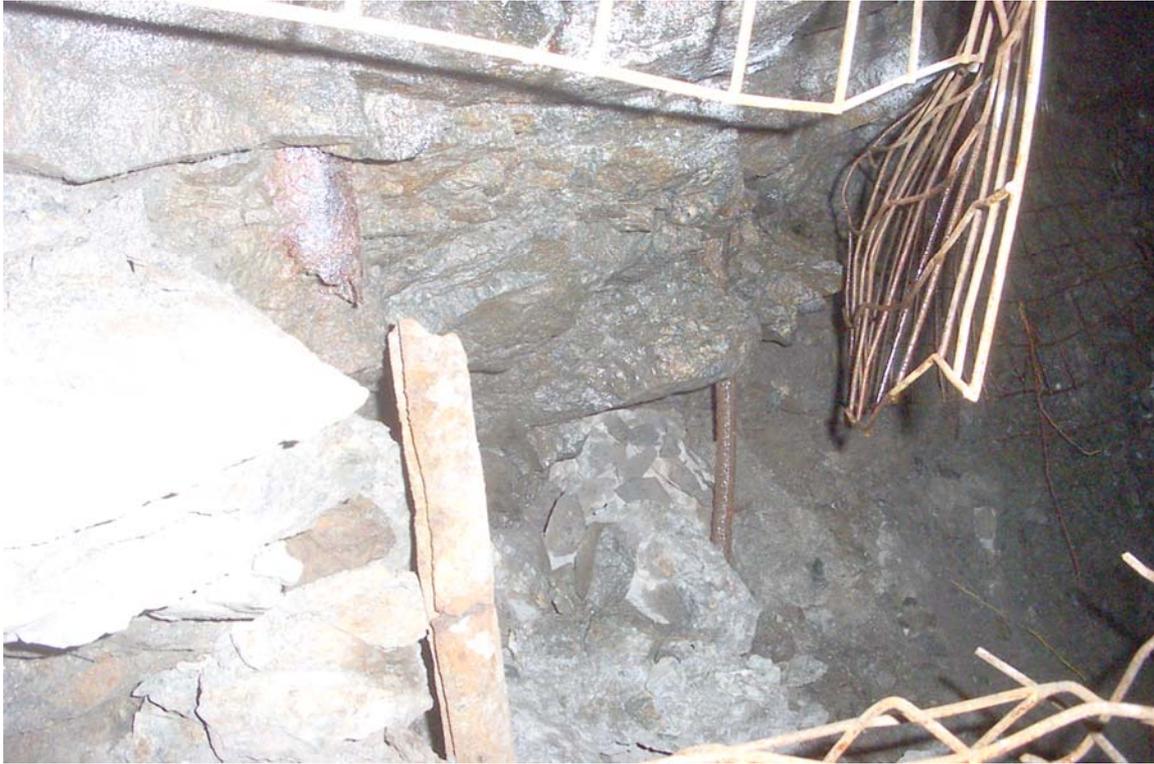
There are various pros and cons with different support systems, in Figure 10 a super swellex bolt and a 22 mm rebar were both exposed in the lower wall of a cut and fill stope (breasting through the previous cuts' back support). The relatively thin wall swellex is prone to both corrosion and tearing when sheared, whereas the resin encapsulated rebar can bend significantly (see Figure 8 for example) and is generally resistant to corrosion. The swellex however was intended for the relatively short duration of a cut and fill lift and is generally simpler to install with fewer potential quality problems. Resin cartridges can have issues with obstructions in the hole, over spinning, shelf life, catalyst evaporating, etc. At Craig Mine the super swellex are used in 3.5 m or connectable 2.4 m lengths as “long” support generally for wider spans and/or structural wedges in cut and fill mining. For more permanent development or longer duration mining sequences (some blasthole accesses) cables are preferred because they can bend in shear and the grout protects them for rust. Rebar are used most of the time for standard support because of their ability to ‘knit’ together stress fractured rock and control rock bulking (Kaiser et al., 1996). In heavily fractured ground (example developing through failed and dilated rock) it is sometimes necessary to use splitsets and/or swellex to ensure higher quality installation because of difficulty keeping resin cartridge plastic sleeves from shredding prior to filling the hole.

**Figure 10** Sheared super swellex exposed in cut and fill mining. The rebar in the background was bent but not broken

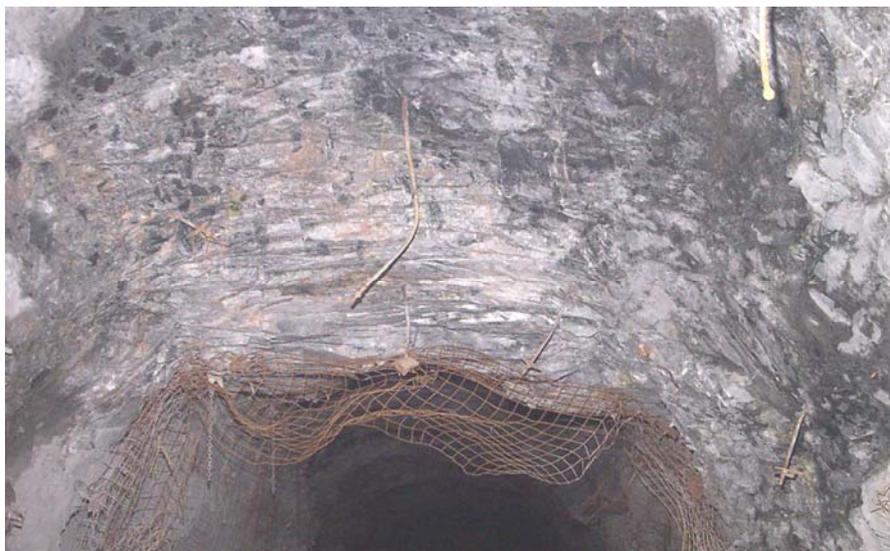
**Figure 11** Stress fracture 'arch' exposed in cut and fill access. Accessing the subsequent cut is done by "taking down the back" of the previous cuts' access providing a sectional view through the fracture zone. 5 x 5 m access

It is reasonable to take some support credit for the arching or laminated beam effect of keeping the fracture zone together (reinforced rock arch – Lang and Bischoff, 1982). However driving an excavation off to the side at a later date can de-stabilise the arch and heavy scaling in the back and upper shoulder is often required.

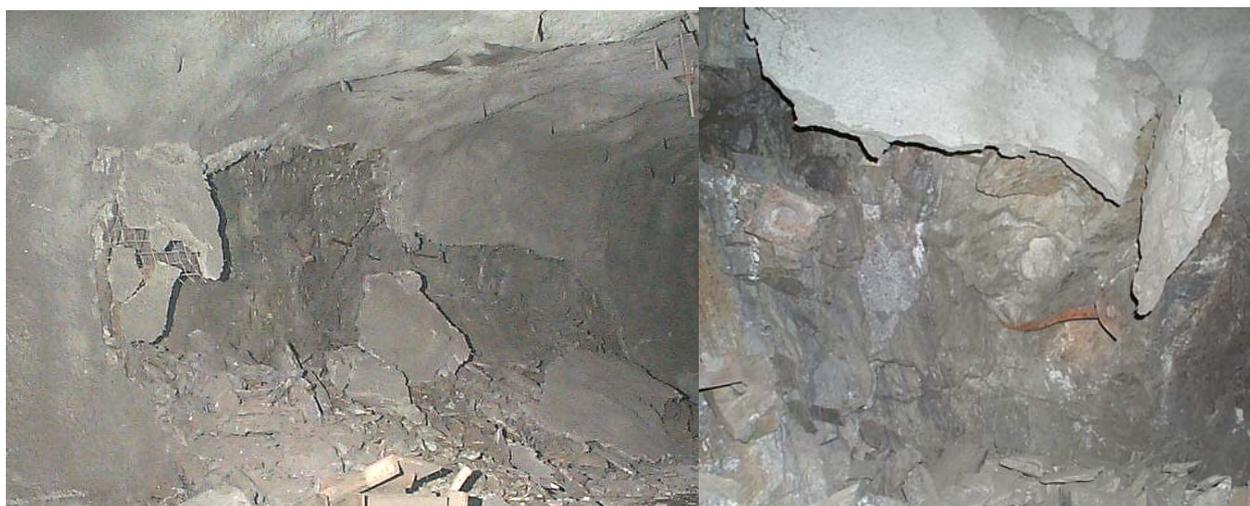
**Figure 12 Shotcrete after rockbursts (two separate incidences). Both had dramix steel fibres in a prescribed thickness of 75 mm. Left photo also had No.9 gauge weld mesh in top half of wall. In both cases about 75% of the bolts were left virtually intact (mix of splitsets and No.6 rebar). In both cases the shotcrete was applied over the primary support (rebar, splitsets and screen) and thus didn't help transfer load to the tendons**

The requirement for shotcrete is usually a cost/benefit decision. A shaft only access and relatively spread-out mature mine may find the logistics prohibitive. For example Craig Mine normally uses dense bolting and durable mesh to control spalling ground, and selectively enhances it with shotcrete to prevent re-work caused by corrosion, machine damage, and blast damage (particularly truck loadout areas, sumps, and above slot raises). The mine often sprays the back where up-hole blastholes (uppers) are being drilled to prevent small scale un-ravelling of the fracture zone. Systematic shotcrete may be more applicable where productivity gains over mesh are realised and the life of mine excavation deformation does not exceed the liner capacity. It can also successfully control some strain bursting and blast vibrations (Kaiser et al., 1996) but as shown in Figure 12 above it can eject from the excavation surface during larger rockbursts.

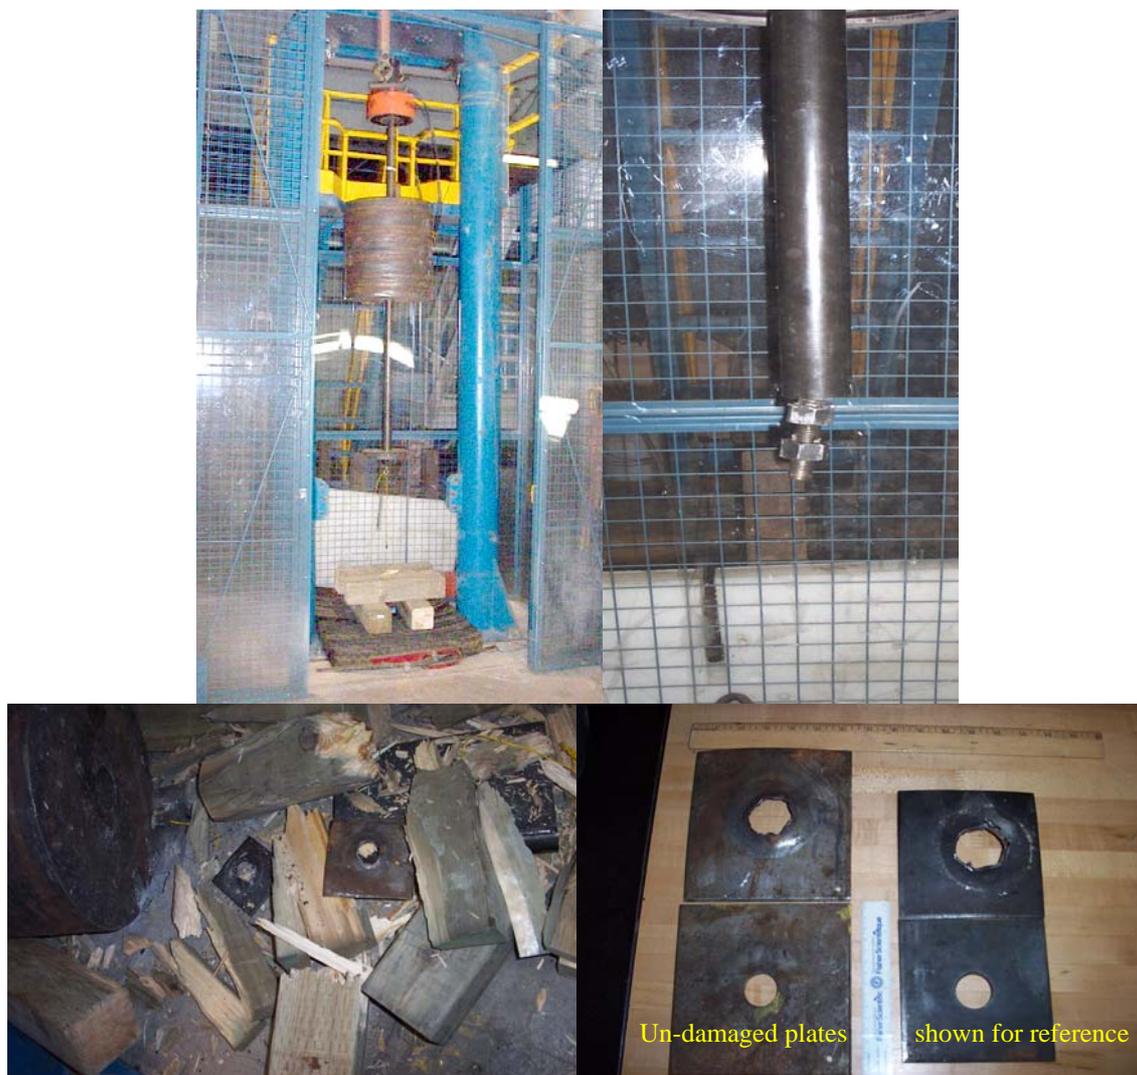
Three toe anchored rebar were tested by spinning them into a thick walled steel tube and subsequently dropping a 1023 kg weight onto the bolt plate (see table 1 and Figure 13 below).

**Figure 13** Toe anchored rebar tests. Upper left test rig with mass in free fall. Right/below – results of first drop, plates tore over nut similar to underground observations in Figure 1
