In-situ Dynamic Testing of Ground Support Using Simulated Rockbursts

D. Heal *Australian Centre for Geomechanics, Australia*

Abstract

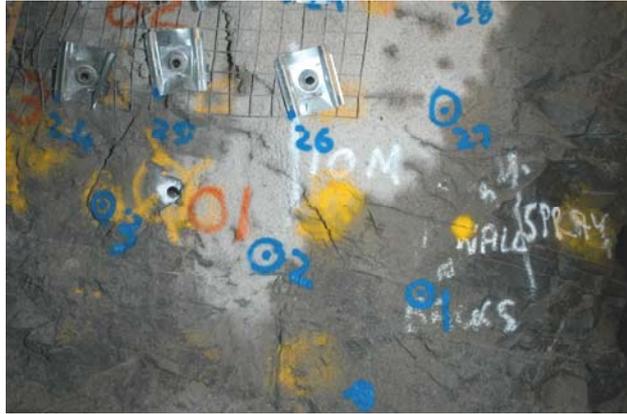
Figure 4 One of two high resolution digital images used by the Sirovision software to generate the three-dimensional point cloud in Figure 5 and the three-dimensional image in Figure 6

Extensive mapping of each test site before and after each blast is carried out using Sirovision, a three-dimensional photogrammetry system developed by the CSIRO and designed primarily for structural mapping of underground or open cut rock faces. Sirovision allows the generation of fully digitised three-dimensional images from stereo pairs of photographs, when accurate survey support is available. As well as mapping, images generated before and after successive blasts are used to identify areas of rock bulking or ejection, accurately measure deformation of surface support and measure the displacement of rockbolt plates and ends. These measurements contribute to the qualitative and quantitative assessment of ground support system performance. In addition, the Sirojoint module allows the user to accurately measure the parameters defining discontinuities in a rock mass and analyse the structure of a rock mass by using three-dimensional images (CSIRO 2003). An example of a three-dimensional image generated from a high resolution digital image is shown in Figures 4, 5 and 6. The Sirovision software uses two digital images of known camera separation to generate a ranged three-dimensional image. Accurately surveyed points visible on the images can then be used to translate the ranged image into a true three-dimensional image, relative to the mine's co-ordinate system. Four numbered points in Figure 4 were used to orient the three-dimensional image in Figure 6 in the mine specific co-ordinate system.

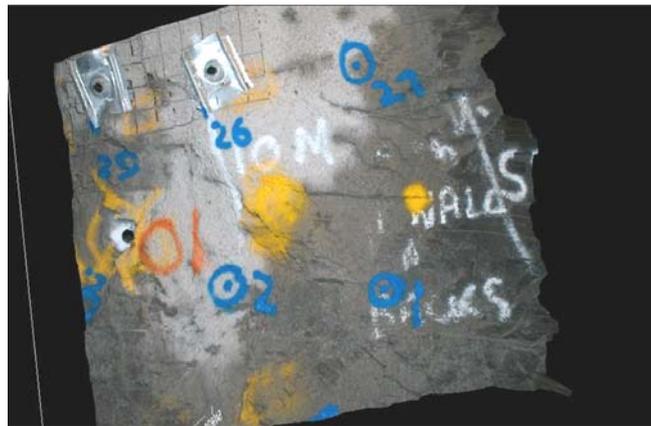
Figure 6 A three-dimensional image generated from the point cloud in Figure 5 and digital image in Figure 4

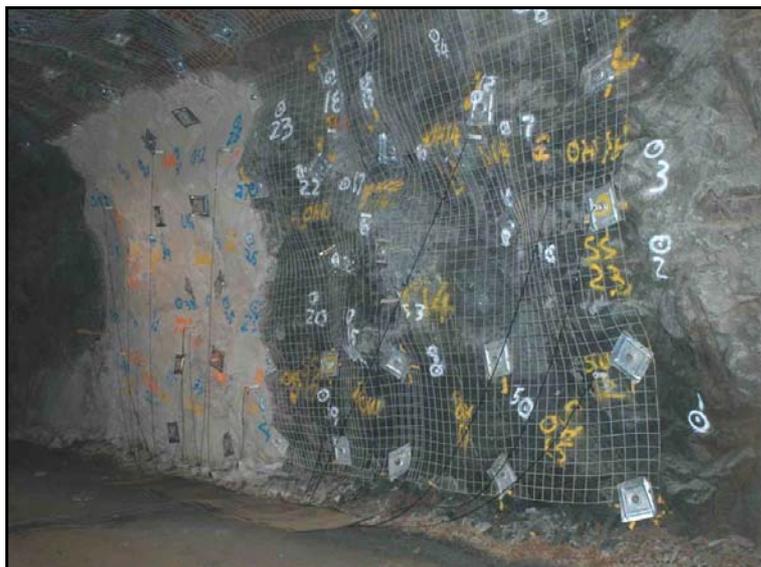
Figure 9 Completed test wall setup from Mt Charlotte, shown prior to the first blast. The numbered circles are Sirovision control points. Surface mounted geophones connected by coaxial cable are attached to the test wall surface at various locations

A photograph of the completed test wall setup is shown in Figure 9, taken prior to the first blast. The photograph shows the two ground support systems tested side by side (in this case Split Sets and Masterseal on the left and Split Sets and Mesh on the right). The numbered Sirovision control points can be seen spread out across the test wall, the locations of which were surveyed before and after each blast. Also visible are the

surface mounted geophones connected with coaxial cable. The cables are protected by conveyor belt where they run along the drive floor, to protect them from falling or ejected material during blasting.

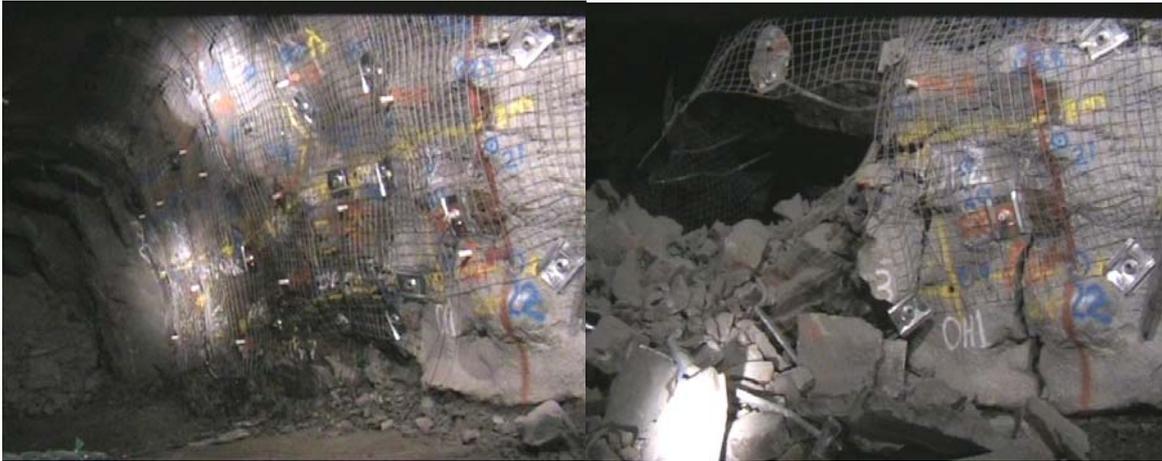
Figure 10 Before and after shots from the digital video camera at the Longshaft Rhondo North Access site. Ground support systems tested were “Split Sets and Mesh” and “Widely Spaced Split Sets and Mesh”

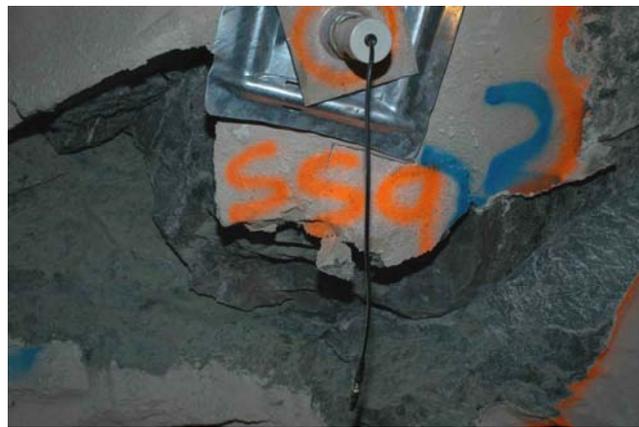
Figure 11 From Mt Charlotte 1155 Access – ejection of rock supported with Masterseal 845A TSL around Split Set plates. A rockbolt mounted geophone is visible

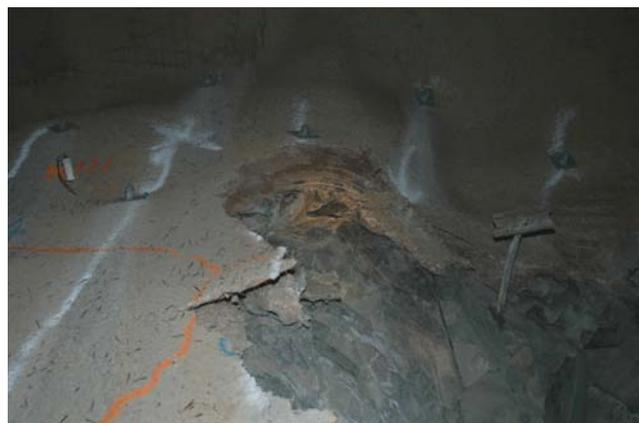
Figure 12 Ejection of Fibrecrete and Split Sets left protruding at the Darlot Walters 1240 Access test site. Note the section of mesh reinforced Fibrecrete higher in the photo suffered far less damage

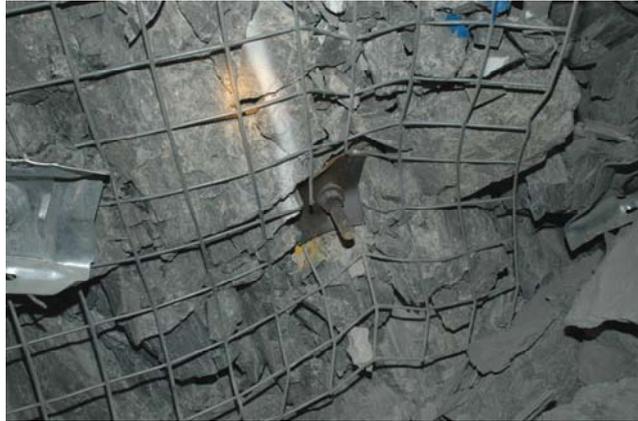
Figure 13 Moderate damage to the Split Sets and Mesh with Cone Bolts test section at the St George 8 Level Stockpile site. Severe bulking of mesh was observed and the small Cone Bolt plate has cut the mesh

Bolts” system only marginally outperformed the “Split Sets and Mesh” support systems tested at other mine sites. This is considered to be due to the fact that in many cases where there was bagging of mesh, the mesh was cut by the small Cone Bolt plates. If larger plates had been used it is likely that this ground support system would have performed better and some areas rated R4 or R5 damage would probably have instead sustained R2 or R3 damage.

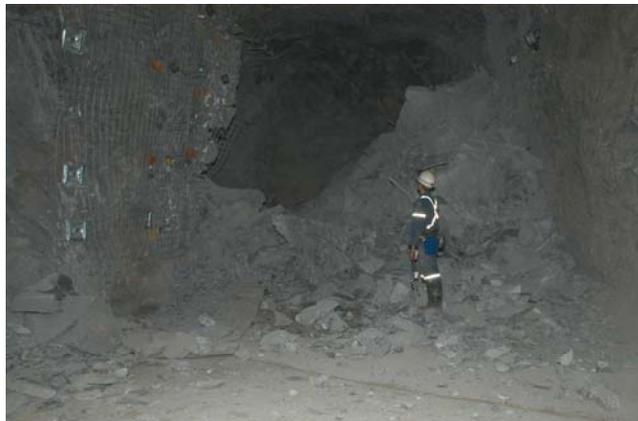
Figure 14 After the 2nd blast at the St George site. The system in the foreground (Split Sets and Mesh with Cone Bolts) mostly survived however the other system (Split Sets and Tunnelguard TSL with Cone Bolts) was completely destroyed

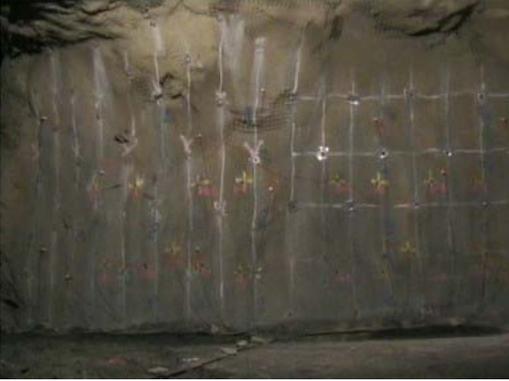
<p><i>Before the simulated rockburst</i> $t = 0s$</p>

Table 2 Individual frames of 1st blast footage from the Darlot Walters 1240 Access test site

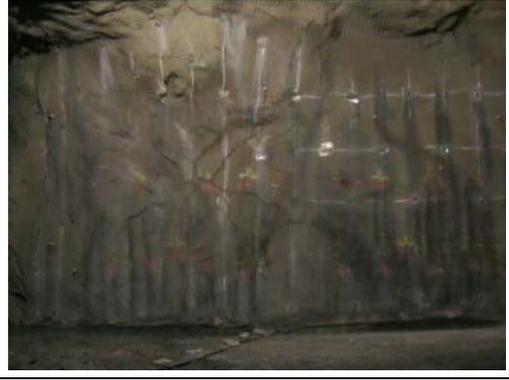
<p><i>Shock phase</i> $t \sim 40ms$</p> <p>This frame shows the arrival of the shock wave from the blast. The propagation of the shock wave generates fracturing across the test wall, particularly in the central region supported by Split Sets and Fibrecrete or Securabolts and Fibrecrete</p>

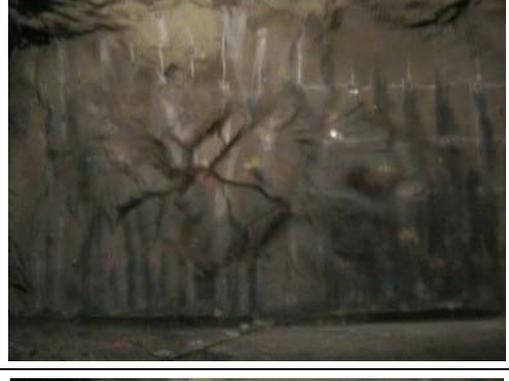
<p><i>Bulking and ejection</i> $t \sim 80ms$</p> <p>Fracturing of the rock mass has caused it to expand (bulk). The energy transferred to the bulking rock imparts a velocity on the fragments, ejecting them.</p>
