# Destressing the ROB5 Remnant Using Tight Slot Blasting at Mt Charlotte Mine

## Abstract

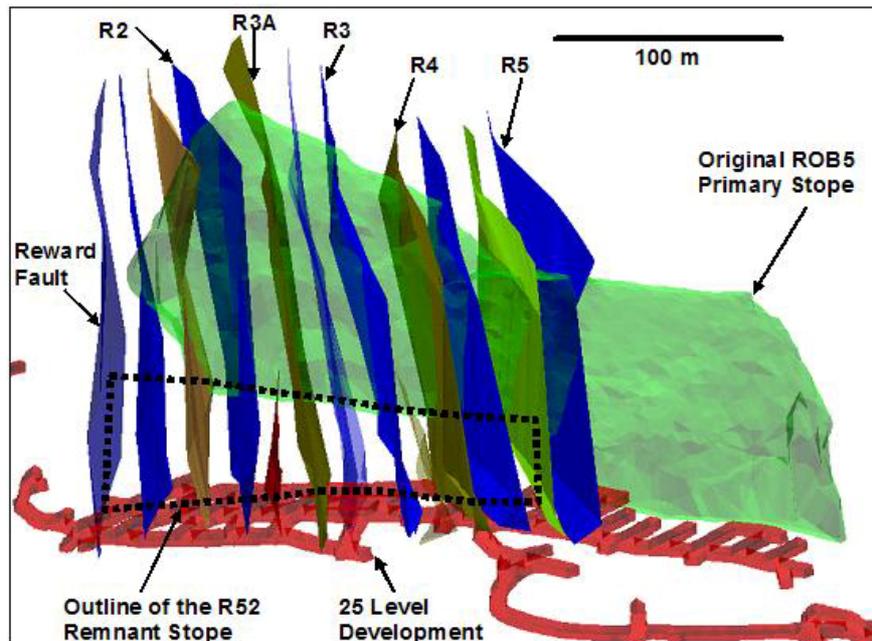
**Figure 1** Perspective view of the ROB5 area showing the larger subvertical structures — the west-dipping structures are omitted for clarity

**Previous mining:** Seismicity in the ROB5 stoping block has been an enigma. The primary ROB5 open stope was very large – 280 m long, up to 135 m high and 70 m wide (Figures 1 and 2). It was mined in 1990-1994 between 21 and 25 Level and from north to south. High stresses, extensive back overbreak and seismicity were experienced, but despite mining through several major structures (R-shears), significant seismicity did not occur until later.

**Sub-vertical shears:** The ROB5 stoping block is bounded by two major sub-vertical northeast striking faults - Reward Fault to the north and Maritana Fault on the southern end. Several R-shears (some shown in Figure 1) are sub-parallel to Reward Fault and transect the stope block at 20 to 50 m intervals. They typically comprise one or several tight sub-parallel semi-continuous surfaces.

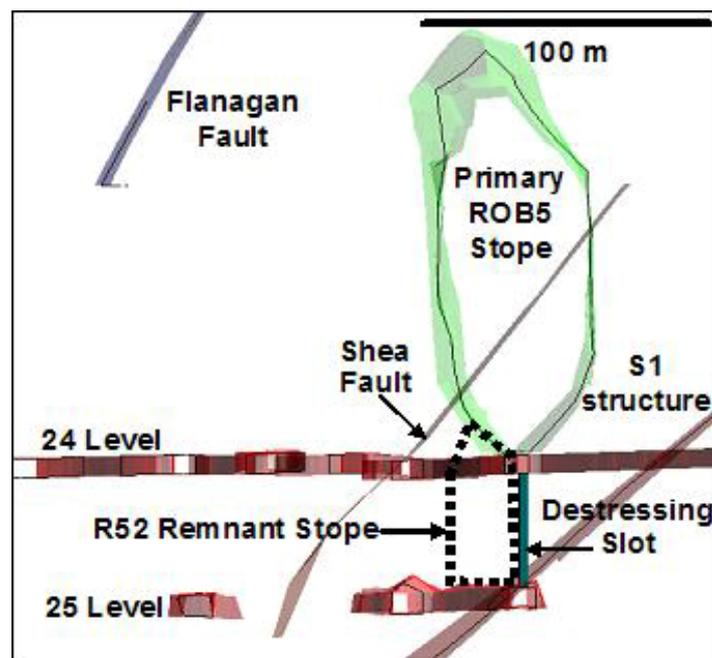
**Figure 2** An east-west cross-section slice through the mining area, showing the major west-dipping structures transecting the stoping area

**Moderate west-dipping structures:** Shea Fault dips approximately  $45^\circ$  to the west and intersects the stoping block, as does the S1-shear which is sub-parallel to Shea Fault. In the prevailing geometry and stress field, both the R-shears and the west-dipping structures experience high shear stresses. The R-shears have numerous minor offsets at intersections with the west-dipping structures, but unfortunately offset locations and styles cannot be easily determined. Offsets, in combination with undulations (roughness), can cause locking on both structure sets. Shear may be difficult even in a slip-favourable stress state, but when it does occur, significant seismicity is possible.

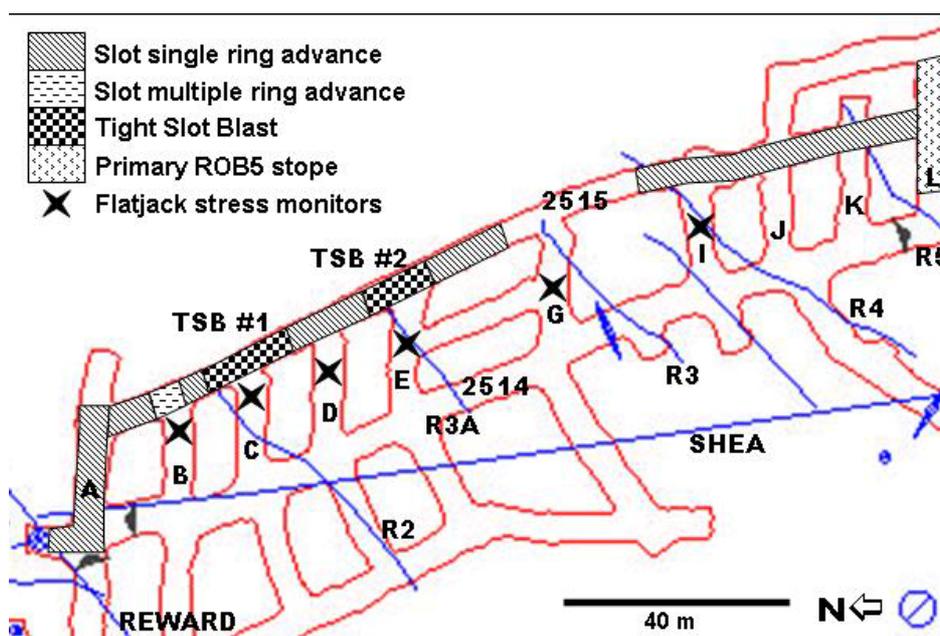
**Figure 3** Plan of 25 level showing major stages in the mining of the R52 slot and location of stress monitors

After exhaustive studies it was decided to close with the previous stoping and that the final slotting interval would be from about millholes G to I (see Figure 3). This interval was considered to be partly destressed due to prior movements on structures, with associated seismicity. It was also more structured, so shearing should occur more readily, i.e. less storage of energy. No known locked-up structures intersected the interval, and Shea Fault was located significantly further west of this slotting interval, compared to its position at B millhole.

The adopted mining plan, which varied slightly from that in the original Map3D modelling, comprised the steps shown in Table 2 and Figure 3. The plan involved uphole retreat with several TSBs from 25 Level. While uphole retreat was not ideal for brow stability, due to high brow stresses, it was thought to be manageable with appropriate ground support.

**Table 2 The implementation stages for the ROB5 TSB project. Locations of key activities are shown in plan view in Figure 3. Only major seismicity is noted**

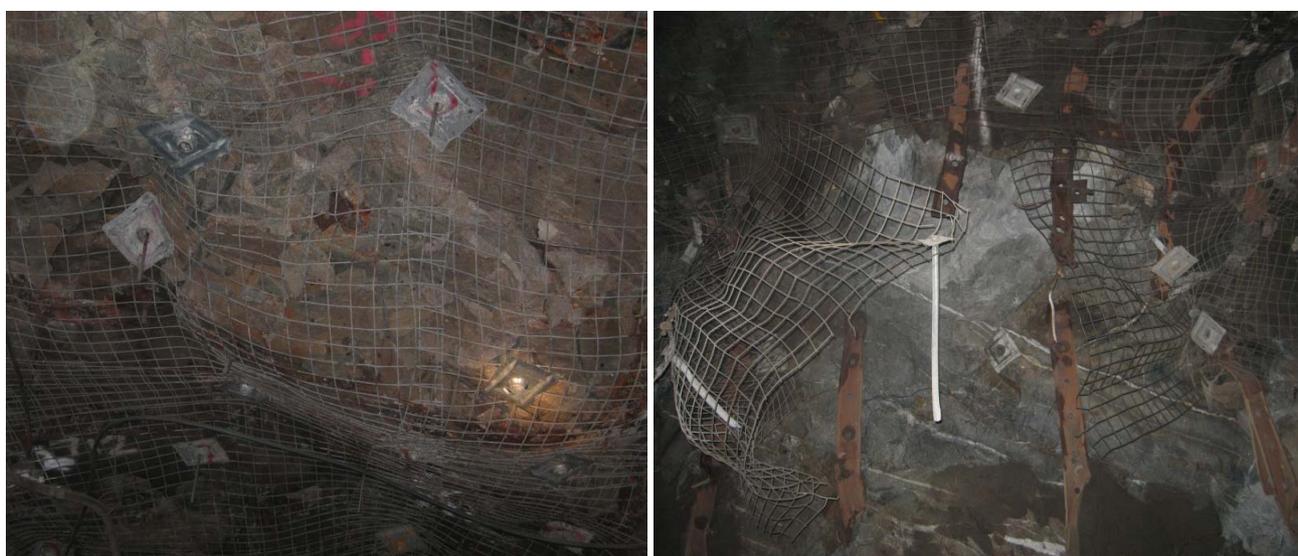
**Figure 4** Ground support performance: (left) Bagging has been reduced by the combination unit of a bulbed cable grouted into an over-drilled split-set; (right) significant seismic damage in millhole B: conebolts survived while split-sets failed

The combination of bulbed cables grouted into over-drilled split-sets was an effective reinforcement element for the prevailing blocky and seismic conditions on 25 level. The cable bolt was 3 m long with a single bulb positioned 0.2 m from the end, and was not plated or tensioned. This combination support element has also been able to reduce bagging (Figure 4). The installation practice was to drill a 3 m deep borehole, install a 2.4 m long split-set, insert the grout hose to the 3 m depth and fully grout the hole while withdrawing the hose, and then push a bulbed cable into the split-set until only 0.1 m was left protruding.

Grouting improved the stiffness (capacity / length) of the split-set, and the cable was well anchored by the grouted bulb above the split-set. No failures of this support element have been observed, but a few were seen to take load (cable ends unwinding). This indicated that the system was providing increased static capacity, compared to split-sets alone, plus it was soft enough to survive some dynamic loading.

It was noted that the conebolts (installed in about 1996) survived the 18 January 2007 seismicity, whereas some of the nearby split-sets (in a small area in B millhole, Figure 4) did not.

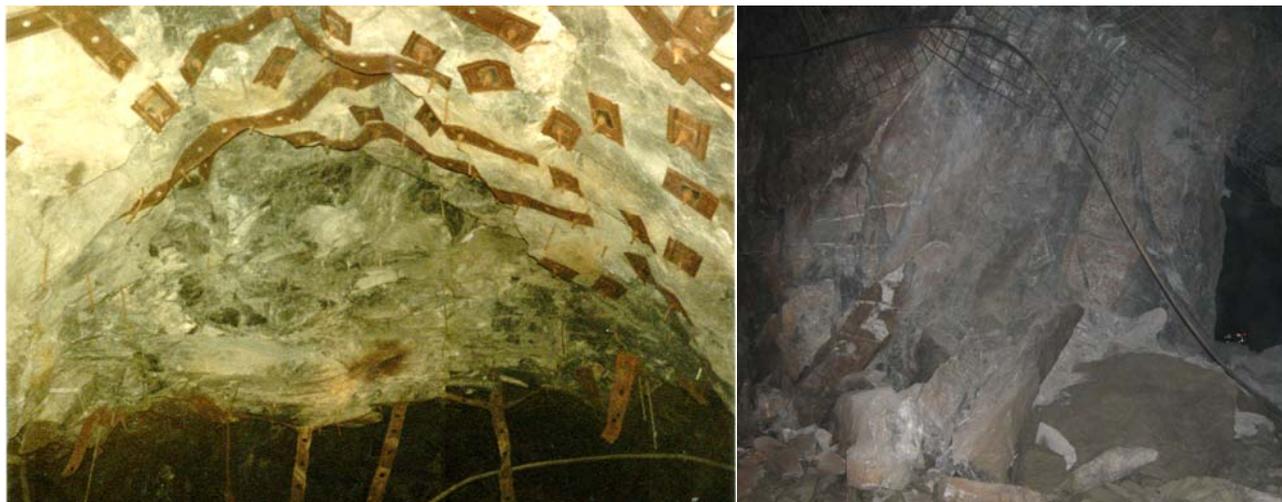
**Figure 5 Seismicity damage: (left) The fracturing developed above the 2514 backs due to seismicity on 17 March 1997; (right) Wall failure due to shearing on Shea Fault on 18 Jan. 2007**

The 2514 footwall drive backs had been severely damaged during the 1997 seismic event (Figure 5). Planning in 2005 had anticipated the possibility of new seismicity on Shea fault affecting the drive. Therefore the drive was rehabilitated by thorough scaling back to sound rock, re-meshing with 3 m split-sets, then shotcreting through the mesh to 75 mm minimum, wrapping into the walls. The grouted split-set / bulbed cable combination bolts were also installed throughout this area. The broken nature of the ground precluded installing resin bolts. To date, this support has functioned very well. No further seismic activity has directly impacted the area, and it appears that this area had been distressed by the earlier seismicity.

As noted earlier, large seismic events in 1995 and 1997 had sheared several structures (R3, R3A, R4, R5 and Shea). Figure 5 shows the sub-horizontal fracturing that occurred with the 1997 events above the backs of 2514. This fracturing, along with other extensive damage along 2514, indicates that some east-west closure had occurred, which would have reduced the local east-west stresses (i.e. destressing had occurred in the rock volume that was selected as the final slotting closure pillar).

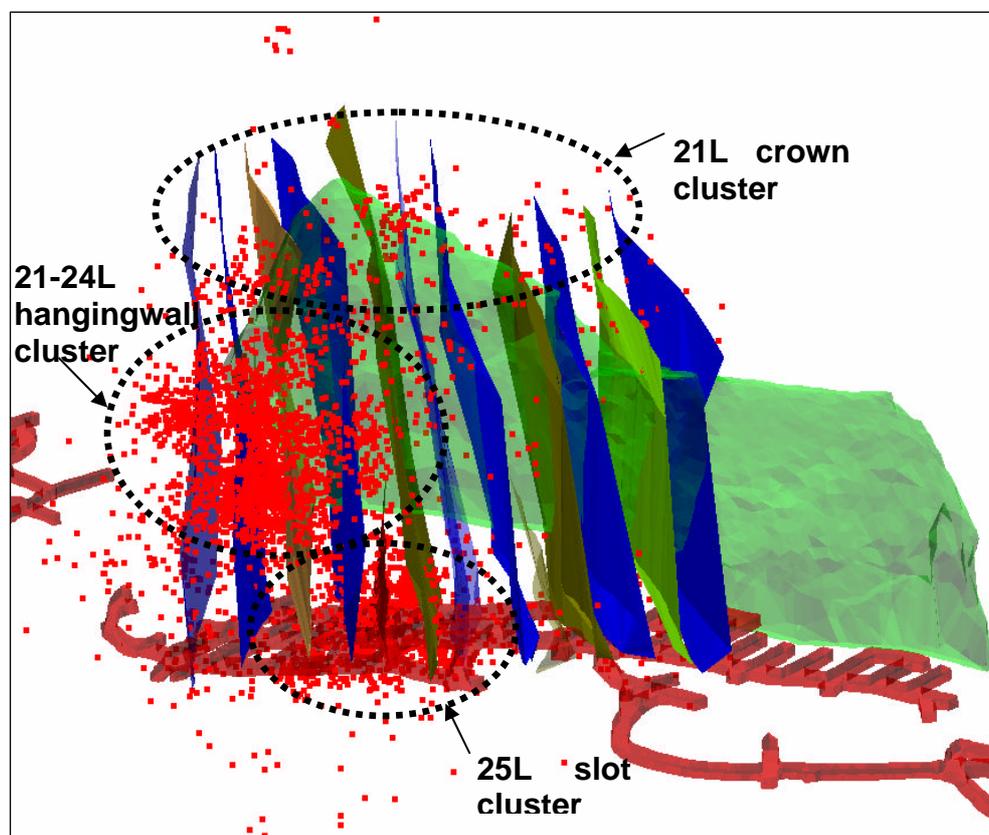
**Figure 6** Perspective view showing the location of seismic events

The largest event recorded to date during the project was  $M_R +2.2$ , compared to target maximum of  $+2.3$ . It was on Shea fault, which while not effectively destressed by the slotting, was restrained by backfill in the slot. An example of the seismic damage is shown in Figure 5, while the overall seismic response is summarised in Figures 6 and 7.

Seismicity was a good indicator of the progress and extent of destressing (Figure 6). Until May 2007, events occurred dominantly within 20 m of the northern slot brow. The turning point was the 4 June 2007 shear event on S1 (Figure 7). From then, there was a reduction in seismicity near the brow, and a very marked increase in seismicity up to 100 m distant from the slotting.

The southern slotting and the interval from G to L millhole have had consistently far fewer events than the northern half of the stoping block. Events extended up to 70 m west of the northern slotting area.

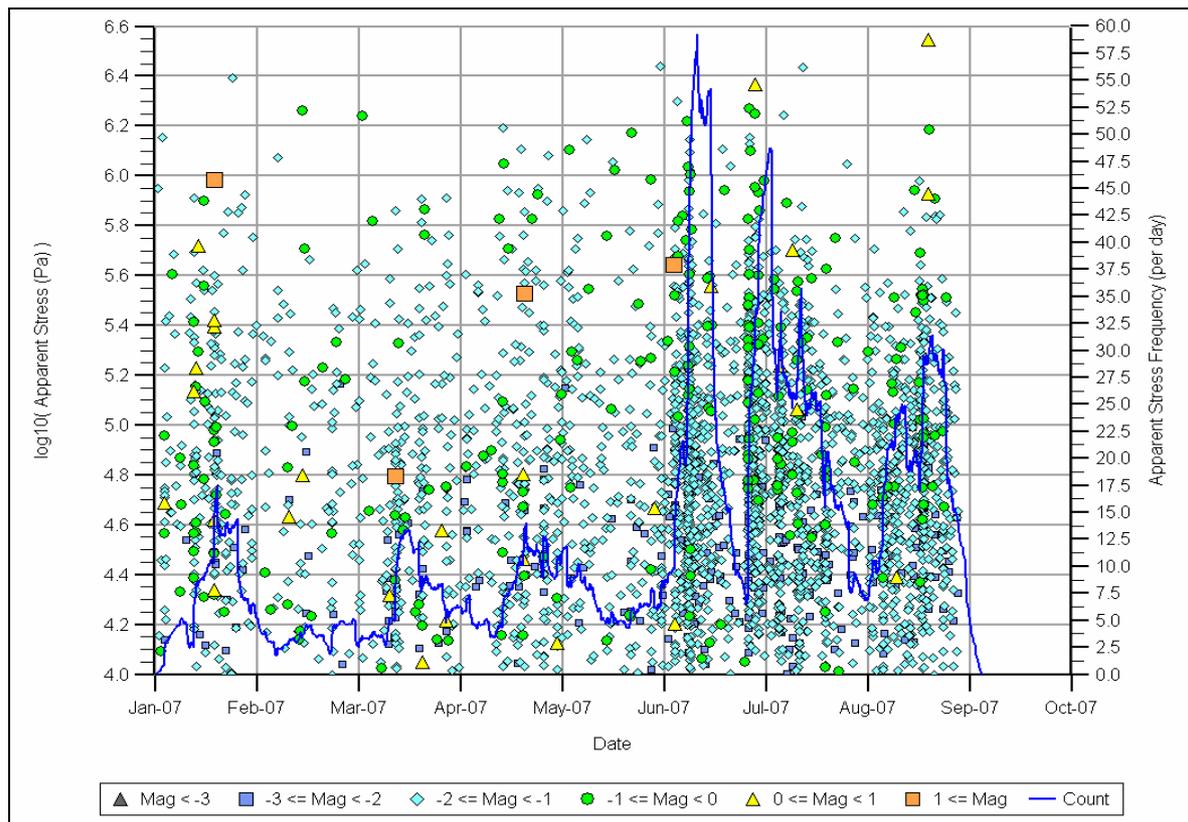
**Figure 7 All ROB5 seismicity as a graph of Apparent Stress over Time, showing the change on 4 June 2007, and the correlation of higher magnitude events with peaks in the Apparent Stress Frequency. Apparent Stress is a measure of the relative amount of energy in a particular seismic event. The solid curve is the 7 day trailing average daily number of events with an Apparent Stress greater than a 10,000 Pa threshold**

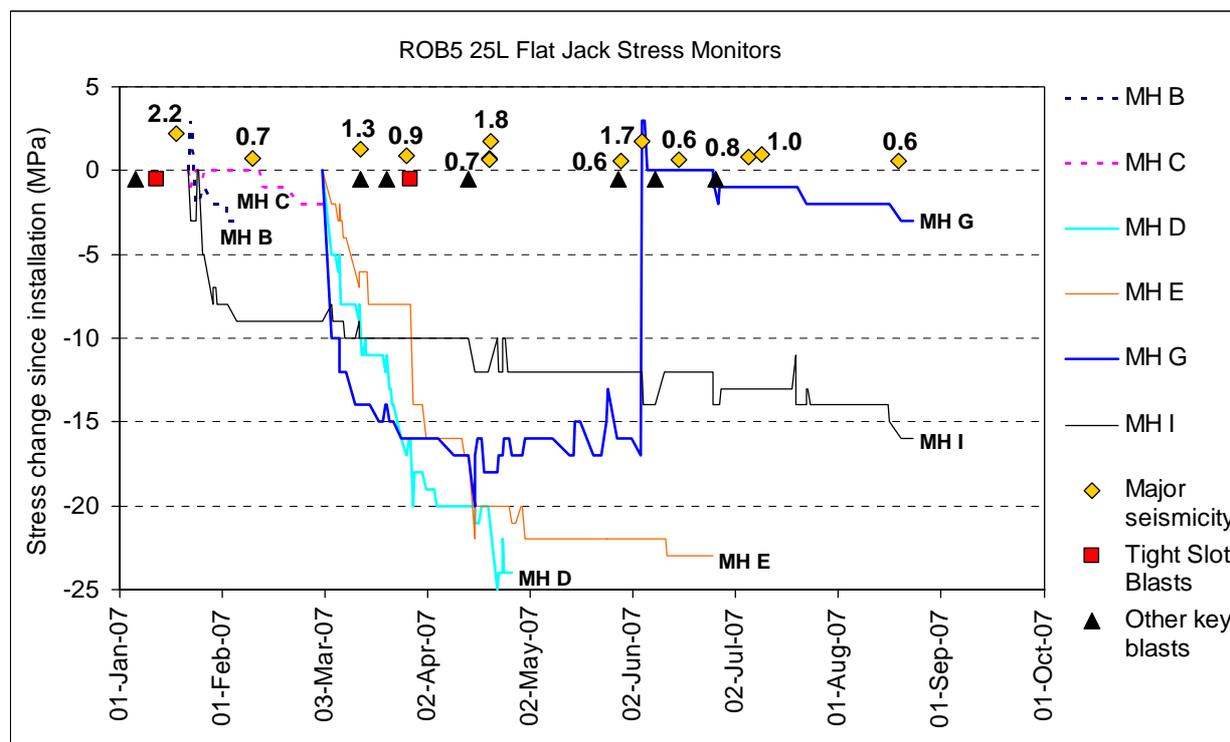
Figure 8 Stress changes recorded by the flatjack monitors (monitor locations are shown in Figure 3)

As of 29 August 2007, two units were still functioning despite significant seismicity and blasting damage to the surrounding rock. Typically the flatjacks remained functional until the stope brow was only two rings away. CSIRO HI cells were previously considered as an alternative to the flatjacks. While the data would have been three dimensional (technically superior), monitoring data would have been more difficult to collect and slower to process. It is also unlikely that they would have been as rugged as the flatjacks and still be operating.

The stress changes monitored show that the ground responds to mining, also that pillars and asperities influence the stresses, and stresses can change quickly. The flatjack readings took some time to stabilise after installation. In summary, after stabilisation, destressing of up to 19 MPa was recorded.
