# Trident Mine Raisebore — A Bored Pile Case Study

## Abstract

This paper documents geotechnical and operational issues associated with the construction of the four metre diameter Southern Primary Ventilation Shaft through the weathered zone at Trident.

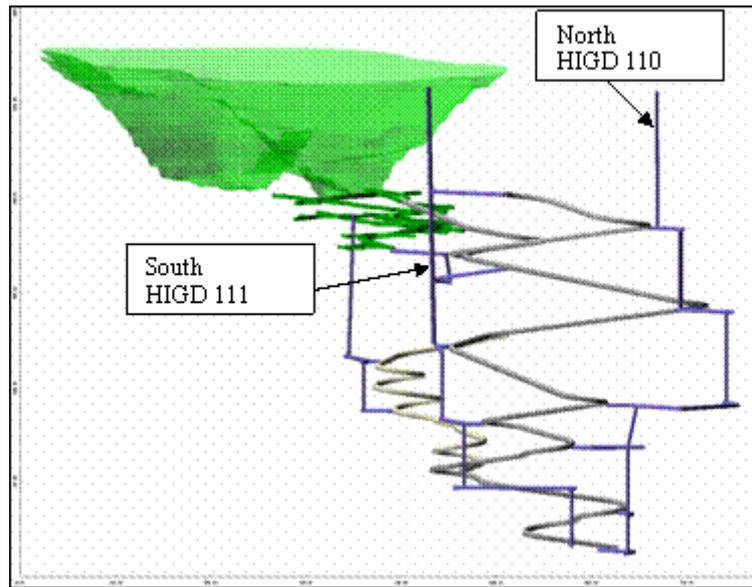
**Figure 1** Location of the North and South raisebore sites. Also shown are the old Poseidon South pit shell and limited existing underground workings, and the notional layout of Trident Life of Mine development

Avoca Resources Ltd required two 150 m deep ventilation shafts, of three and four metre diameters, to be constructed as part of bringing their new Trident gold mine into production (Figure 1). As is typically the case in the Western Australian Yilgarn Craton, specific site investigation drilling confirmed about 50 m of weak weathered rocks (saprolites) at both sites, with sharp contacts to strong competent rocks below (Figure 2). In particular, at the site of the southern four metre diameter shaft, a five metre thick clay zone was present.

While vertical site investigation boreholes were drilled at each planned raisebore site (Figure 1), this paper focuses on hole HIGD 111 for the four metre diameter southern shaft.

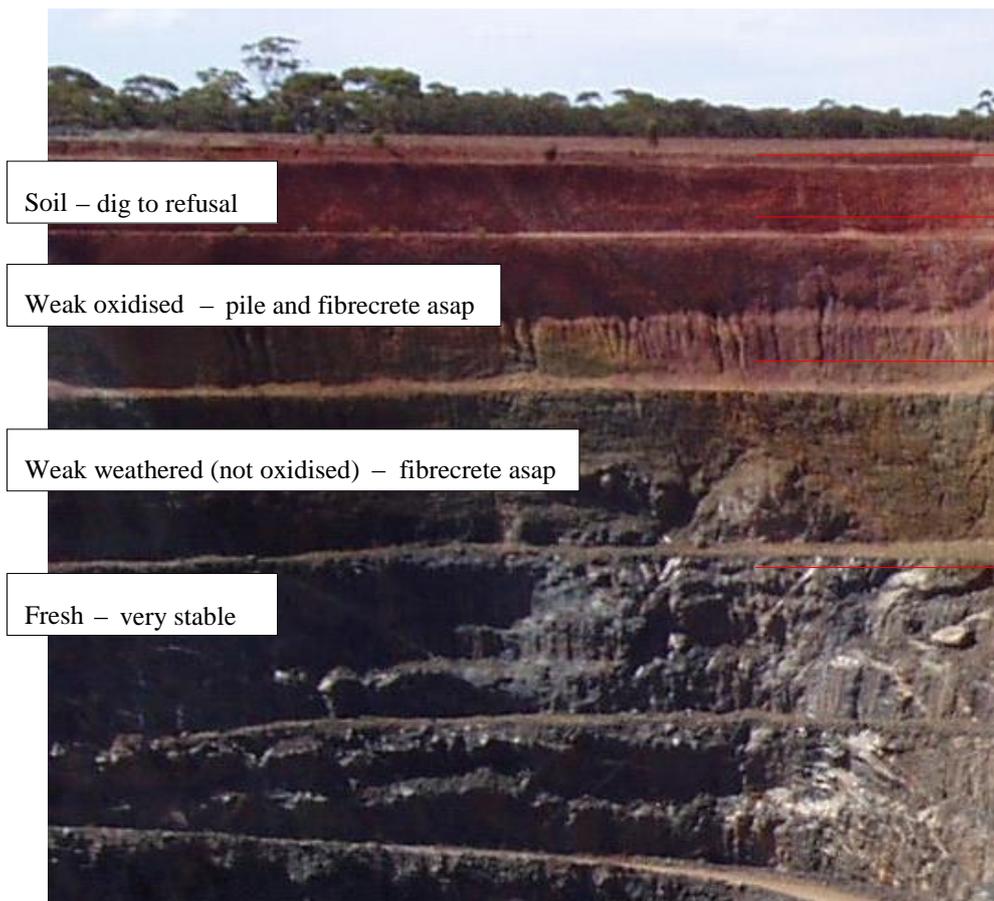
**Figure 2** View of the northern wall of the Poseidon South pit, showing weathering intervals (soil, saprolite and fresh gabbro) and potential implications for raiseboring stability

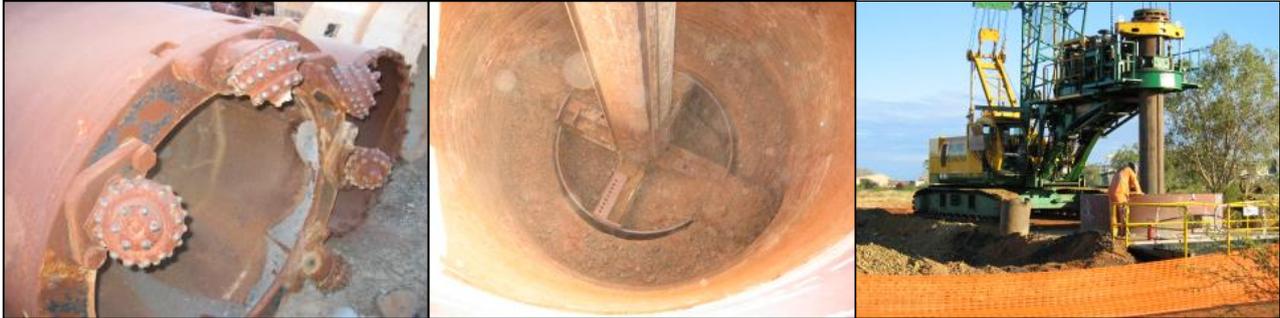
**Figure 3** Large diameter piling technology

*Large diameter piling.* At some mines, large pile boring machines have been used to excavate weak surface rocks, e.g. at Cannington (Figure 3). Piling up to about five metres diameter through weak weathered rock is possible, and civil engineers are now boring a few large piles rather than many smaller ones. Large piles are bored through to refusal. Pile wall stability is an issue, but it can be addressed in several ways, e.g. casing or progressive fibrecruting. The main constraint with large diameter piling is rig availability and mobilisation costs.

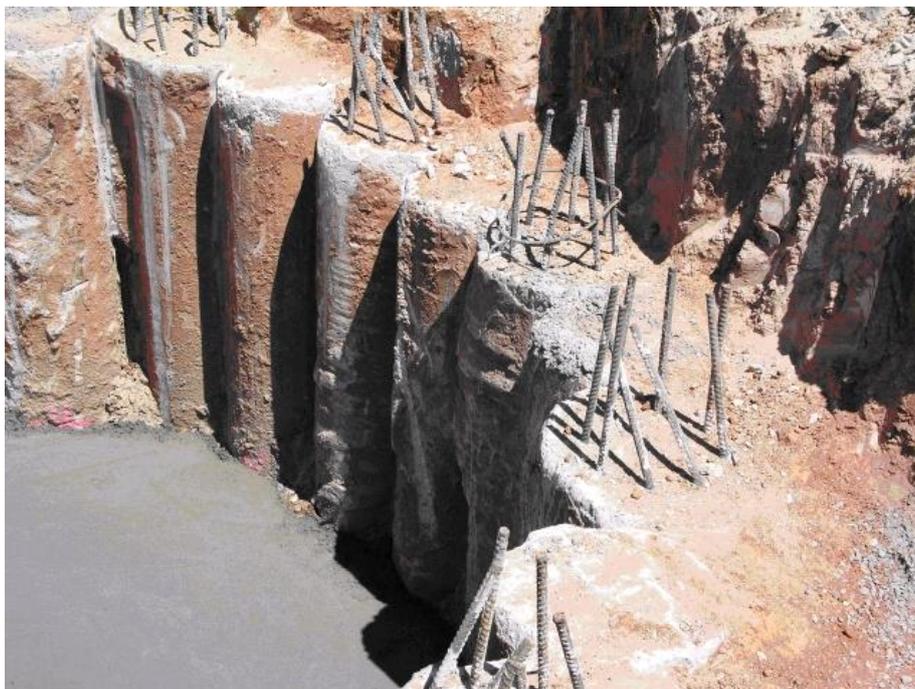
**Figure 4** A ring of contiguous bored piles forming a curtain at another mine site

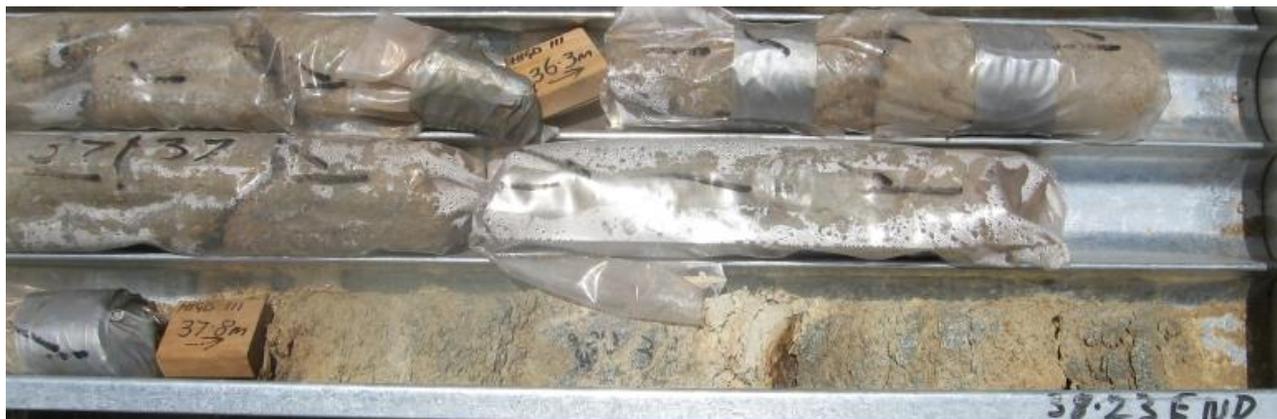
**Figure 5 Drilled core from the HIGD 111 weathered zone. Highly weathered rock and clays are wrapped in plastic. Exposed material has severely degraded within a few weeks of drilling**

*Borehole core.* Fresh gabbro started at a depth of 50 m and posed no stability issues. Only the weathered zone was found to be of concern, due to the presence of soft wet clays (Figure 5) mainly over the zone 17–29 m. The thickest single soft clay band, five metres thick, extended from 20–25 m depth. The clay zones were extensive, and their thicknesses were not small compared to the four metre raisebore diameter.

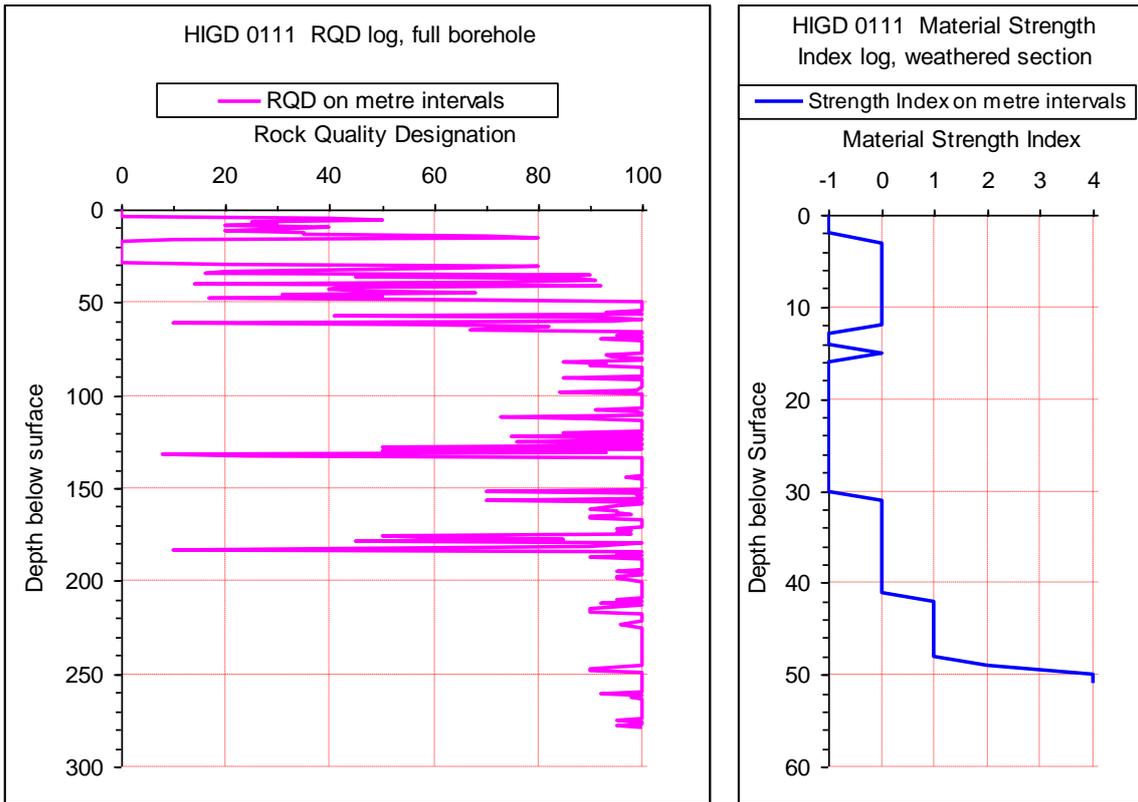
Figure 6 HIGD 111 core log data. Left: RQD log for full hole. Right: material strength index log for the weathered interval (0 and -1 indicate soil strength, 1–4 indicate rock strength)

Apart from the usual geotechnical logging of core using Barton's Q-System, the fresh rock interval was logged using an acoustic televiewer. Logs of rock quality designation (RQD) and material strength index (Figure 6) were compiled.

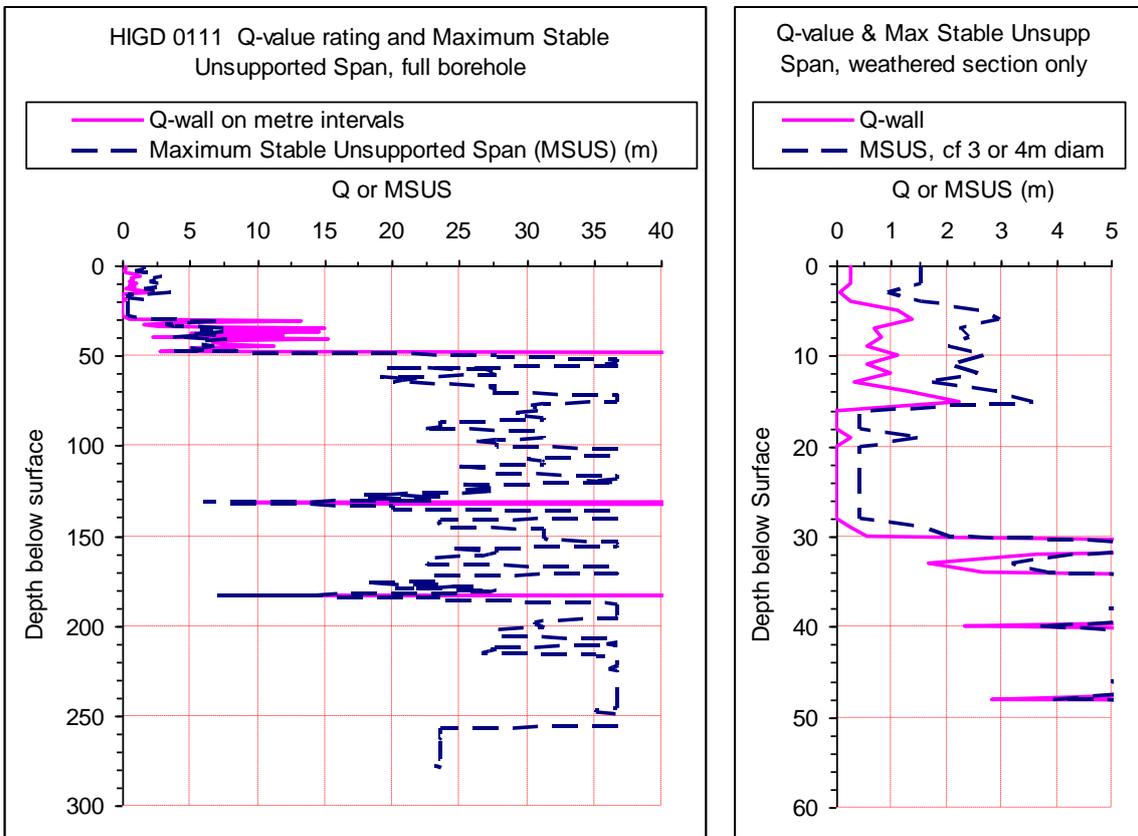
Figure 7 Q and MSUS versus depth for HIGD 111

Because the clay zones encountered in HIGD 111 was judged to be worse than any of the ground conditions exposed in the pit slope, high 'Ja' values of ten were used to estimate Q.

Calculated Q and MSUS values are summarised in Figure 7 versus depth. The weathered zone is clearly the only zone of interest regarding the stability of the four metre diameter shaft. Note: As RQD should only be applied to 'rock-like' materials, Q does not strictly apply in weathered materials and soils (i.e. the clays at Trident). The field strength logging identified some intervals of soil-strength materials. The Q and MSUS values shown in Figure 7, for the weathered zone, are therefore only illustrative.

*Pile length.* The pile lengths needed to be sufficient to bed into fresh rock having a MSUS of about five or better, i.e. 44 m depth (see Figure 7). However, for staggered piles, only the longer piles needed be this long.

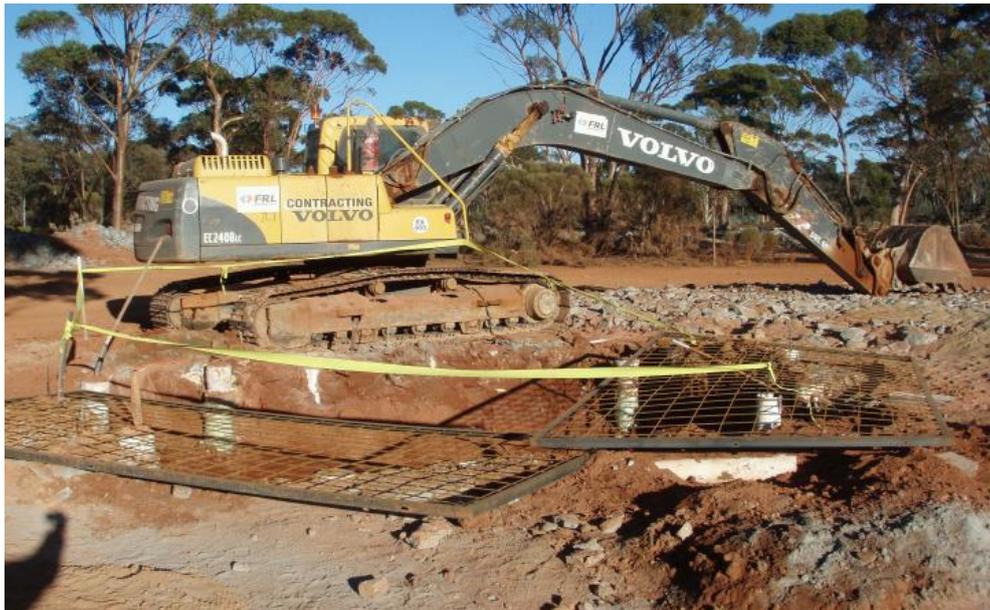
**Figure 8** South raisebore site during excavation for the surface pad. The tops of several of the bored piles are visible in the walls of the excavation

Rings of non-contiguous piles were designed around the shaft position through the weathered zone, with cable dowels being grouted into some of these piles (Figures 8 and 9). Ideally they toe into fresh rock below. The piles were incorporated into the shaft cap, but they were de-coupled (using poly-casing) to allow vertical creep of the shaft cap relative to the piles, which was considered possible during back-reaming.

Two cycles of holes were drilled; refer site view Figure 8 and the plan of holes Figure 9.

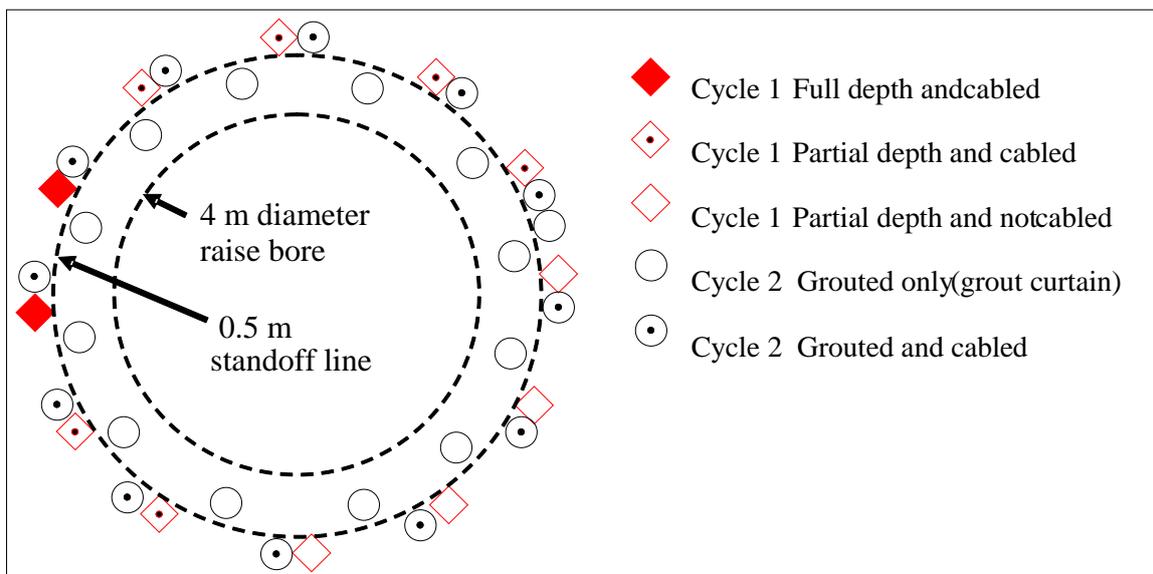
**Figure 9** Schematic pile layout, showing positions of (a) the first cycle of piles, most of which failed to reach full depth, and (b) the inner and outer rings of the second cycle of piles

*First cycle of holes.* The initial 270 mm mud drilling holes were quickly found to be unsatisfactory. Washouts of the clays occurred and the holes became blocked with mud below about 18 m. Four of the failed holes were filled with grout only. Cable dowels were installed in the remaining six and they were grouted to the blocked depths. There were only two successful holes from this series, one to 50 m and the other to 35 m. This experience resulted in the abandonment of wet drilling 270 mm piles.

*Second cycle of holes.* At short notice, the best alternative available for a second attempt was 140 mm reverse circulation (RC) boreholes.

The second cycle of holes comprised two rings of 140 mm RC drilling. The inner ring (a grout curtain) was drilled just inside the ring of failed 270 mm holes and filled with grout to backfill the washouts from the original drilling. The outer ring of holes was cable reinforced and replaced the failed 270 mm holes.

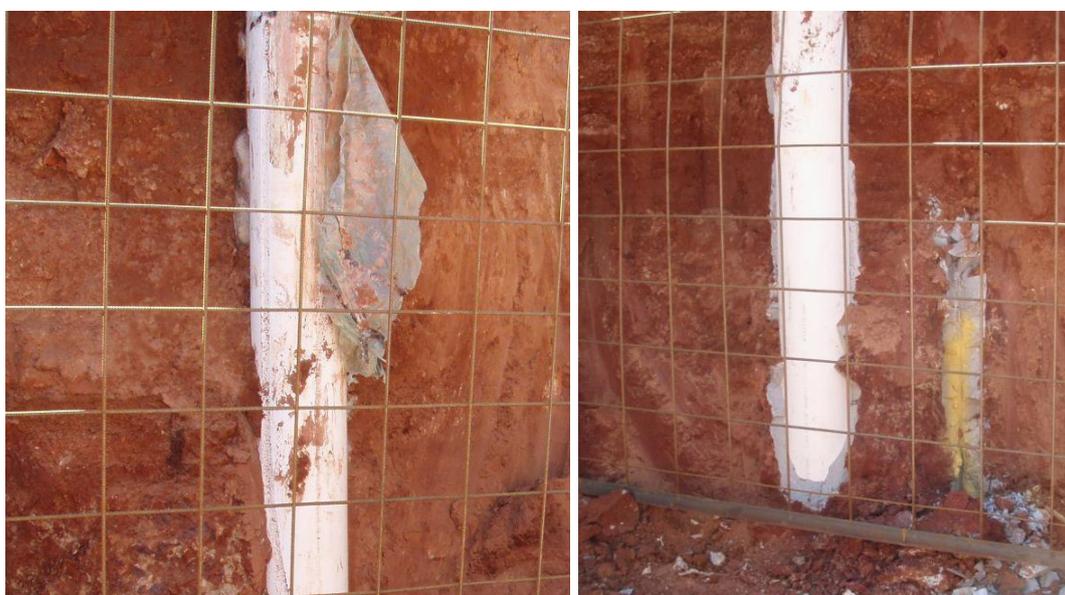
**Figure 10** Some of the bored grouted piles intersected in the surface pad excavation, showing grout filling the sidewall voids created during the boring of the RC holes

*Surface pad.* The surface pad was excavated after the bored piles were completed. It intersected some of the piles as shown in Figure 10.

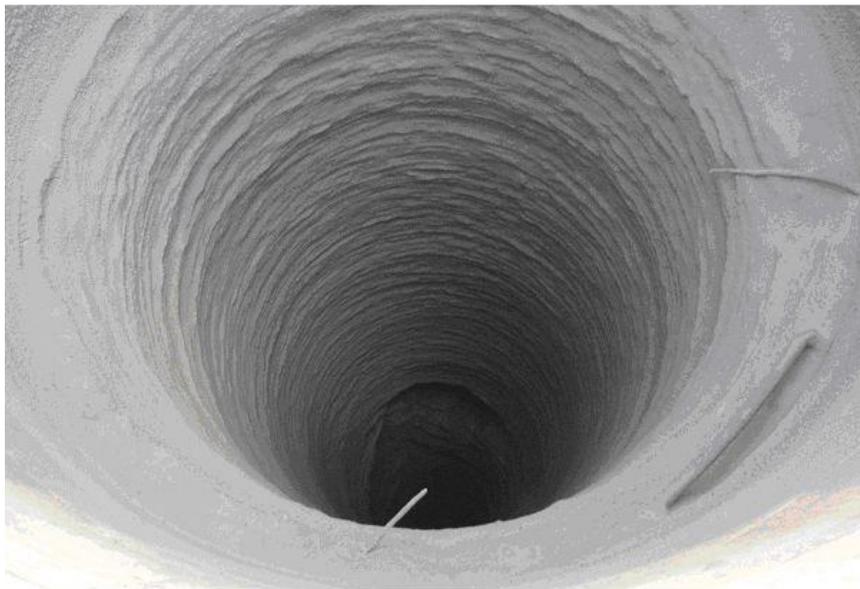
**Figure 11** Completed shaft after fibrecreting — note the widened zone below 20 m

Initially, 10 m<sup>3</sup> of fibrecrete was sprayed at the failure zone, then 75 mm on the full interval, starting from the collar down to fresh rock (at 50 m), in three passes of 25 mm. Rebound was found to be only about 10%, so the actual fibrecrete thickness was probably nearer 130 mm. A cavity monitoring system (CMS) survey of the raise was done after fibrecreting. It confirmed that fallout, in the main clay zone, extended out to the ring of piles (Figures 11 and 12).

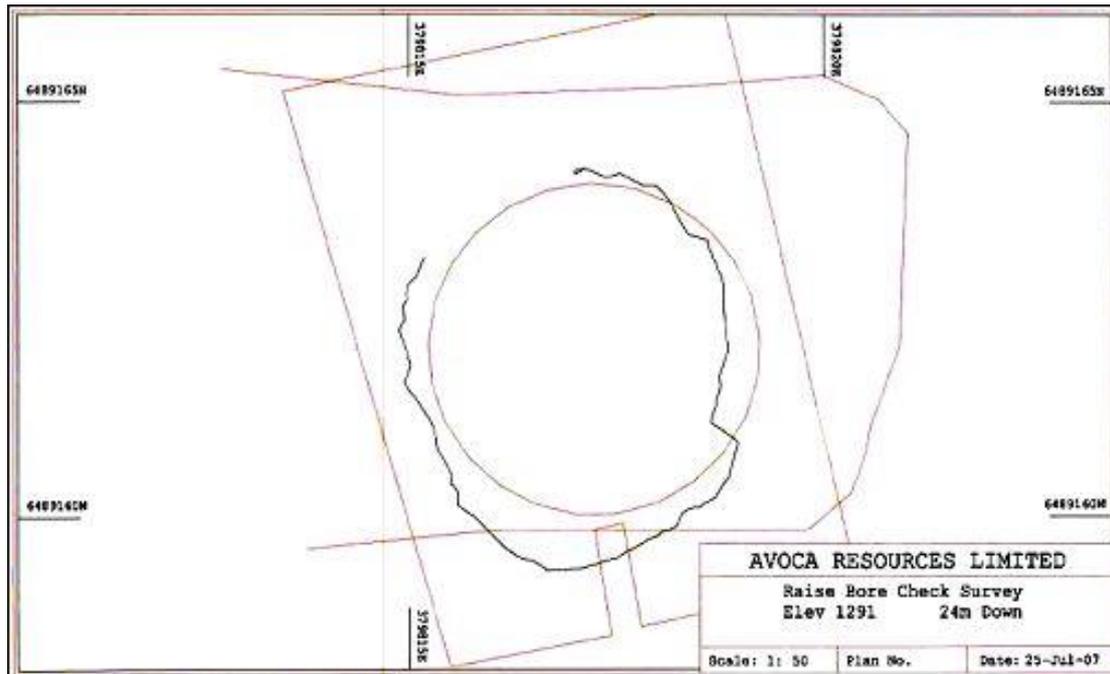
**Figure 12 CMS survey profile of the completed shaft at the widened zone 24 m below surface**
