# Toppling Slope Failure — Predicted Versus Actual, Ok Tedi, Papua New Guinea

**N.R.P. Baczynski** *Ok Tedi Mining Ltd, Papua New Guinea*

*This paper describes a classic toppling failure that has moved eight metres whilst retaining overall slope integrity. The failure is in the current Ok Tedi Mine open pit which is 3000 by 2000 m in plan and 700 m deep; final depth will be 1000 m; although the final depth beneath the failure will be increased by only 30 m. Large fault-defined block toppling failure was anticipated for some slope areas on the basis of kinematic stability analyses, and FLAC and UDEC numerical modelling undertaken during the 1997–2000 Risk-Based Slope Design Optimization Study. Signs of toppling instability were first noted in 2005. Ground displacements accelerated rapidly in 2006 during mining at the slope toe. Additional UDEC modelling predicted cyclic, stop-start type, cumulative displacements of 10–11 m as successive benches were mined down; with the slope face ravelling but the overall slope remaining stable. Actual slope behaviour and failure mode have largely mirrored modelling predictions. Spasms of ground displacement have been triggered by mining activity

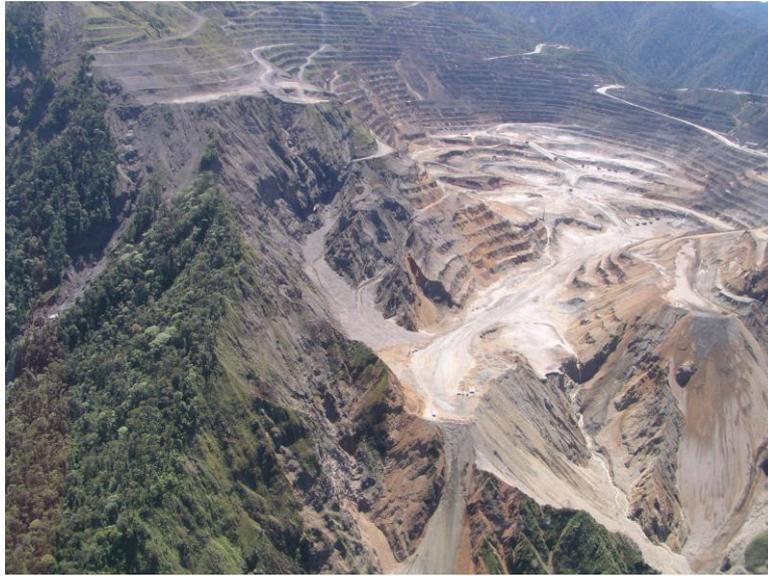
**Figure 1** Ok Tedi pit looking north (toppling failure of ‘bullnose’ in centre of photo on West Wall)

Ok Tedi is a major open pit copper-gold mine in the southern highlands near the western border of Papua New Guinea (PNG) and Indonesian Papua. Figure 1 is a photo of the mine pit and toppling failure area.

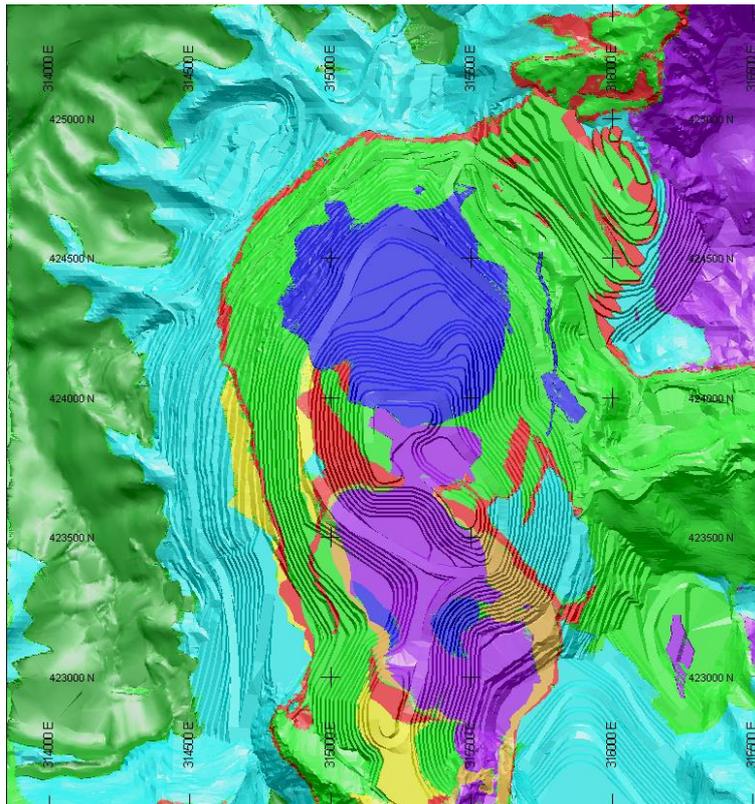
Fubilan Monzonite Porphyry (dark blue); Sydney Monzodiorite (purple); Southern Porphyry (blue within/near purple); Ieru Siltstone (bright green); Darai Limestone (pale blue); Pnyang Siltstone (dull olive green); Deep Skarn/Gold Coast Skarn (red); Endoskarn (orange); Taranaki/Parrot's Beak Thrusts (yellow); Taranaki/Parrot's Beak Skarn (red)

**Figure 2** Ok Tedi pit 13D4 plan layout and geology (500 m grid)

Figure 2 shows the pit layout and geology in plan. Figure 3 presents the 423100N east-west geological section (looking north).

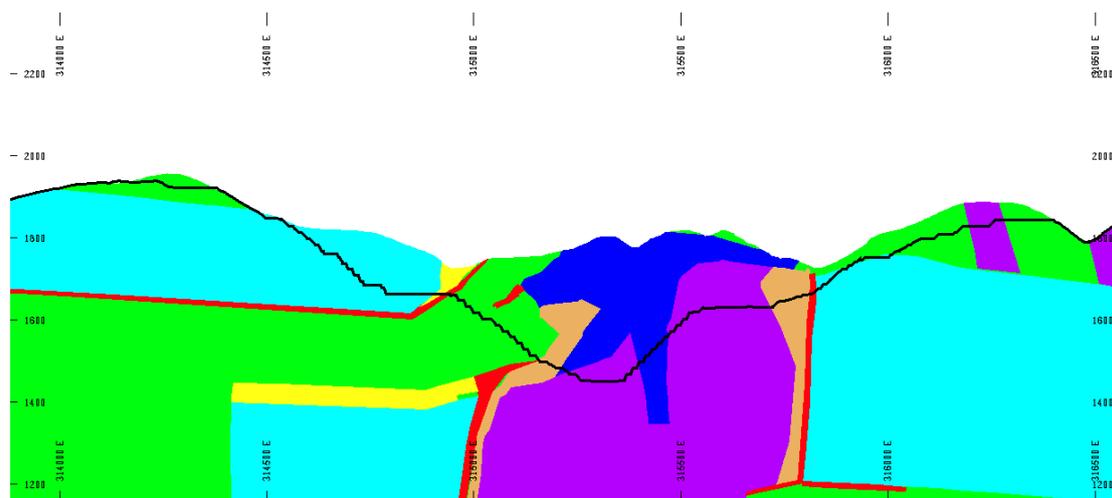
**Figure 3 Ok Tedi pit: 423100 N east-west geological section (looking north)**

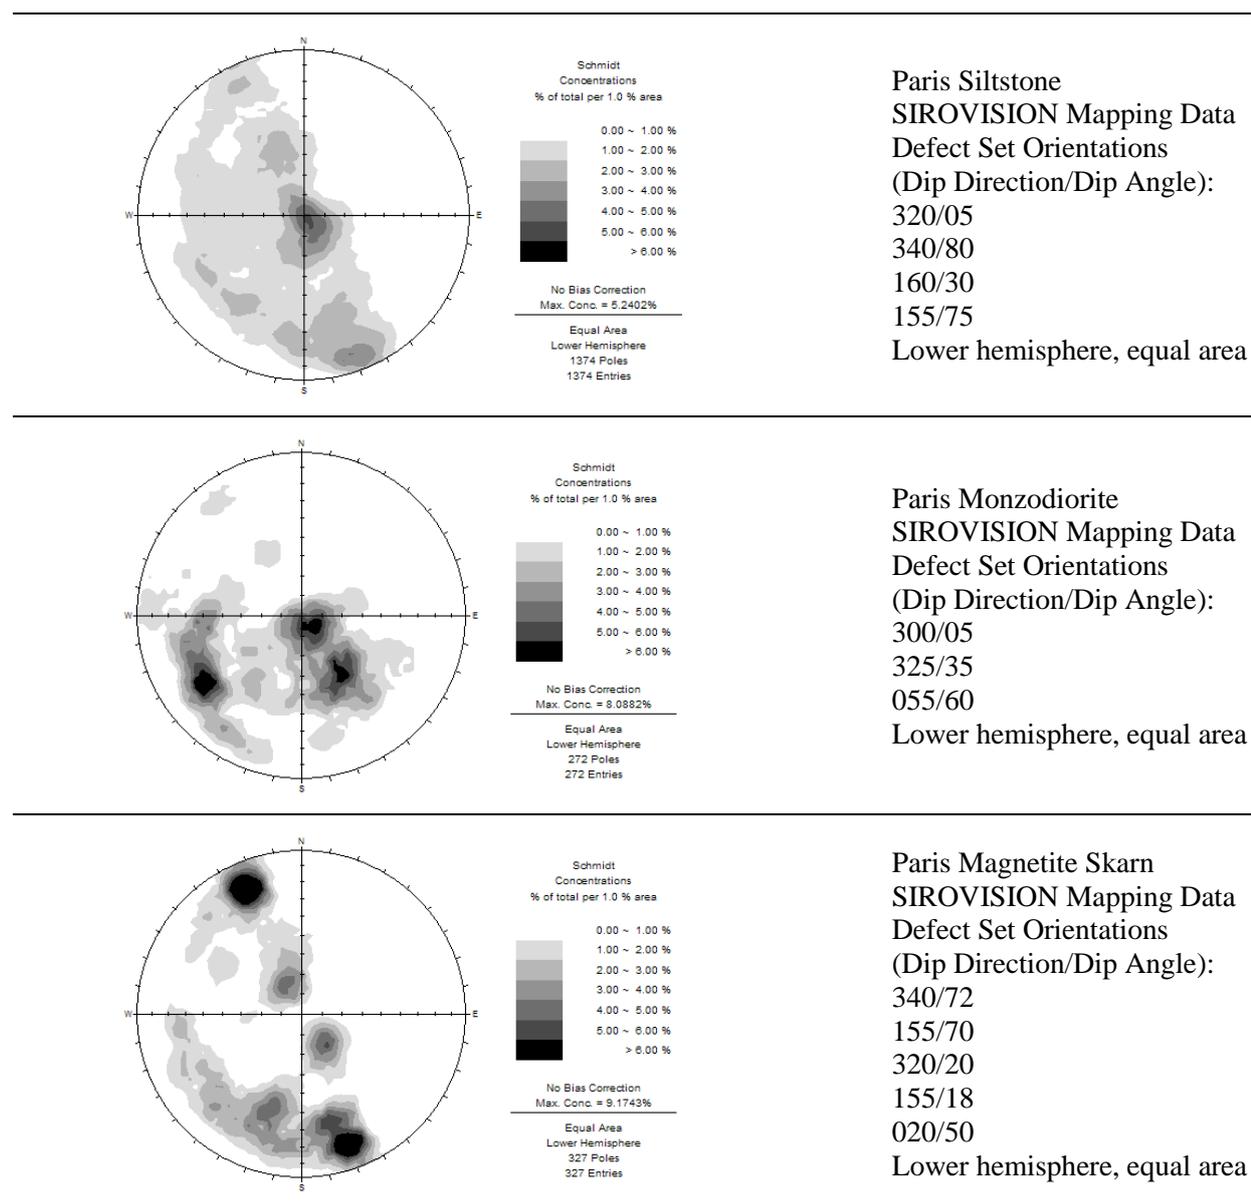
**Figure 4 Stereographic projections for toppling failure area**

The structural pattern in both the siltstone and limestone is dominated by a pervasive set of defects that dip into the slope face and control the development of the toppling failure. These defects mostly dip at 45–85° towards NNW (see defect traces on photo of slope face in Figures 11 and 12 and defect pole concentrations on stereoplots in Figure 4). Flattening and drag folding of these defects induced by tectonic displacements on

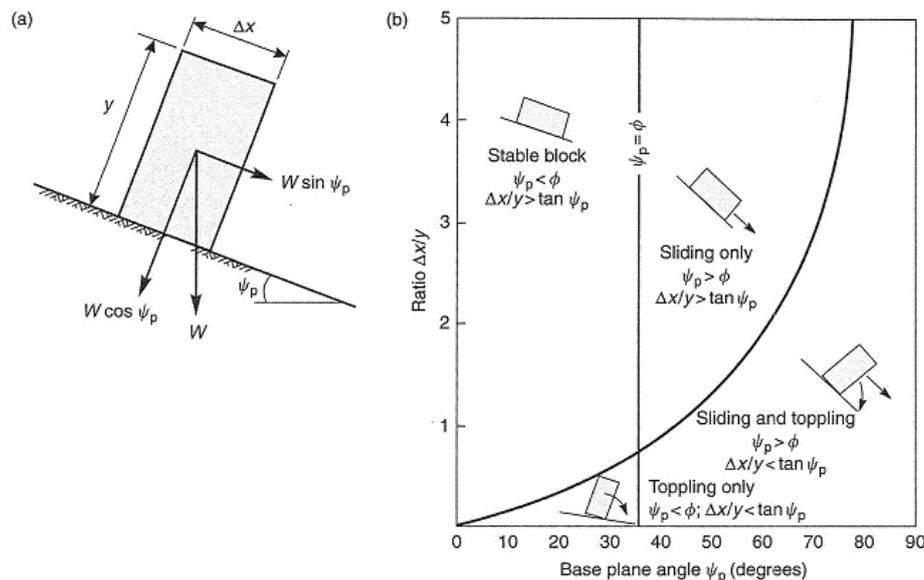
**Figure 5 Geometrical conditions for rock block toppling failure (Wyllie and Mah, 2004)**

Figure 5, reproduced from Wylie and Mah (2004), shows the relative displacements and progressive stages in the development of toppling failure where a single defect set dips steeply into the rock slope. In situations where sub-horizontal defects occur, the shown tensile bending failure of the rock mass columns or plates is unnecessary as the latter defects provide a base release mechanism for toppling instability.

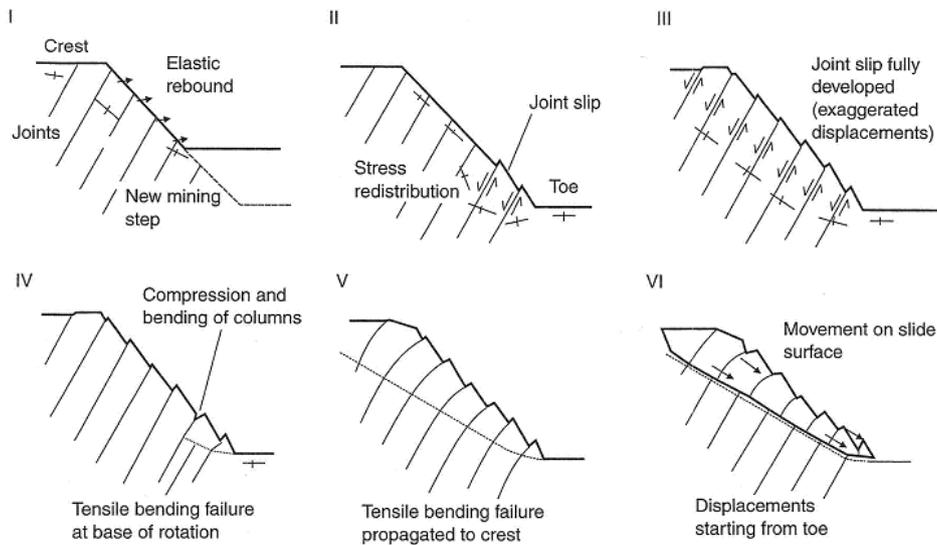
**Figure 6** Toppling failure stages for slopes (Wyllie and Mah, 2004; after Sjöberg, 2000)

- Displacements on sub-vertical defects: the up-slope blocks to be displaced downwards with respect to the down-slope blocks, akin to Stage III mechanism shown in Figure 6.

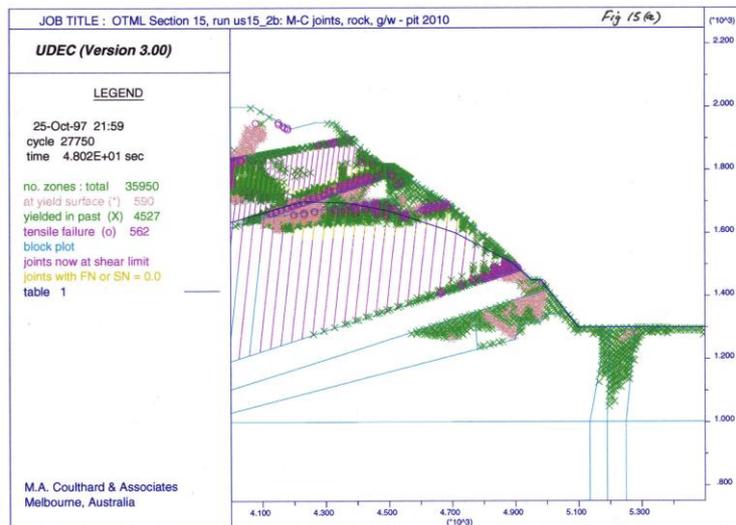
**Figure 7** 1997 UDEC modelling suggesting toppling failure

The 1997 UDEC modelled slope in Figure 7 was 700 m high. Subvertical defect spacings above and below the Taranaki Thrust Fault were 15 m and 30 m respectively; but this structural pattern did not continue into the strata below the Parrot’s Beak Thrust Fault. The slope above the Taranaki Thrust was dewatered, but the watertable was only partially drawdown below this fault. A horizontal to vertical stress of 0.5–1.0 was adopted.

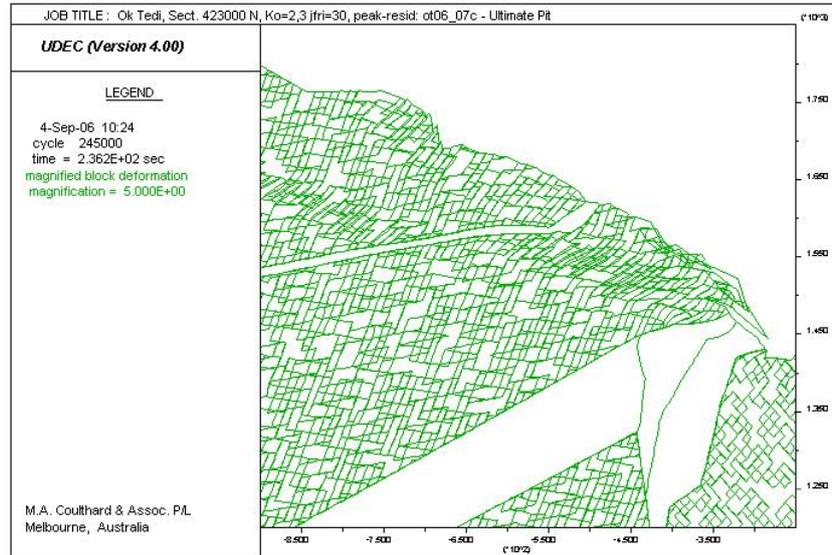
Taranaki Thrust: thin, clear/non-jointed, shallow dipping (to LHS) zone in mid slope; Parrot’s Beak Thrust: thick, clear/non-jointed, dipping (to LHS) zone 150 m behind slope toe; Siltstone: jointed zone between Taranaki and Parrot’s Beak Thrusts; Limestone: jointed zone above Taranaki Thrust; Endoskarn: clear zone below slope toe; Skarn: clear zone between Endoskarn and Parrot’s Beak

**Figure 8 2006 UDEC modelling demonstrating toppling failure mechanism**

Following a late May 2006 initiation of a 3–4 m pulse of slope displacement, Dr Coulthard remodelled the situation. Figures 8 to 10 summarise the key UDEC modelling.

Updated models included sub-vertical plus two sub-horizontal defect sets and horizontal to vertical stress ratios of three to one and two to one for the N-S and E-W directions, respectively. The groundwater drawdown profile was the same as the one adopted for the 1997 UDEC analyses.

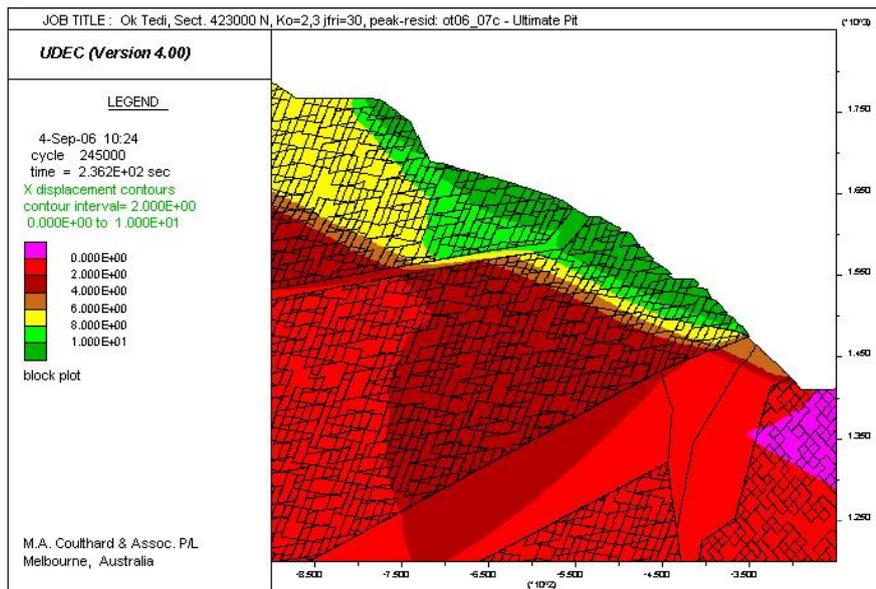
**Figure 9 2006 UDEC modelling results: horizontal displacement contours for toppling failure**

- Cumulative displacements: 10 m and 3 m in horizontal and vertical directions, respectively; with a 3D cumulative displacement vector of 10–11 m.

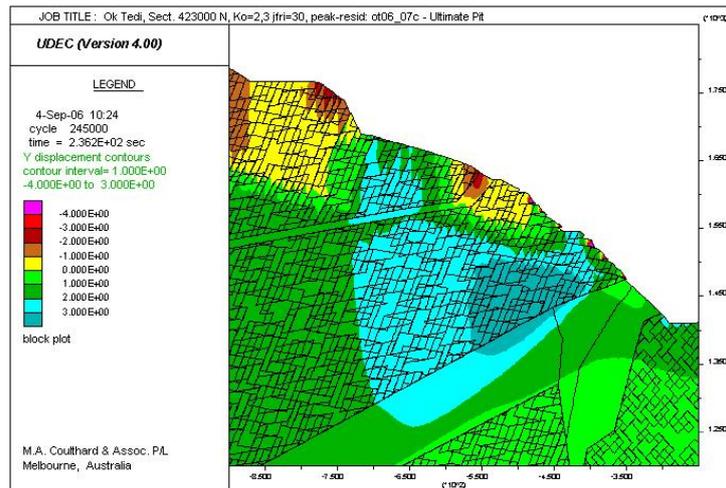
**Figure 10 2006 UDEC modelling results: vertical displacement contours for toppling failure**

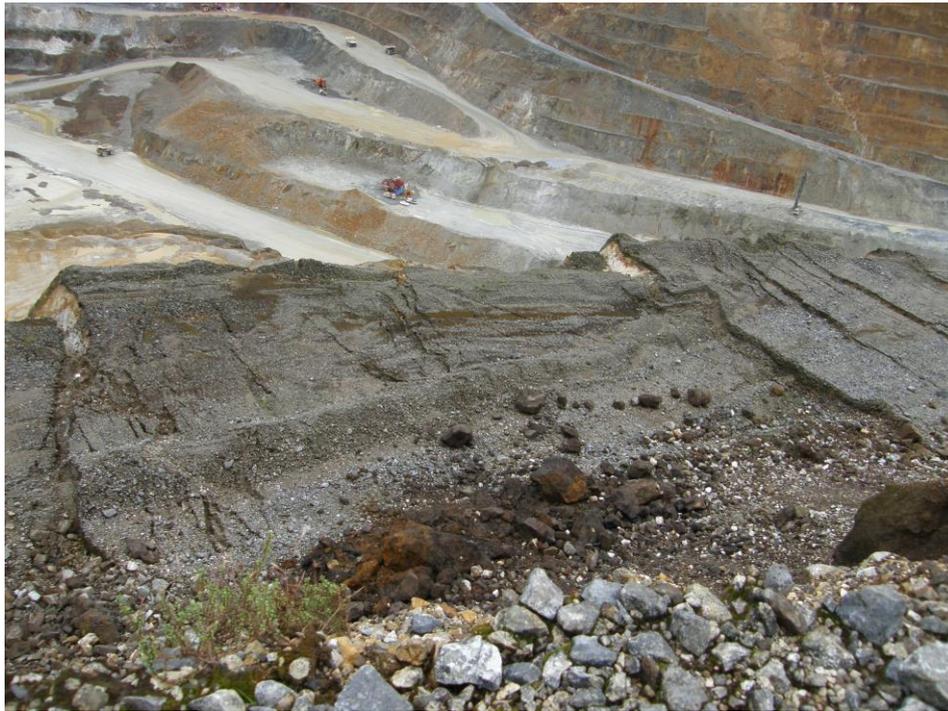
**Figure 11** 1.5 m step-up on defects: toppling failure direction is towards RHS (8 m wide bench)

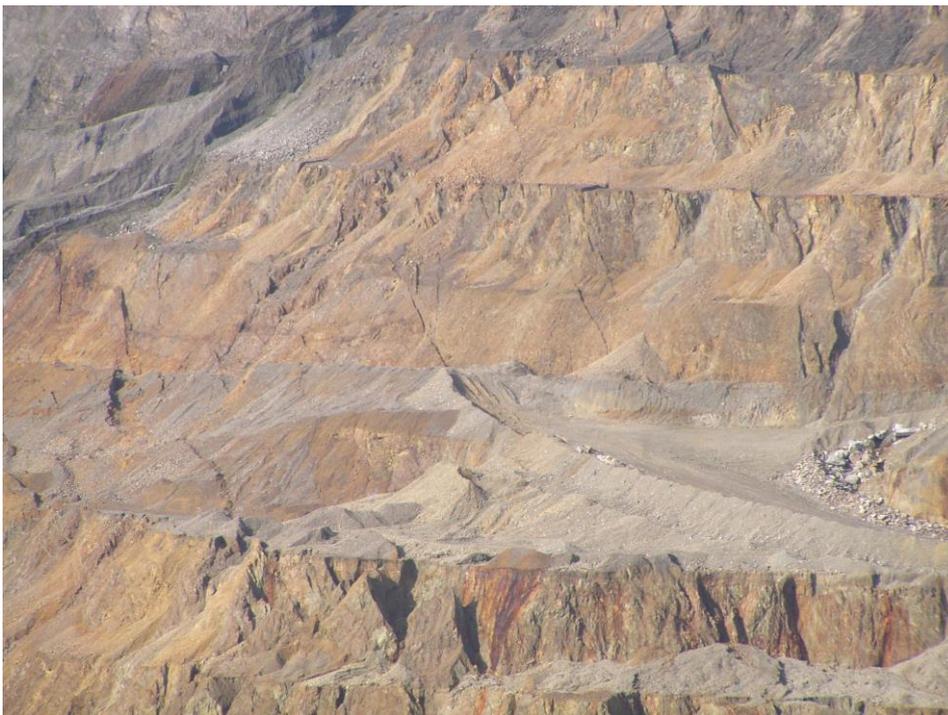
**Figure 12** Side View of failure area, with toppling towards LHS (benches are 15 m high)

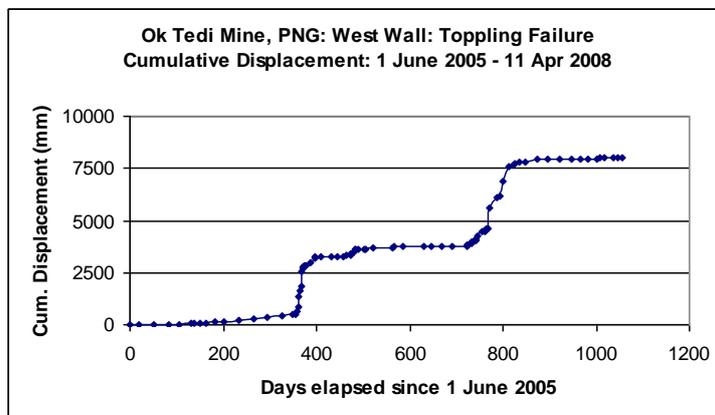
Surface extensometers (0–150 days); manual EDM (150–500 days); computerised EDM (500–1100 days)

**Figure 13 Cumulative displacement**

Figures 13 and 14 summarise ground displacements which, till mid-April 2008, exceeded 8 m. Further displacement is expected as the final bench lift is mined down. To date, the slope remains stable overall.

Successive blasts along the slope toe (a) progressively loosen the already disturbed rock mass within the toppling failure and (b) reduce the modulus of the rock mass that buttresses the slope toe. The time–displacement plot in Figure 13 suggests that, for the three bench lifts mined at Ok Tedi mine in May 2006, September 2006 and May 2007, toppling failure displacements in the subject slope increased to 15–30 mm/day immediately after blasting.

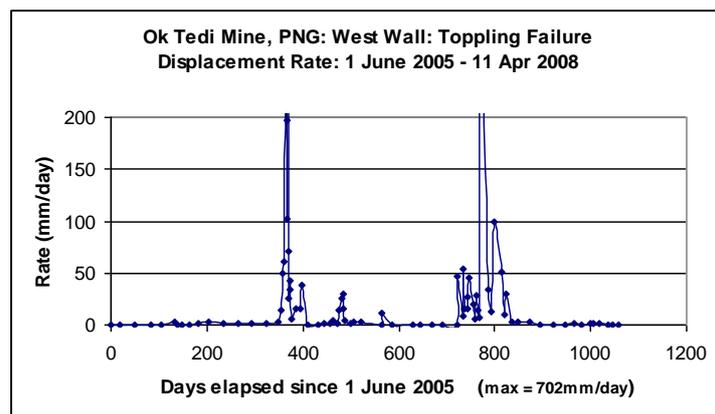
**Figure 14 Displacement rates**

Displacements averaged 1 mm/day from June 2005–May 2006 but displacements prior to monitoring are unknown.

In late May 2006, displacements accelerated rapidly during active mining along the slope toe. The maximum displacement rate exceeded 700 mm/day, but was generally less than 50 mm/day. Cumulative movement was 2.5–3 m within 5 weeks.

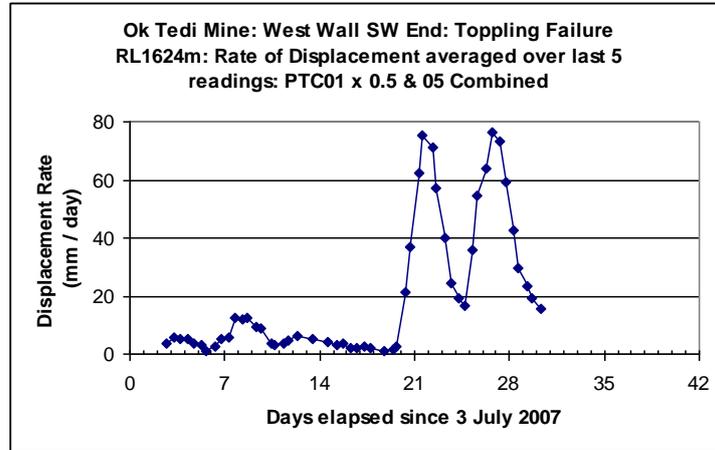
Figure 15 Displacement rates (surface extensometers: 3 July–3 August 2007)

Figures 15 and 16 show that rainfall intensity and ground displacements were related (correlation coefficient of 0.82), especially at rainfall intensities in excess of 20 mm/day, whilst surface water runoff works were in progress. After the works were completed, correlation ceased even when rainfall intensity exceeded 100 mm/day.

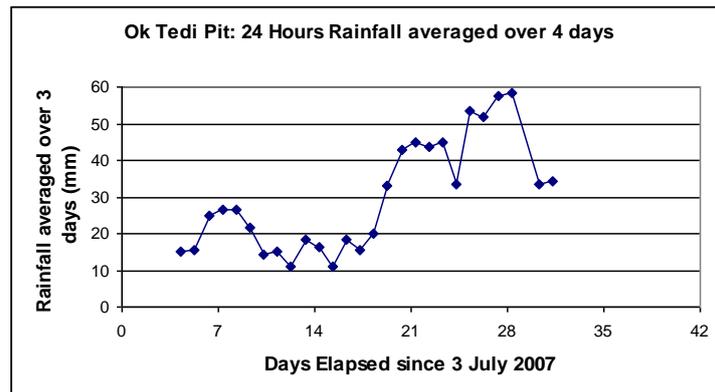
Figure 16 Pit rainfall intensities (3 July–3 August 2007)

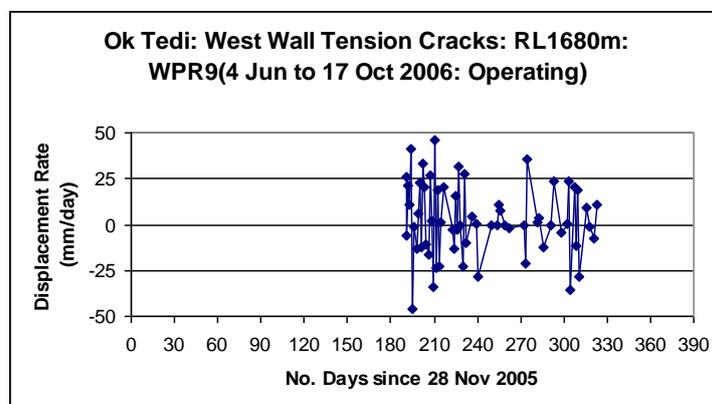
**Figure 17 Probable survey accuracy (manual EDM):  $\pm 25$  –  $\pm 50$  mm over 2 km**

Figure 17 shows that manual surveying results over distances of 2000–3000 m, even during a period of abated displacements, may vary from +50 – -50 mm/day; this being the effective survey accuracy. The effective error for computerised ATS and manual GPS monitoring is about half the above and demonstrates the advantage of an instrument that is set-up once and never moved (except for maintenance and servicing). The accuracy limitation means that a rolling average of a few readings should be used during times of little or no movement.
