Ortlepp Shears — Dynamic Brittle Shears of South African Gold Mines

G. van Aswegen *ISS International, South Africa*

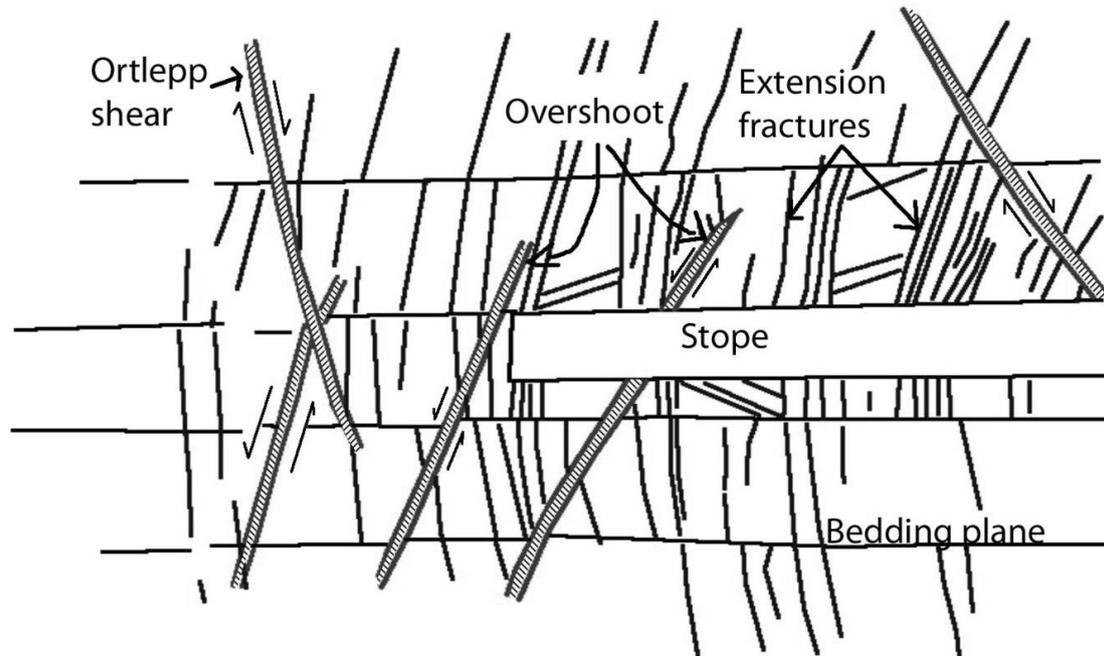
Figure 1 Schematic of a stope in a deep South African gold mine and its associated extension fractures and Ortlepp shears (re-drawn after Brummer, 1987)

In the standard description of fractures around tabular stopes in deep South African gold mines (Figure 1), a specific class of fractures are labelled ‘Type II’ fractures or simply ‘shear fractures’. Since their origins are essentially the same as those of conjugate shears under tri-axial load, they differ in orientation from the more common extension fractures (tensile fractures) forming ahead of the advancing stope and yielding the bow wave fabric. Ortlepp shears are large shear fractures, associated with significant seismic events.

An Ortlepp shear would originate ahead of an advancing stope face (ideally a longwall face), always show normal displacement and would dip towards the stope face when in the hangingwall and dip away from the stope face when in the footwall. The occurrence of part of an Ortlepp shear in the ‘wrong’ orientation is ascribed to overshoot – the shear would, for example, initiate ahead of the stope face and below the reef horizon, and ‘overshoot’ by ending above the reef horizon (Figure 1).

The structure shown in Figure 3c is, of course, not an Ortlepp shear in the classic sense because the displacement is reverse. It is not an overshoot end of a footwall shear exposed by subsequent mining as explained in Figure 1.

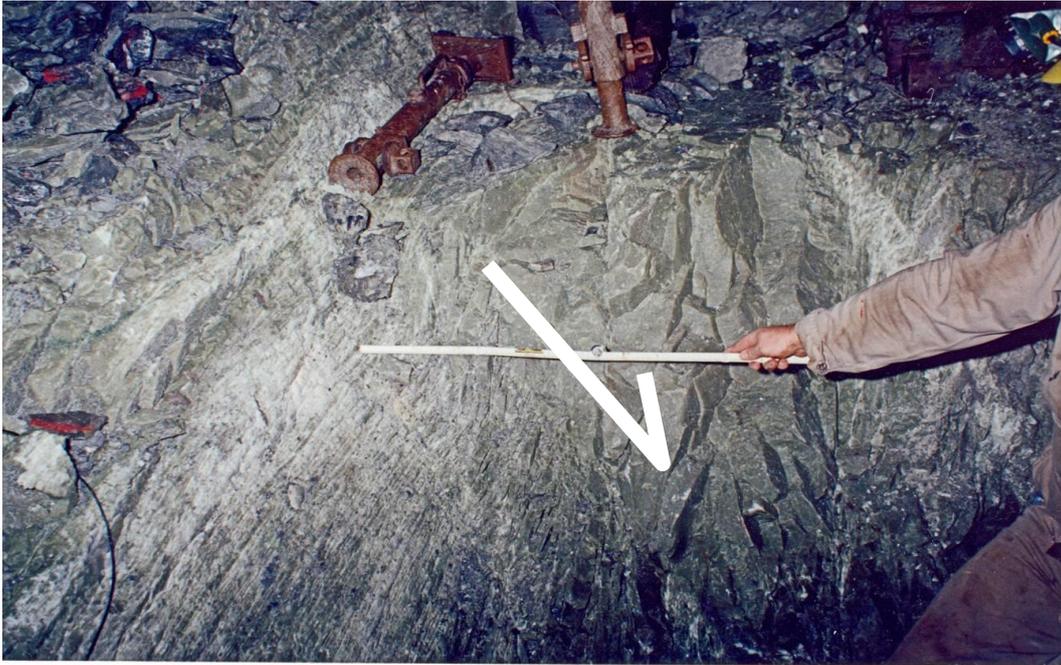
Figure 2 (a) Photograph of the end of a roadway in the footwall of a South African gold mine stope – the end coincides with an Ortlepp shear zone wall, exposing the shear zone wall lineation (bottom left quarter of photograph). The arrow shows the direction of slip of the shear zone hanging wall

Figure 2(c) shows curving extension fractures arranged in an en-echelon fashion that define the shear zone. The strong linear fabric shown in Figure 2(a) results from the intersection of the extension fractures with the footwall of the shear zone. Note the absence of breakthrough shear ruptures. The shear zone is approximately 200 mm wide and the finite displacement is approximately 20 mm.

The shear zone described previously (Figures 2(a) and (c)) is somewhat atypical in the sense that it does not display one of the other diagnostic features of the namely breakthrough shear ruptures (‘through-going rupture’ in the terminology of Wibberley et al., 2000). In the archetype Ortlepp shear, the shear zone consists of an intricate combination of en-echelon extension fractures and breakthrough shear rupture zones, the latter at a low angle to the shear zone itself in a Riedel-like geometrical configuration (see Tchalenko, 1970 and Logan et al., 1979 for definitions of Riedel features). It is along breakthrough shear rupture zones that rock pulverisation is commonly observed and along which significant displacement takes place (Figure 3b; Figure 4(c)). These would be the initiation zones for the ‘through-going principle slip surfaces (PSS) which persist in a particular configuration for extended time periods and accommodate subsequent shearing’ as described by Sibson (1986).

One of the uncertainties we are faced with when a complex shear zone such as shown in Figure 2(a) is exposed is whether the structures represent one or a multitude of deformation events. The understanding gained from these experiments explains the observations that the extension fractures form chronologically before the breakthrough shear ruptures. The experimental results are thus consistent with the notion, but do not prove, that most of the sub-structures defining the shears evolved during one dynamic event. The uniqueness of the Ortlepp shears of the type locality lies in the fact that each of them was a one event phenomenon.

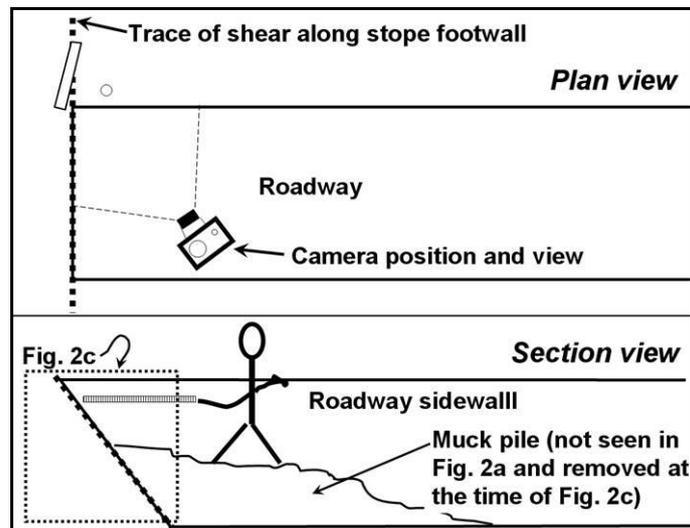
Figure 2 (b) Schematic plan and section views to explain Figure 2(a) and 2(c). The camera position and view is for the photograph in Figure 2(a)

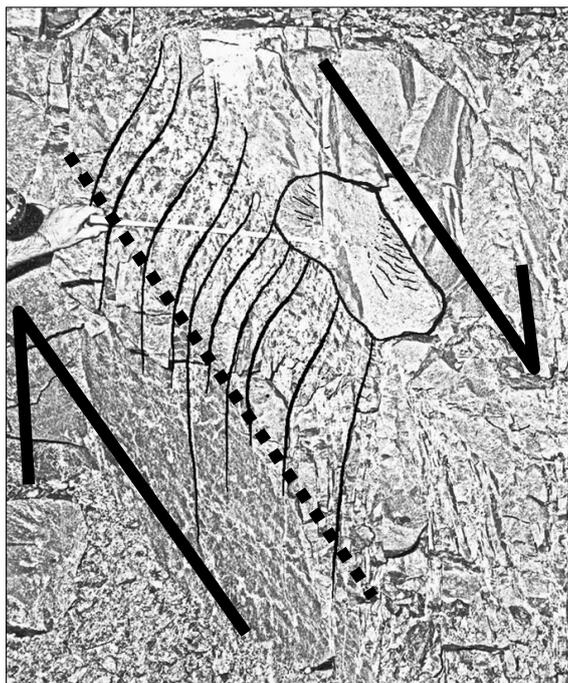
Figure 2 (c) View of the shear zone on roadway sidewall shown in Figure 2(a), but after some advance of the roadway. The broken line is the footwall of the shear zone along which the roadway end had been broken away in the case of Figure 2(a). An (unrelated?) extension failure surface, with plumose lineations is super-imposed on the shear zone fabric

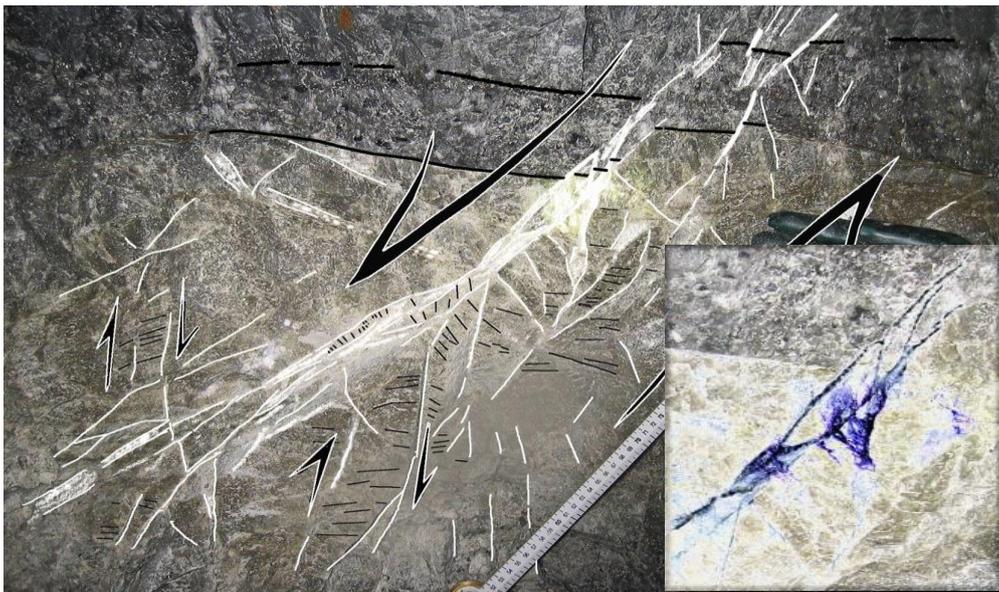
Figure 3 (a) A conjugate set of Ortlepp shears, the source of a seismic event some 6 metres ahead of a longwall stope (see Figure 3(b)). 200 mm of a clino rule is visible for scale. Finite normal displacement along the dominant shear is about 100 mm. Dark parts of the inset accentuate the zones of breakthrough shear rupture and pulverisation

In many places Ortlepp shears have been observed to consist of conjugate sets of shear bands, although one direction generally dominates (Figure 3). It appears that in the area directly ahead of the stope face, conjugate sets are more common, while further away into the hangingwall or footwall of the reef, the one set would dominate. This follows from the common understanding of the formation of shear fractures ahead of stopes as shown in Figure 1.

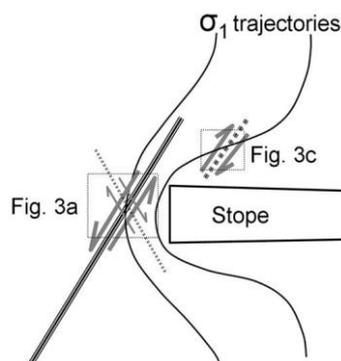
Figure 3 (b) Schematic of a conceptual model for the source and damage mechanisms for a particular rockburst (Case B). Note that, in the case of Figure 3(c), the sense of shear is different from the similarly positioned overshoot case shown in Figure 1

An example of extreme pulverisation was found in the second shear zone of case B and shown here in Figure 3(c) (see Figure 3(b) for the position of this shear zone relative to the stope). The site response to the specific dynamic load imposed by a ‘face parallel burst’ (terminology as proposed in Jager and Ryder, 1999), involved stope hangingwall failure in the form of dynamic reverse slip along a newly formed shear zone, causing partial stope closure (van Aswegen, in prep.). Figure 3(c) shows the internal structure of this reverse slip shear explained in Figure 3(b). In this case extreme shear and extensional strain rates resulted in the explosive pulverisation of the strong, siliceous quartzite resulting in a large volume of rock flour. Note that, despite the obvious shear displacement involved, no flow structure as such is present.

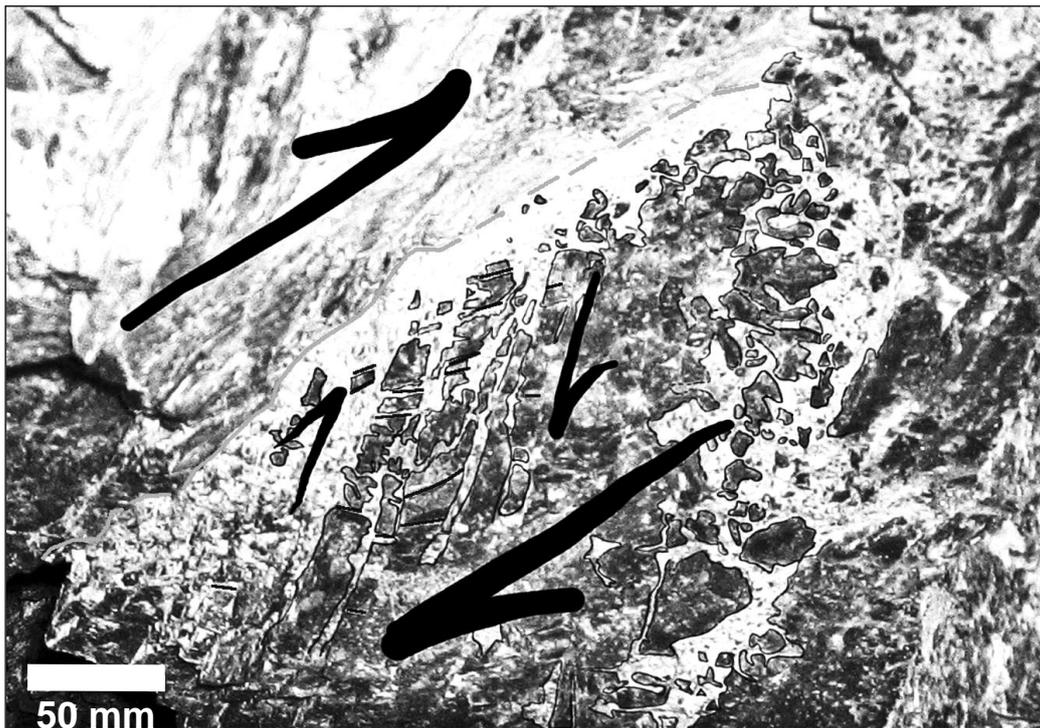
Figure 3 (c) Details of a reverse slip dynamic shear associated with co-seismic hangingwall failure during a particular rockburst (Figure 3(b)). In parts, rock fragments are ‘drifting’ in rock flour

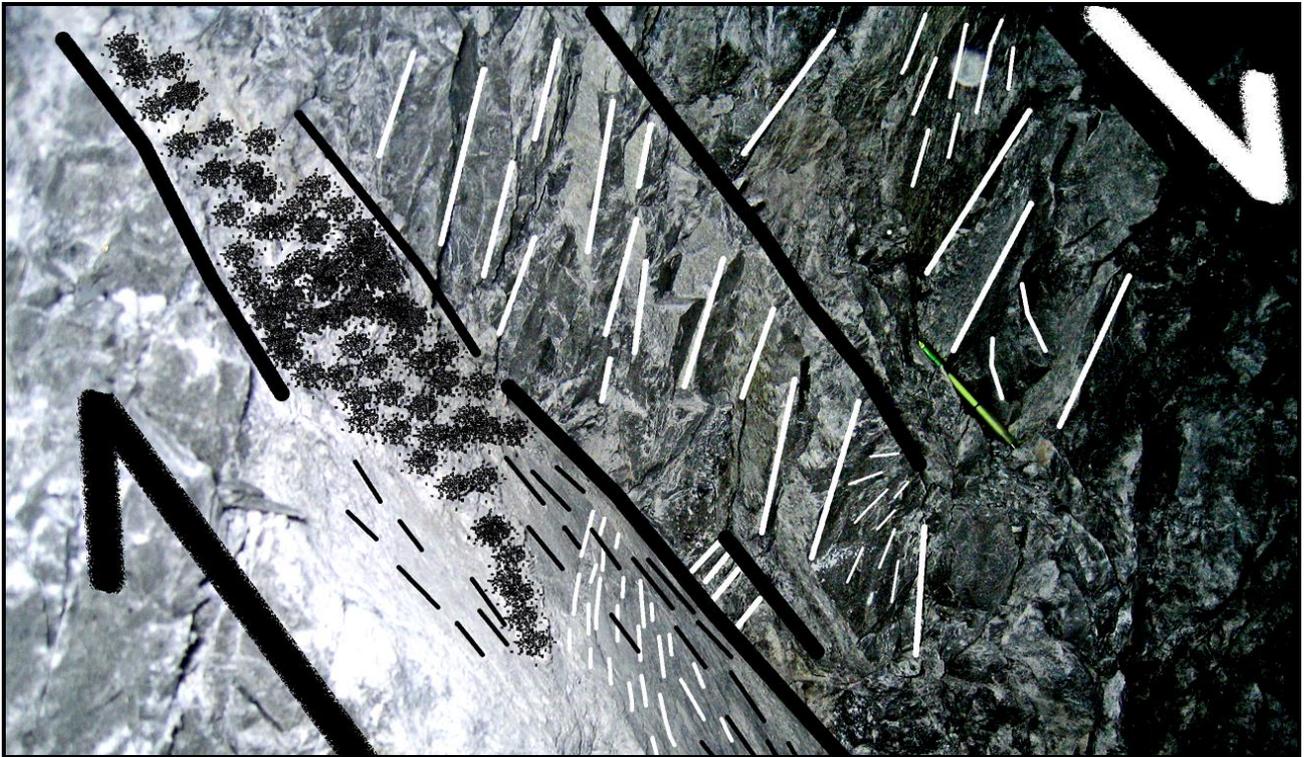
Figure 4 (a) Photograph of a complex dynamic brittle shear zone observed in the sidewall of a tunnel severely damaged by a local rockburst

Since extension fracturing form part of the dynamic brittle shear zone, one should observe the plumose striations common on other extension fractures such as joints indeed found when one looks closely enough. They are, however, difficult to capture photographically because of the small scales involved. Case C considered here (rockburst damaged tunnel far from mining, i.e. in the virgin stress field of approximately 2500 m below surface) afforded the opportunity capture images of such features because of the different scale of the associated shear zone (Figure 4).

Careful 3D study using stereo-pair photographs allowed the recognition of several internal structures as shown in Figure 4. The interpretation given depends on the chronological sequence of events as visually deciphered and the assumption that it all happened as part of one dynamic sequence of events. The intense local rockburst damage is the circumstantial evidence suggesting (but not proving) the latter assumption.

From Figure 4 one can infer the following: in the immediate vicinity of the tunnel the stress distortion invokes low-angled shear traction such that a pre-existing metre-spaced discontinuity set is in the appropriate geometrical relation to fail in tension (ext. 1), yielding plumose structure with rupture propagation towards the mine opening (plumose 1). Partial loss of cohesion (in the proximity of the tunnel only) weakens the discontinuity set on a macro-scale allowing shear deformation to initiate in R_1 style as indicated by the large arrows. This causes extension failure in the rock between the discontinuities (ext. 2) with their own plumose features (plumose 2). Slip along ext. 1 starts (s2) and evolves into ‘breakthrough’ shear rupture with pulverisation (pulv2) and slip striations (LS2), superimposed on the first plumose structures. A repeat of this process sees slight shear displacement along ext. 2 in R_2 style, resulting in new extension fractures (ext. 3).

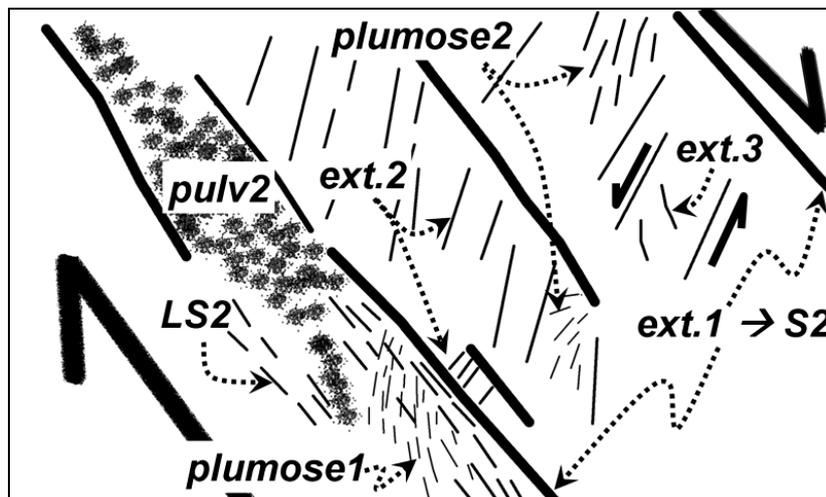
Figure 4 (b) Naming system for the different discontinuities marked in Figure 4(a)
