# Rock Mass Stability in the Southern New England Fold Belt, New South Wales, Australia

**S.G. Fityus** *The University of Newcastle, Australia*

**J.H. Gibson** *The University of Newcastle, Australia*

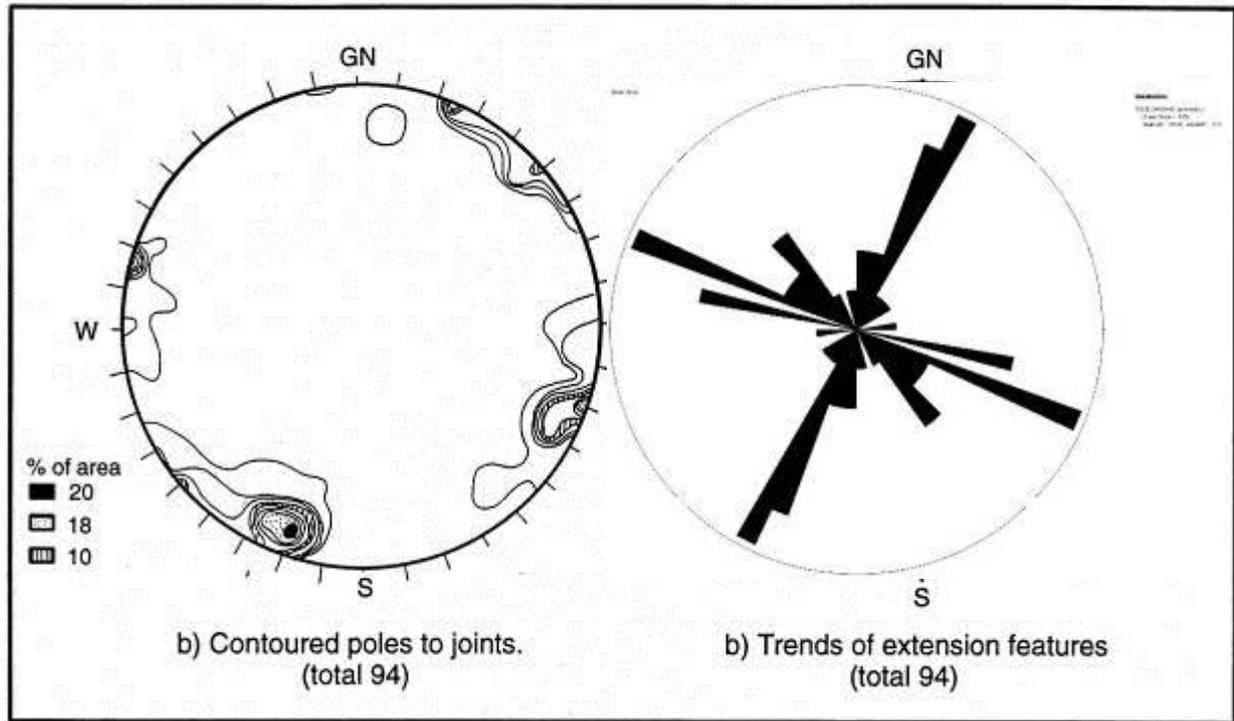
A study of the joints occurring within the rocks of the area was also undertaken. There are two major sets of penetrative, orthogonal, systematic joints and two minor sets of diagonal, systematic joints that do not appear to penetrate the orthogonal system. Only a few non-systematic or curvi-planar joints were observed. Generally, the dominating orthogonal sets tended to form square or rectangular blocks, only occasionally disrupted by the diagonal joints. The orientations of 39 systematic joints were measured and are plotted in Figure 2(a).

Figure 2 Distribution of joint planes at the Paterson slide (Fityus and Gibson, 2000)

In the case of the Paterson slide, it appears that the two dominant joint sets have mostly been able to combine to achieve this condition, although there is some suggestion that a third and perhaps, a fourth set have made some contribution. In the case of the Pilchers Hill slide, at least five significant joint sets are recognised, and some of these could be further differentiated. Figure 9 provides an analysis of the joint planes that have combined to form the main scarp at the crest of the slide. To facilitate a visual analysis, the joints in the scarp are emphasised, to illustrate their relation to those in the joint frequency diagram. The first observation afforded by Figure 9 is that the geometry of the scarp is complex and many different joint sets have combined to achieve an interference-free failure scarp. On closer inspection, it is apparent that different combinations of joints are needed to achieve the necessary scarp geometry throughout its length. To the west, a particular combination of four joints is mostly involved; in the centre, three different joints are involved; and to the east, 3 different joints again define the scarp. This result confirms that the geometry of slides in bedded sandstones is very strongly influenced by basic rock mass characteristics.

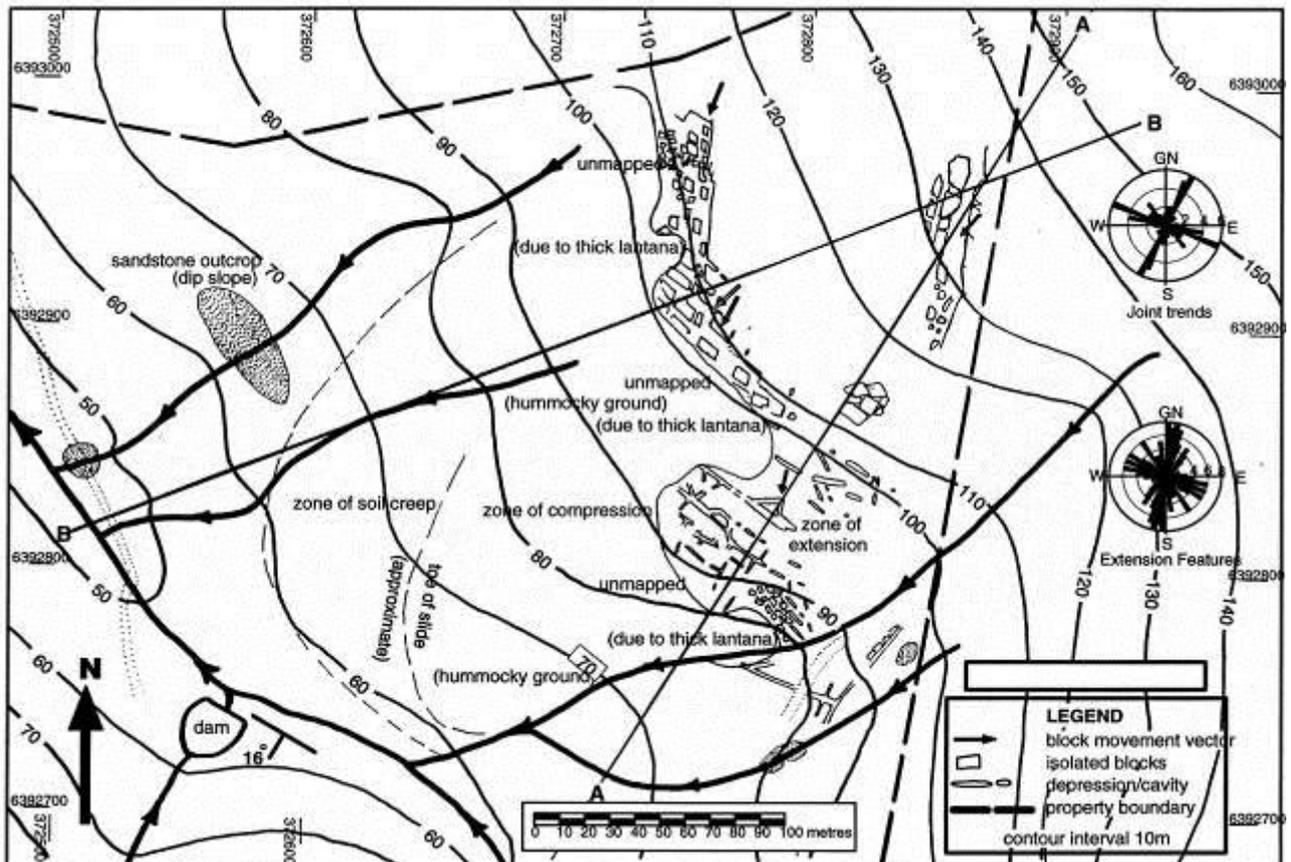
The Paterson Slide occurred by sliding of large joint-bounded sandstone blocks. It affected the south-western facing slopes of a valley, produced a series of extension and compression features. The arrangement of slide features is shown in Figure 3. On the basis of the field mapping, it appears that two different areas of block sliding exist on the site. A deeper feature (up to 4 m) consisting of a single chasm around 80 m long, occurs at an elevation of about 130 m, adjacent to the upslope property boundary. A shallower (up to 2.5 m), more extensive series of features wraps around the hill slopes from an elevation of about 80 m in the south, to about 115 m (Australian Height Datum) in the north. It is also noted that the upslope feature is mostly developed in what appears to be a single bed of sandstone up to 3 m thick, whereas the downslope features seem to extend down through a number of different sandstone units, each up to 2 m thick, separated by siltstones up to 150 mm thick.

Figure 3 Size and extent of the Paterson slide (Fityus and Gibson, 2000)

Extension features appear to result from the translational spreading of the large, joint bounded sandstone blocks. The size of these blocks can exceed 5 m, although they are typically of the order of 2 to 4 m. Translation of adjacent blocks to differing extents results in the formation of sub-vertical openings between blocks. The measured strike trends of 94 extensional openings are plotted in Figure 2(b). It can be seen that the openings are relatively uniformly manifested in two principal strike directions, 010 and 115 degrees (see Figure 3). The translational movements usually involve a component of movement perpendicular to each of these directions, although translation in a direction orthogonal to the 115 degree trend is typically dominant.

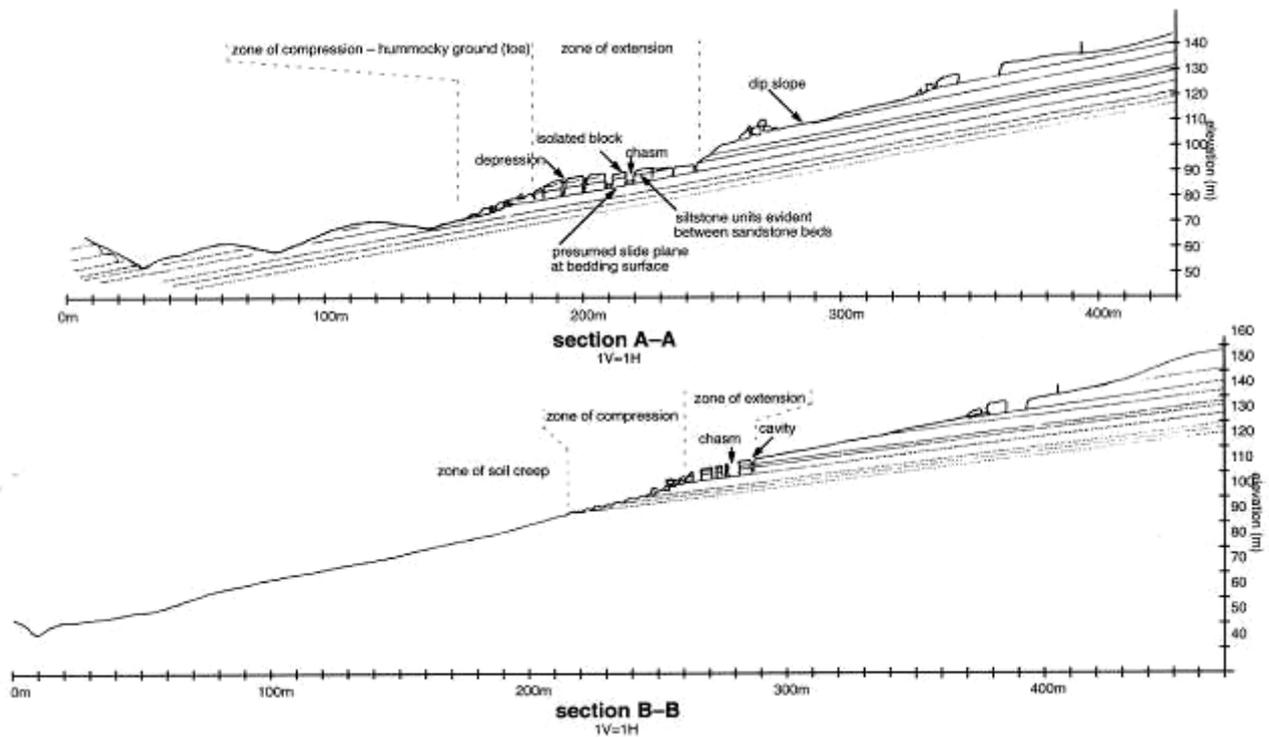
Compression features are mostly developed at the toe of the slide. These mostly comprise hummocky ground, with deeper soils and common scattered boulders and rock debris, mostly rotated. The amplitude of the hummocks is up to 1 m. On the lower slopes, beneath the main slide area, there are areas of forest regrowth in which most of the trees show some degree of bowing or curvature in the lower part of their trunks. The ground in this area is not hummocky, but scattered loose rocks are common. Figure 4 shows two cross-sections through the slide affected area.

**Figure 4** Cross-sections through the Paterson slide (Fityus and Gibson, 2000)

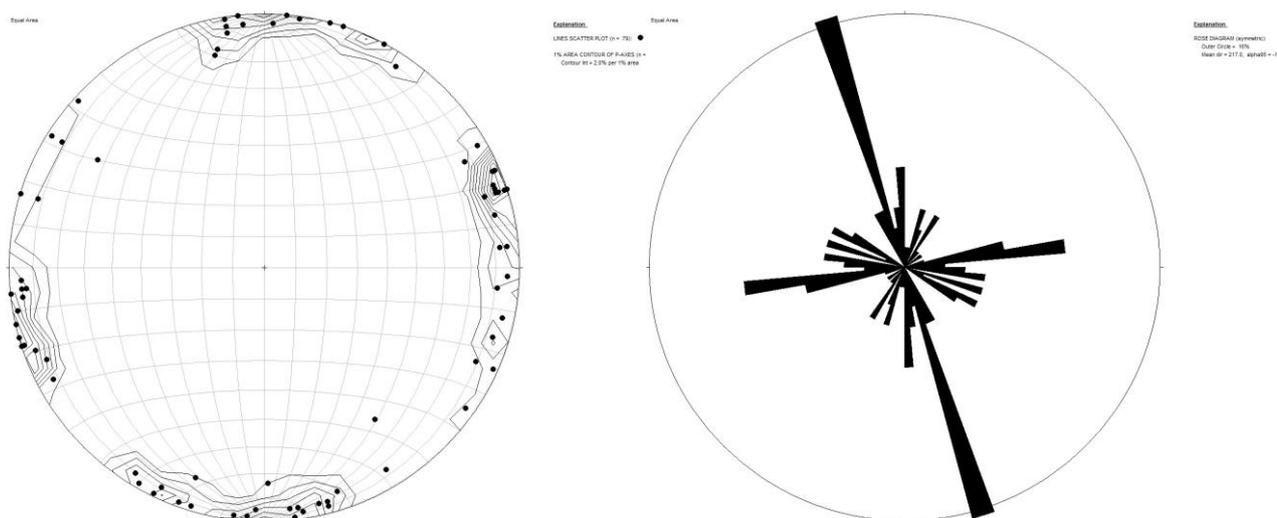
A study of 79 joints exposed in the uppermost (stable) scarp reveals that joints with a wide range of orientations are present in the area. In summary, major sets of sub-orthogonal joints are developed in the 160–340 and 80–260 degree directions; minor sets of joints are developed in the 000–180, 100–280, 110–290 and 120–300 degree directions; and joints are notably absent in NNW–SSE and ENE–WSW directions. In general these joints are vertical or sub-vertical (steeper than 80 degrees). The orientations of the 79 systematically measured joints are plotted in Figure 5.

**Figure 5** Distribution of joint planes at the Paterson slide

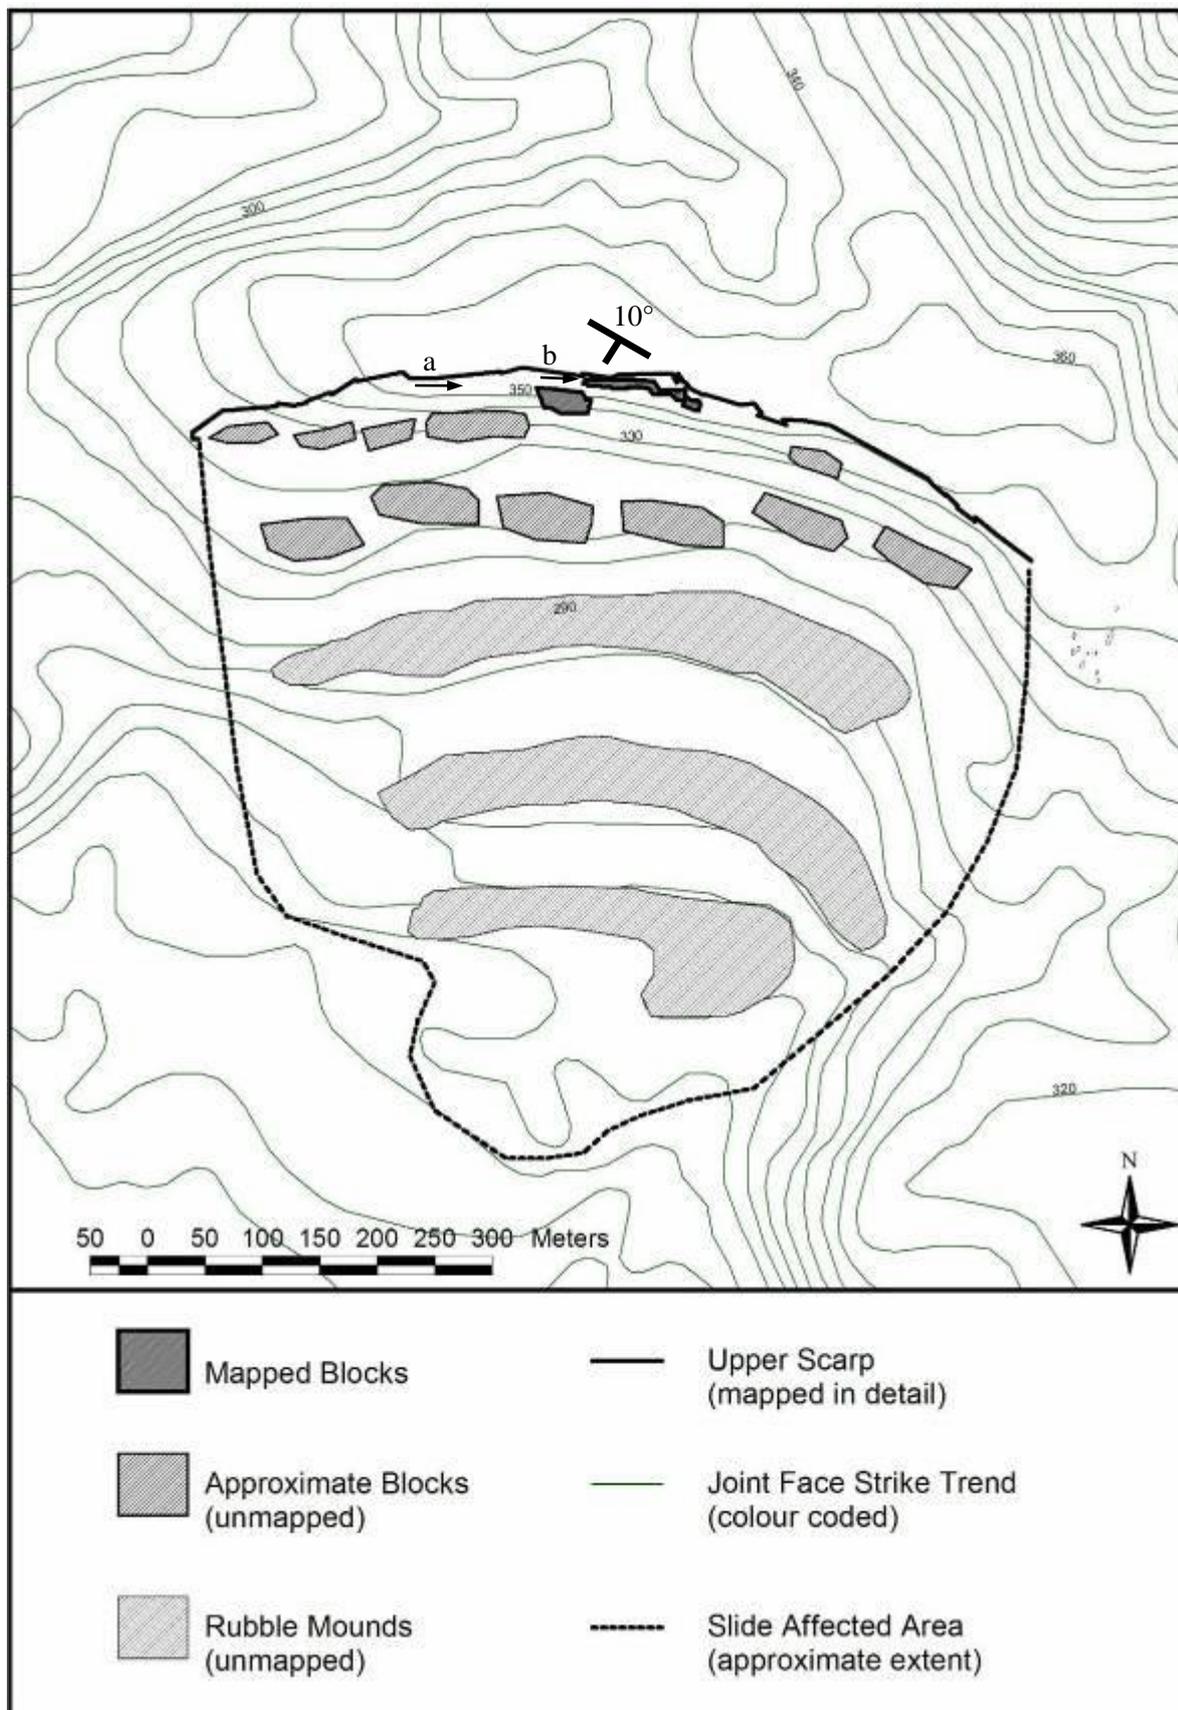
The Pilchers Hill slide is developed as a series of slices of a thick, gently dipping sandstone bed. The axes of the slices are aligned approximately parallel to the strike of the ground surface, and they appear to have separated through translation in an approximately downslope direction. The general arrangement is illustrated in Figure 6, and a cross-section of the slide is reproduced in Figure 7(c). In all, five main slices are identified. The upslope slices are massive, often well-formed, in-tact blocks of sandstone that appear to have separated along joints. A typical well-formed block from the upper slice is shown in Figure 8(a). The form of the slices deteriorates progressively, in a succession toward the bottom of the slope, so that the lowermost slice is little more than a pile of coarse sandstone block rubble (see Figure 7(c)).

Figure 6 Approximate size and extent of the Pilchers Hill slide

The morphology of the uppermost scarp has been mapped in detail using tape and compass techniques. Two larger blocks in the first slice have been mapped in detail, but considerable further work remains to complete detailed mapping of the entire slide affected area.

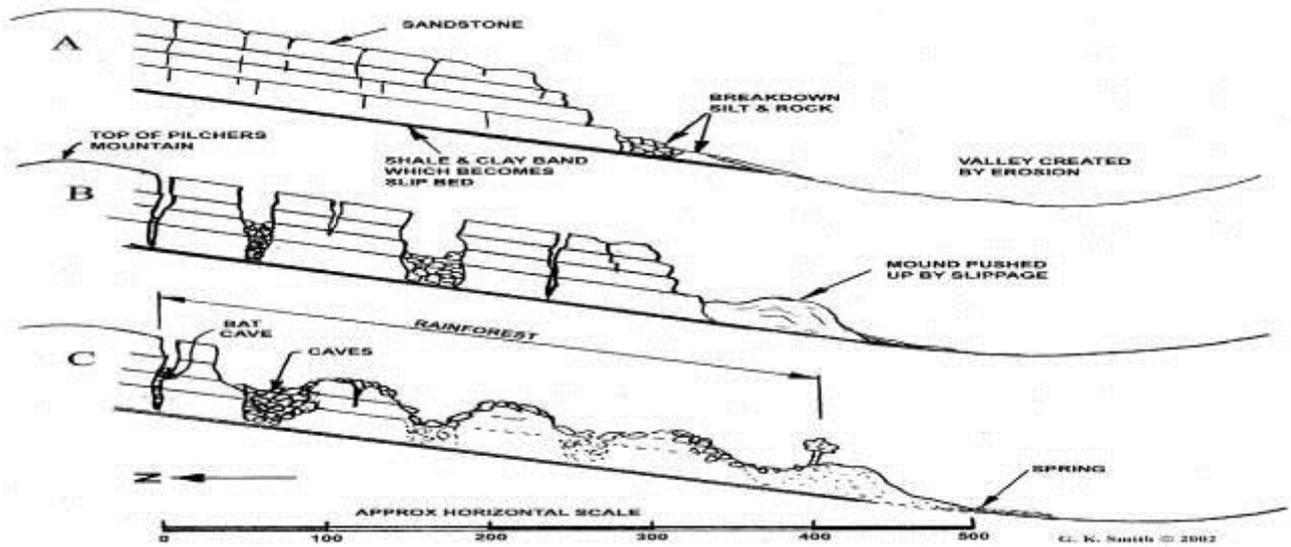
Figure 7 Cross-sections through the Pilchers Hill slide (after Smith, 2007 – note that the figure has been compressed vertically so that it is close to natural scale)

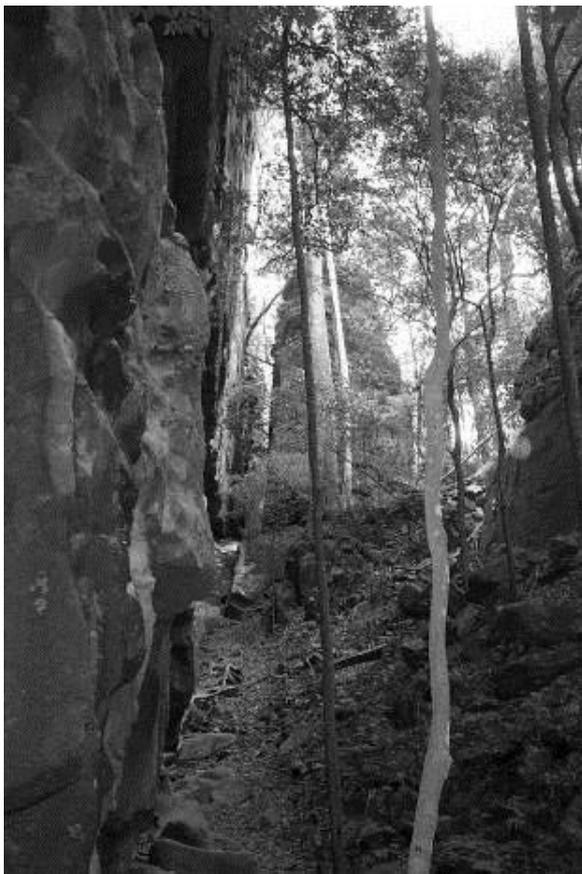
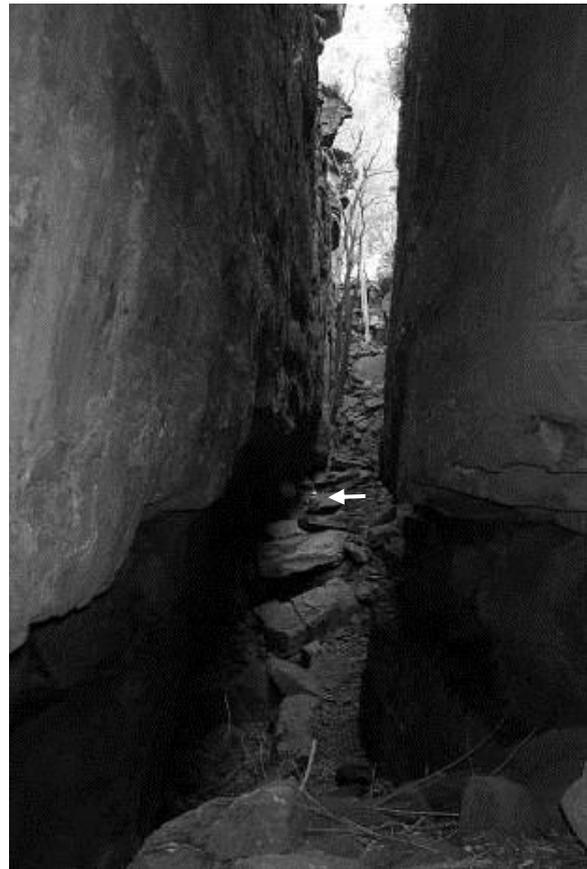
The uppermost scarp, which is presumed to be formed in rock that has not yet moved, is clearly formed from the intersection of many vertical and sub vertical joint planes. The chasms that are formed by this scarp and the adjacent downslope slice are from 3 to 10 m wide, and have open depths of up to 15 m. A photograph showing a deep, narrow chasm is presented in Figure 8(b). Smith (2007) describes a number of tectonic caves that exist in the base of the chasms, formed within a considerable thickness of large block rubble that is present in the bottom of chasms in most areas. He reports that the base of the deepest cave is around 32 m below the top of the adjacent scarp, suggesting that the slide is occurring on a deep-seated slide plane, affecting a sequence of sandstone beds greater than 30 m thick.

Figure 8 Photographs of uppermost chasms, looking west; a) chasm between the stable scarp on the left, and a free standing block on the right; b) 3 m wide chasm with stable scarp on the left, and displaced block on the right. Note the adult in the bottom of the chasm (white arrow) Photographs are taken from positions a and b as indicated in Figure 6

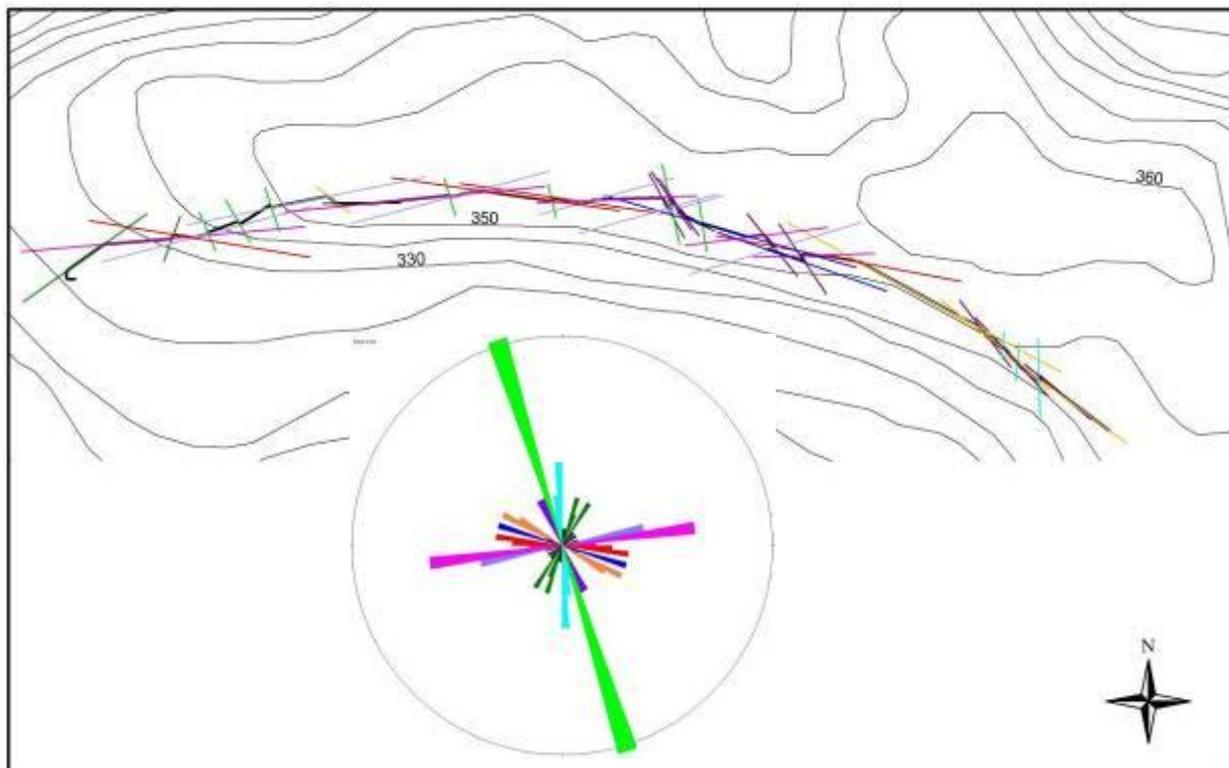
**Figure 9** Analysis of the distribution of joint surfaces in the main failure scarp at Pilchers Hill
