Resolving challenges in tailings closure in semi-arid deserts — a case study into the decommissioning and rehabilitation of the Tanami Mine Three Cell tailings storage facility

K.L. Pang *Outback Ecology, Australia*

R. Haymont *Newmont Asia Pacific, Australia*

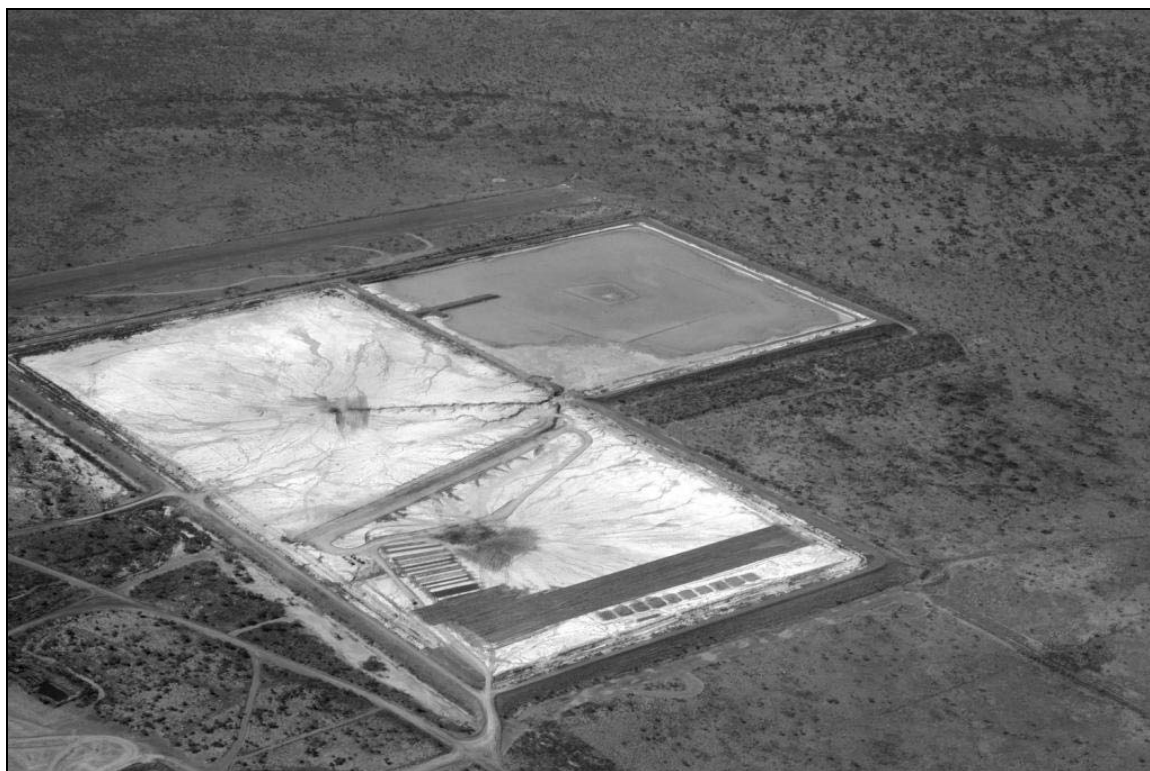
Figure 2 Aerial view of Cells 1, 2 and 3 (taken prior to closure works) with trial works in the foreground

The mine site and its satellite pits are scattered over a length of 70 km adjacent to the Tanami Road. The Three Cell TSF is in close proximity to the processing plant and on-site accommodation village. The facility is a standard paddock styled structure comprising of three cells, each approximately 25 ha in area (Figure 2). At the time of writing this paper the facility was in the final stages of closure.

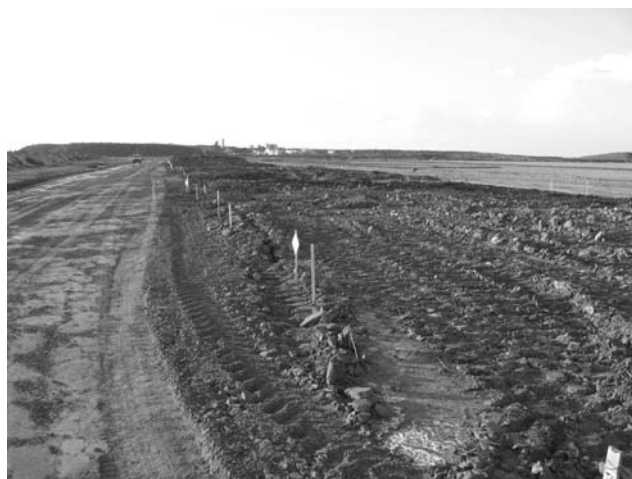
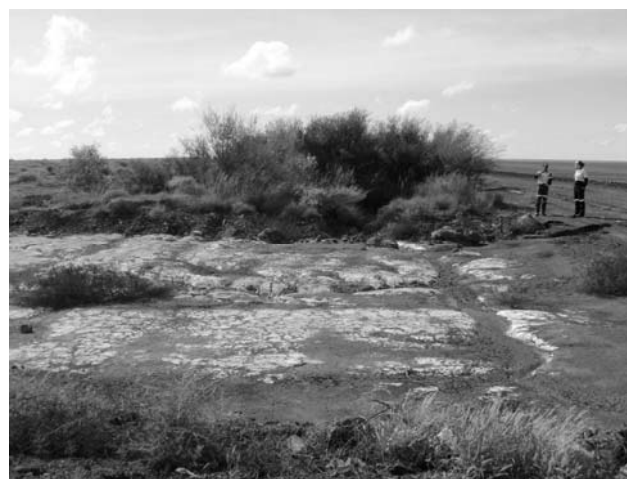
Figure 4 (a) Field trial on Cell 1 near completion (December 2005) looking in a westerly direction; (b) Treatment 2 (background) comprising 10 cm topsoil over 50 cm waste rock (August 2008) proved to be the most successful treatment. A control treatment plot is shown in the centre

Two treatments were identified as performing well across all parameters measured in the recent assessment conducted in August 2008 (Outback Ecology, 2009). Treatment 2 (Figure 4b), which was the second deepest

From the commencement of the trial, the control (Treatment 6) performed poorly in terms of tailings chemistry and plant growth. The tailings material recorded the highest salinity of all treatments and vegetation was absent. Salt concentrated on the tailings surface is due to capillary rise (Figure 4b).

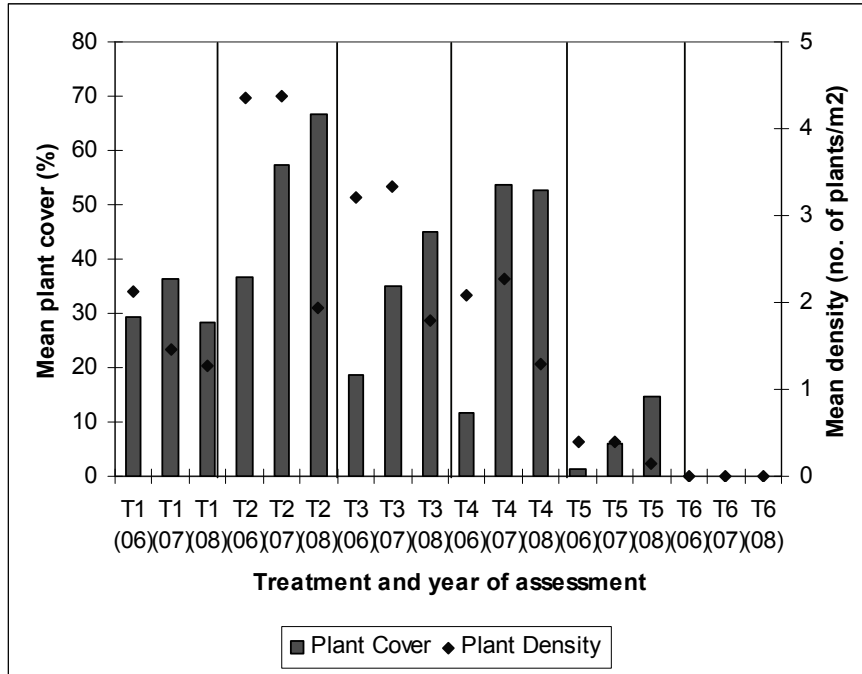
Figure 5 Mean plant cover (%) and mean plant density (number of plants/m²) for each treatment. The year of assessment is shown in parenthesis (Outback Ecology, 2009)

cover treatment (10 cm topsoil and 50 cm waste rock), recorded the highest plant density, highest plant cover and the third highest species diversity (Figure 5). Furthermore, the treatment recorded the lowest average tailings EC (Figure 6). One of the shallower cover treatments (Treatment 4), comprising of 10 cm topsoil and 20 cm mill scats, recorded the second highest plant cover, third highest plant density value and the lowest average EC of all cover materials.
