Earth observation data and satellite InSAR for the remote monitoring of tailings storage facilities: a case study of Cadia Mine, Australia

To demonstrate the application of EO data and InSAR in identifying pre- and post-failure mine activities and TSF deformation, the authors will present a case study across Cadia mine, New South Wales, Australia, which had a localised TSF failure on 9 March 2018. The InSAR results presented show that low-magnitude subsidence signals were observed across the TSF dam during the year preceding the collapse. In January 2018 a notable change in behaviour was observed, with a concentrated area of subsidence focused on the region which initially failed on 9 March 2018. Furthermore, post-collapse InSAR measurements show an increased rate of subsidence for regions either side of the failure zone. Review of medium- and high-resolution satellite images show that the failure was phased, with an initial failure and then a subsequent failure at least two days after 9 March 2018. It also highlights what might be construction activity associated with a dam raise prior to failure.

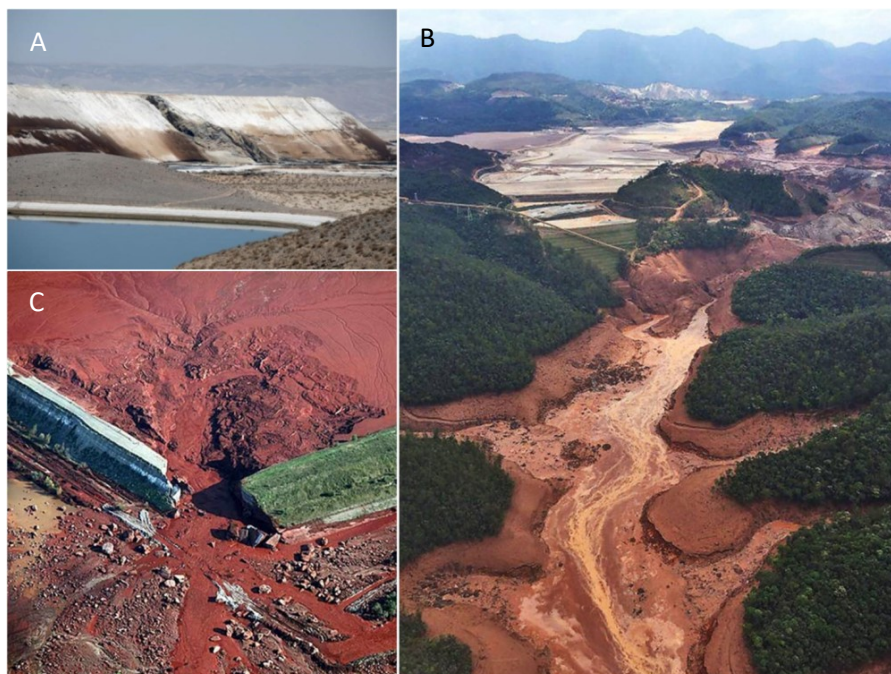
Figure 1   Examples of tailings storage facility failures: (a) shows the July 2017 failure of the Mishor Rotem mine, Israel (Copyright REUTERS/Baz Ratner 2017); (b) shows the November 2015 failure of Samarco/Bento Rodrigues, Brazil (Copyright Corpo de Bombeiros/MG 2015); (c) shows the October 2010 failure of Kolontar, Hungary. Photos sourced from AGU The Landslide Blog (2018)

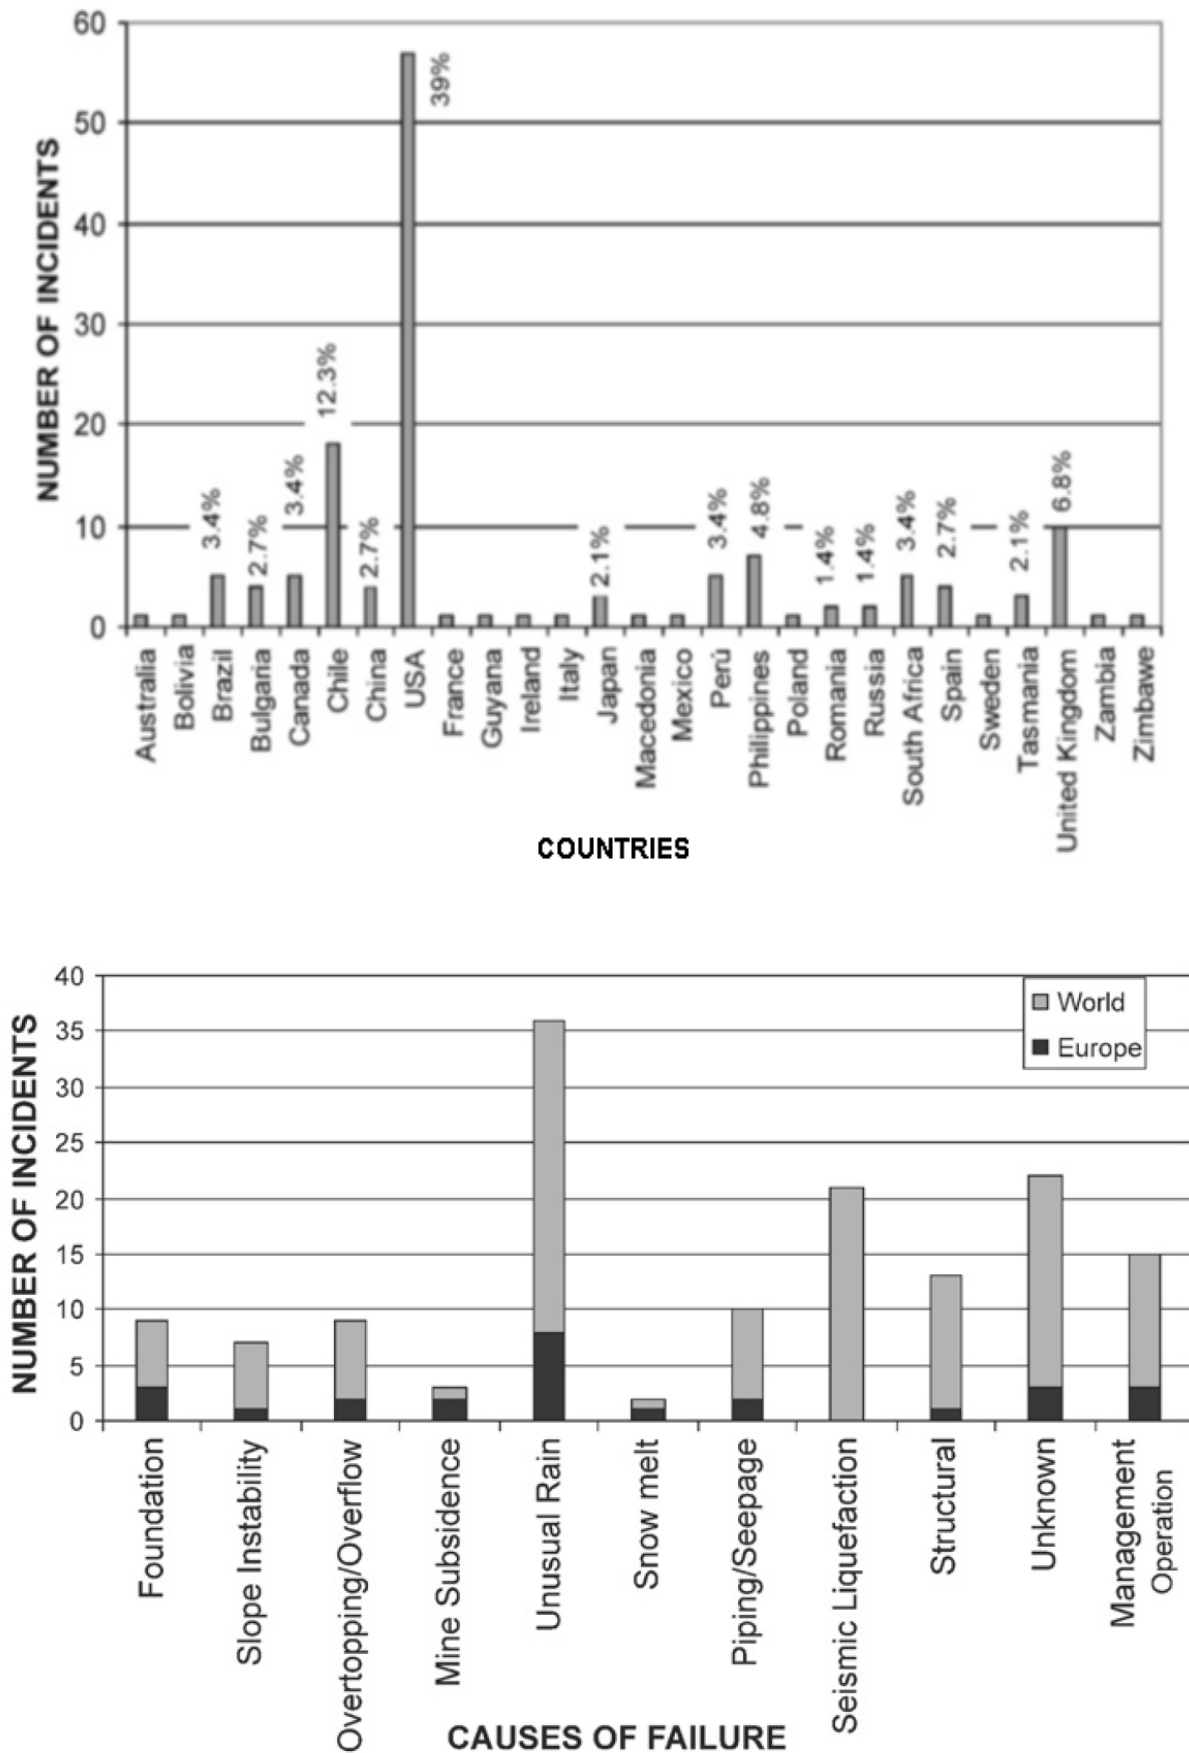
Figure 2   Global distribution and causes of tailings incidents reproduced from Rico et al. (2008)

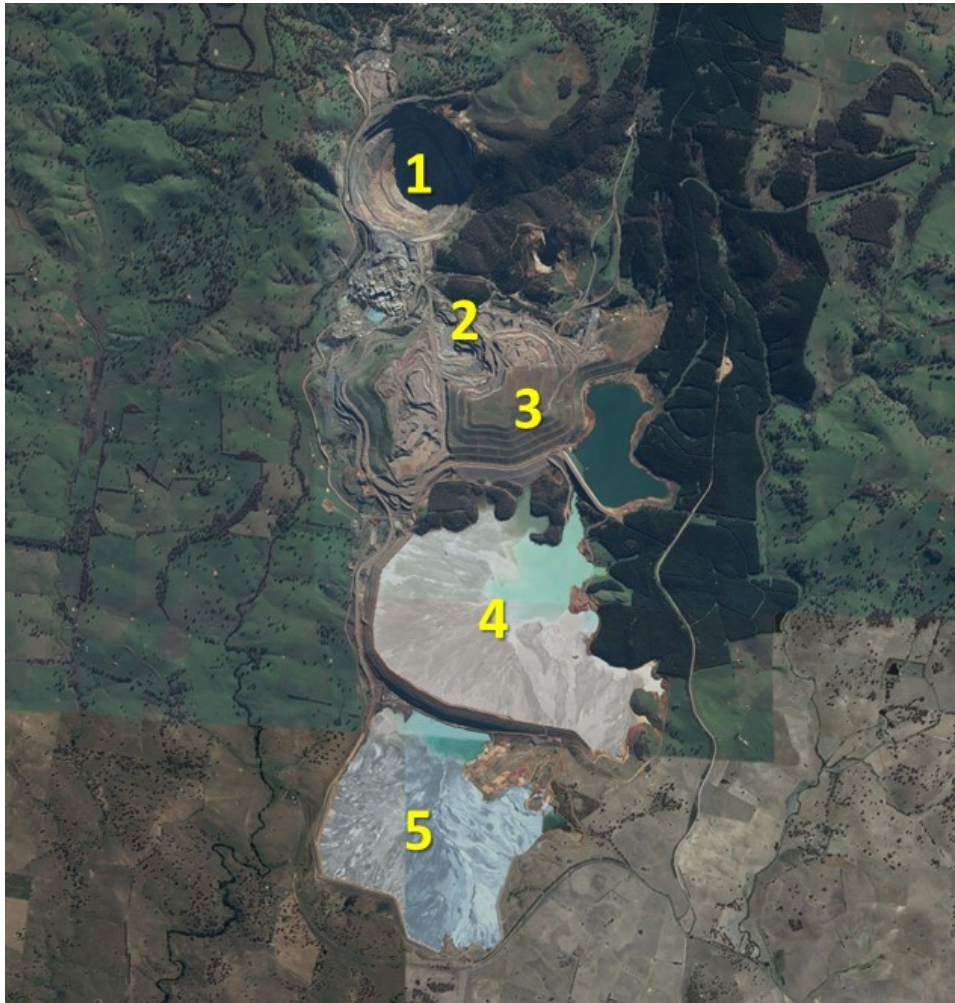
Figure 3 shows the key regions of the mine. The main focus of this paper is on the two TSFs labelled 4 and 5.

Figure 3   **Overview map of Cadia Valley Operations site: (1) Cadia Hill open pit; (2) Cadia East underground mine; (3) South Waste Rock Dump; (4) Northern tailings storage facility; (5) Southern tailings storage facility. Image copyright DigitalGlobe, CNES/Airbus (Alphabet Inc. 2018)**

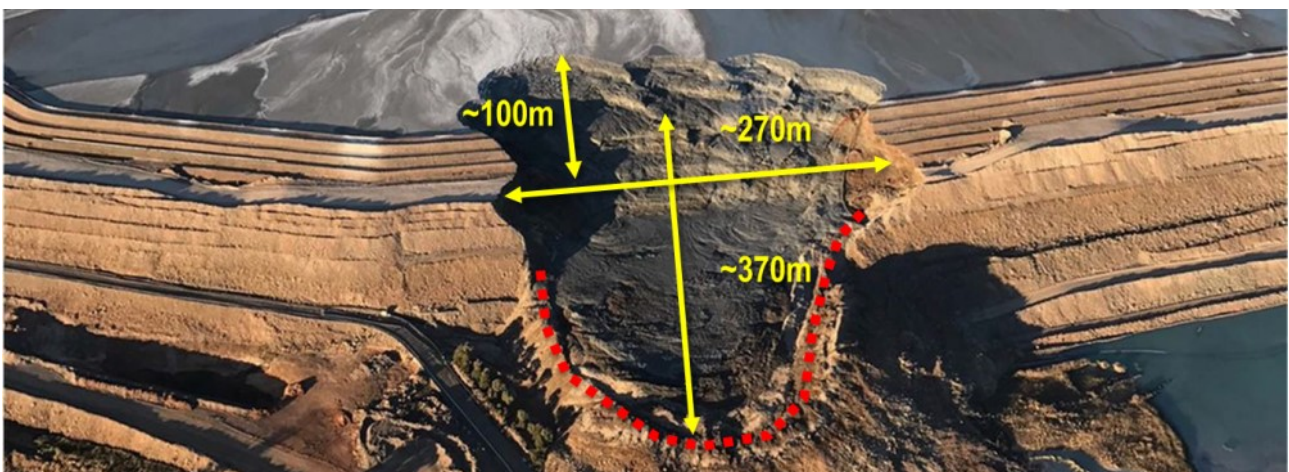
On 9 March 2018 a news release issued by Newcrest Mining announced that a limited breach of the northern TSF had taken place. The failure was contained within the southern TSF. It measured ~270 m across, with a back-scar from the crest of the dam measuring ~100 m and the main slump event measuring ~370 m (Figure 4).

Figure 4   **Aerial photo of failure and estimated dimensions. Image sourced and modified from Newcrest Mining Ltd. (2018)**

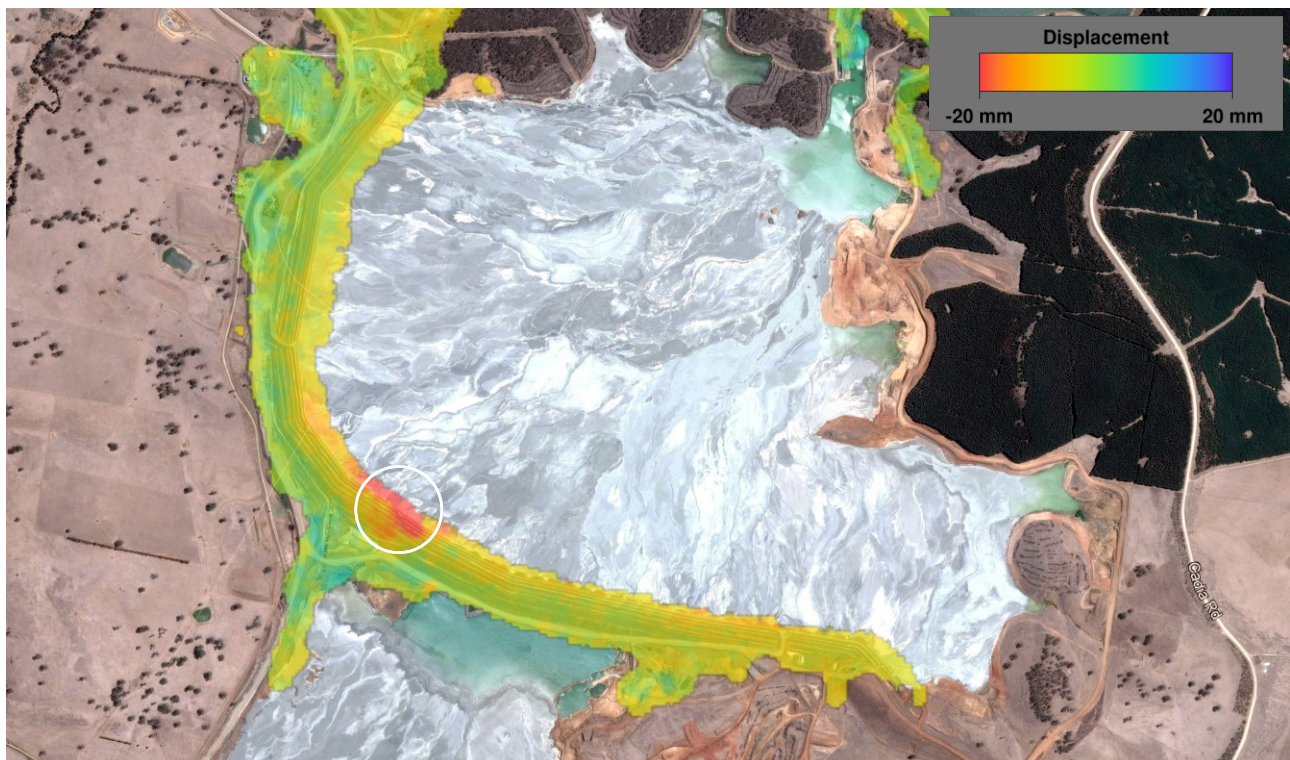
In mid- to late-January 2018, a change in behaviour was apparent, with a stronger concentrated area of subsidence focused on the area of eventual failure (Figure 5). The time series graph (Figure 6) indicates that deformation was occurring at this location as far back as March 2017, with a displacement of around 10–20 mm up to December 2017. In late January 2018, an accelerating period of progressive deformation began, with 29 mm of displacement occurring between 20 January and 25 February 2018, prior to cracks being observed on the morning of 9 March 2018 and failure that same evening.

Figure 5 Displacement map spanning 20 January 2018 to 25 February 2018. Failure zone denoted by the white circle, Background imagery © CNES/Airbus (Alphabet Inc. 2018). InSAR data contains modified Copernicus Sentinel data (2018), © CGG 2018

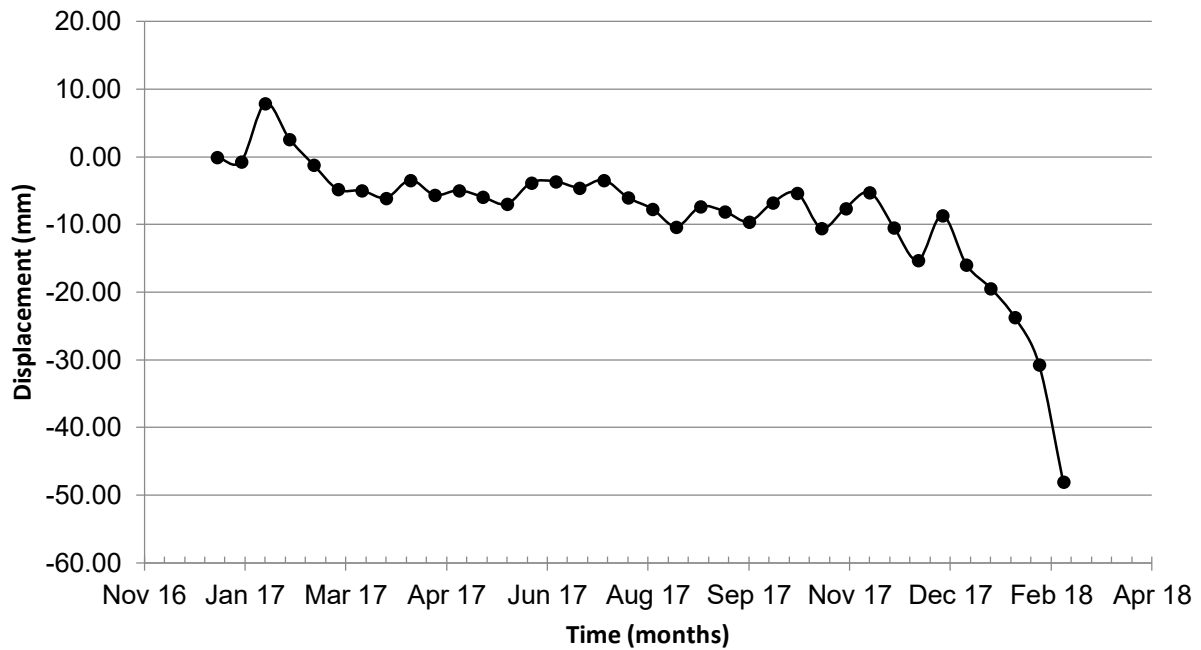
Figure 6   Time series of displacement for a pixel located within the subsiding region shown in Figure 5, © CGG 2018

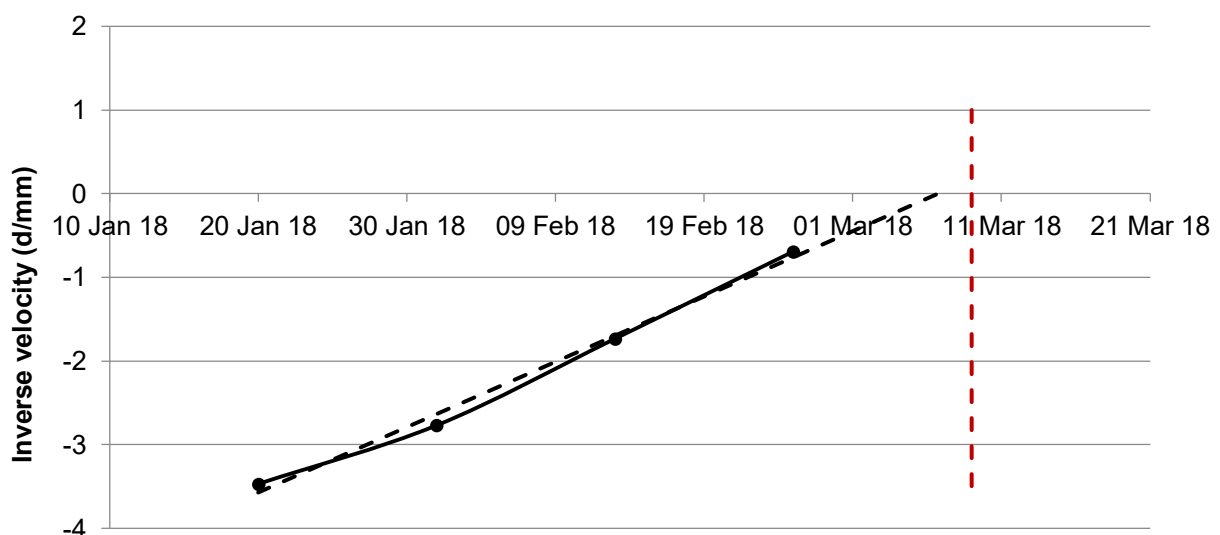
Figure 7 shows the time series of the inverse velocity for the period between 20 January and 25 February 2018. There is a clear trend of increasing acceleration, and extrapolating these results show that failure (an inverse velocity approaching zero) is predicted approximately two days before the failure occurred.

Figure 7   Time series of inverse velocity, calculated for the same location as Figure 6, © CGG 2018

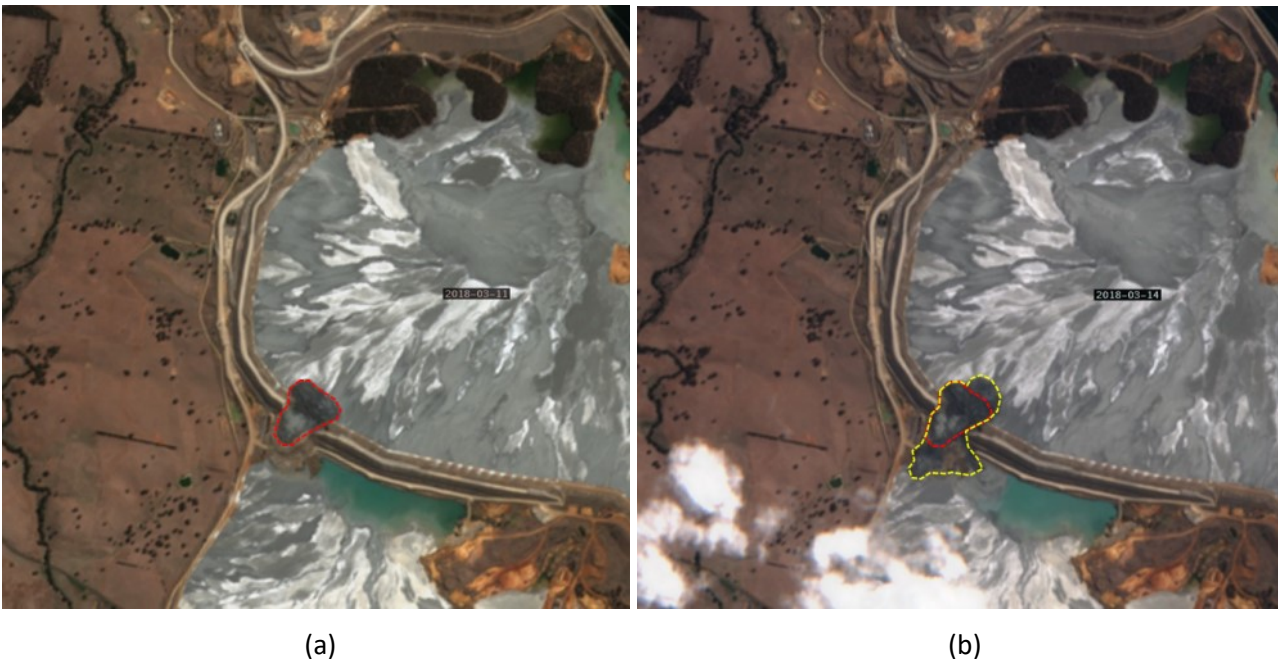
Optical satellite imagery (Sentinel-2, 10 m resolution) shows that the failure occurred in two stages. Imagery acquired on 11 March 2018 shows the boundary of the initial failure (Figure 9), however a second Sentinel-2 image acquired on 14 March 2018 shows a secondary failure that occurred at the same location (Figure 9).

Figure 9 Sentinel-1 imagery acquired on (a) 11 March 2018, with the boundary of the initial failure indicated by the red polygon; (b) 14 March 2018 with the secondary failure indicated by the yellow polygon. © Contains modified Copernicus Sentinel data (2018), CGG 2018

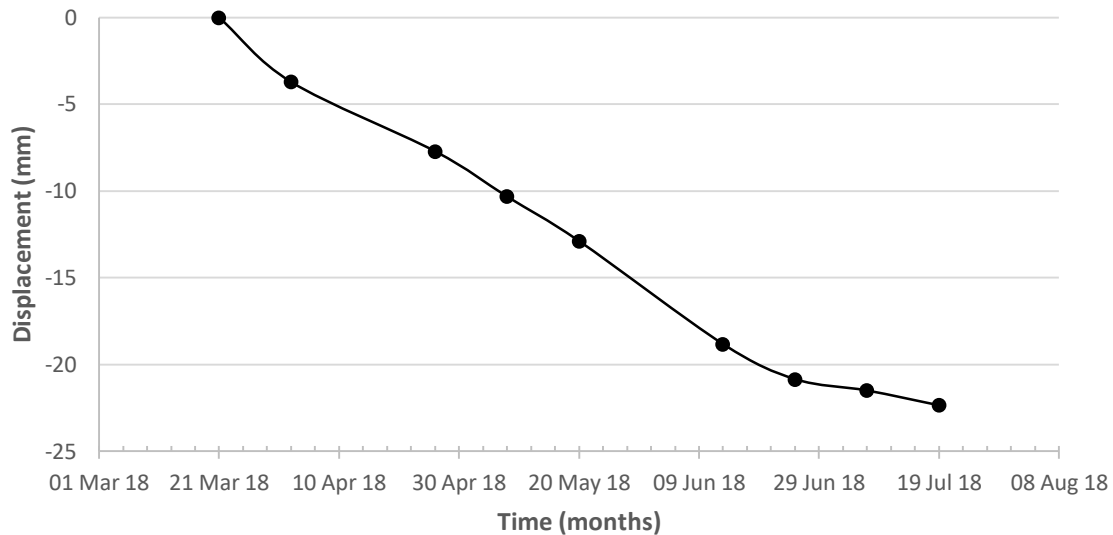
Figure 11 shows a time series of cumulative displacements from the region just to the west of the collapse. This area was still significantly subsiding post-collapse, with a maximum measured deformation of 23 mm at this location. The rate of change of displacement reduces from June 2018 onwards implying the region is beginning to decelerate and possibly start stabilising.

Figure 11 Displacement time series showing the cumulative displacement against time from 21 March to 19 July 2018 for the area of the tailings dam just to the west of the failure. © CGG 2018

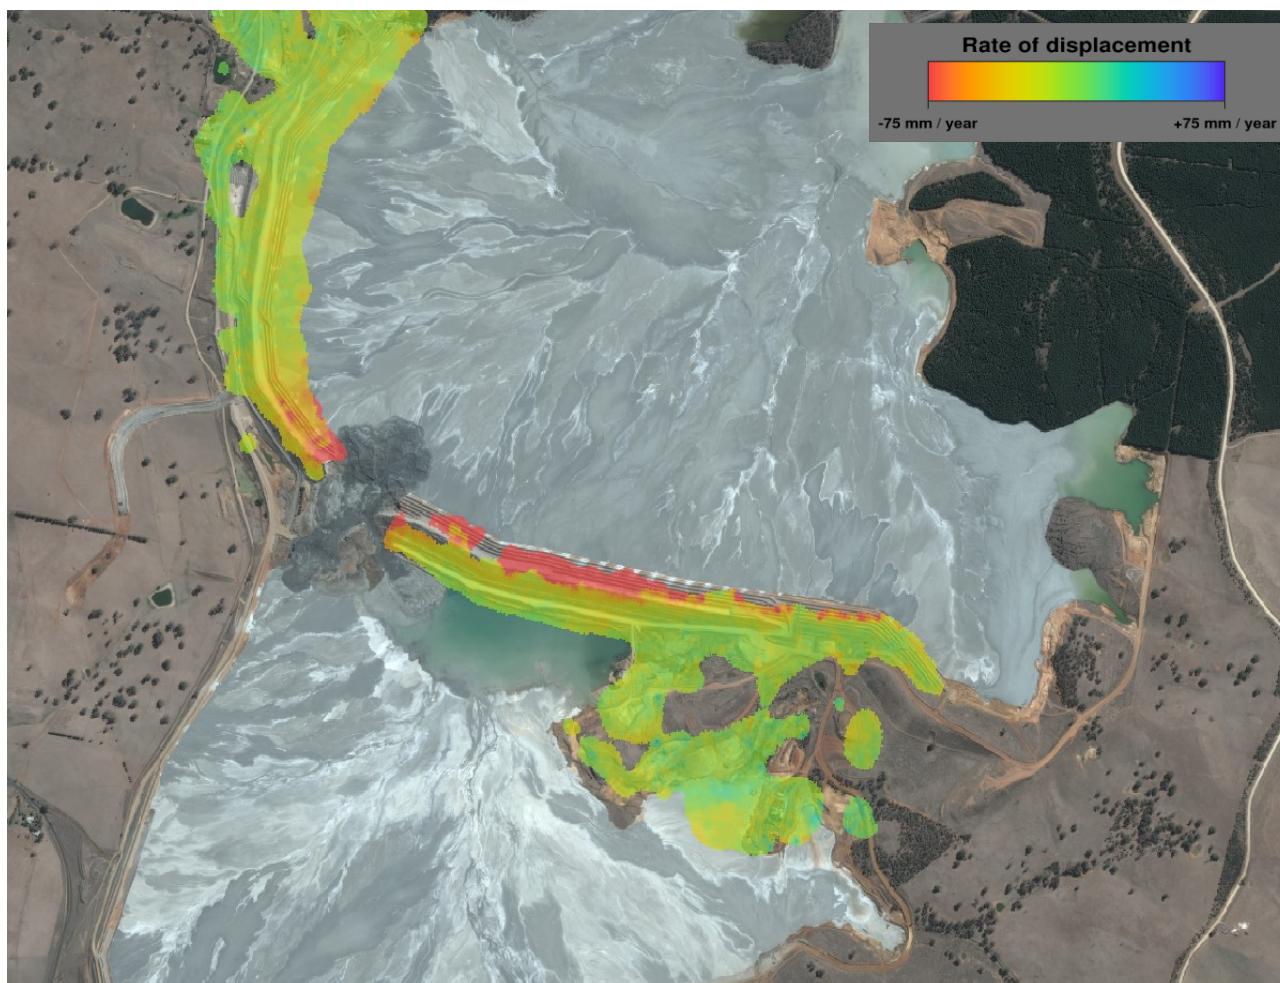
Figure 10 shows the mean displacement rate for the TSFs post-collapse. The red and orange regions on the map show where the TSF dam was still subsiding following the collapse, with the highest amount change occurring in the regions surrounding the failure. The greatest subsidence occurred in the region to the east of the failure (red area) with displacements of up to 40 mm over the time period. This region of the tailings is notably subsiding more compared to the pre-collapse event measurements, implying that it could be under additional stress following the collapse.

Figure 10   Rate map showing the mean displacement rate of tailings storage facilities from 21 March to 19 July 2018. The red and orange regions show where the tailings storage facility dam was still subsiding following the collapse. Background imagery © CNES 2018, Distribution Airbus DS. InSAR data contains modified Copernicus Sentinel data (2018), © CGG 2018
