Rockfalls as precursory strain indicators leading to a large slope failure ('Leo Failure') at Bingham Canyon Mine, USA

Abstract

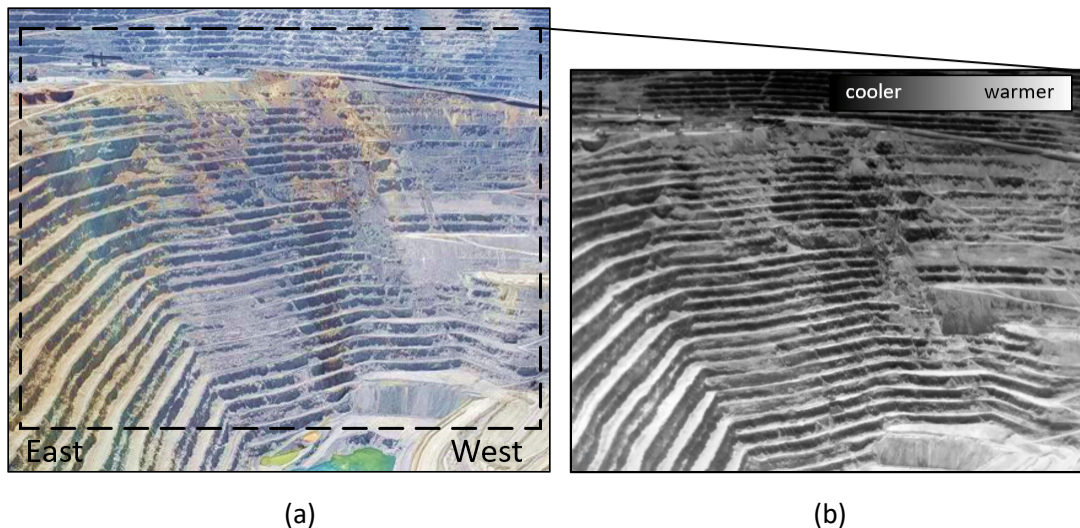
Figure 1   Photograph (a) and thermal image (b) of the monitored pit slope prior to the Leo slope failure

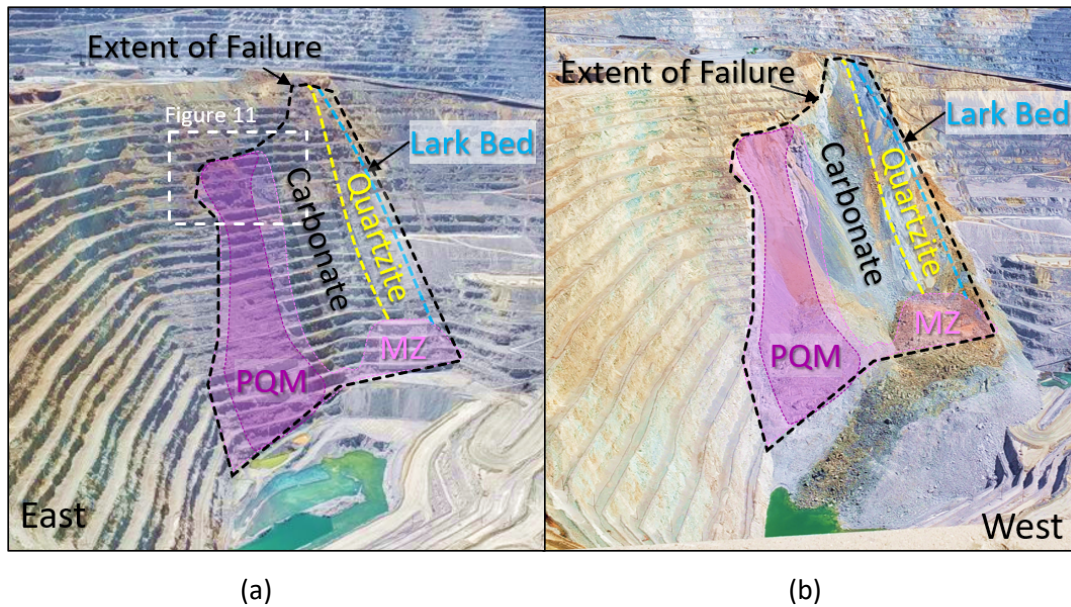
The Leo Failure occurred within multiple lithologies, including: quartzite, limestone, monzonite, and porphyritic, quartz-monzonite; abbreviated as PQM. (Figure 2). The Leo Failure is bound to the west by the base of the Lark Bed, a sedimentary, lithologic contact tectonically reactivated as a fault. Local to the failure, the Lark bedding-parallel fault dips at approximately 40–50° in approximately the same direction of the slope. The Lark bedding-parallel fault-core varies in thickness from approximately 0.1 up to 0.9 m (3 in to 3 ft) and includes sheared clay-sized gouge and clay minerals. The Lark bedding-parallel fault and associated fault gouge is relatively weak based upon strengths estimated from laboratory shear-strength testing. Friction angles range from 18 to 22° and cohesion ranges from approximately 20 to 30 kPa.

Figure 2 **(a) Photograph of the pit slope prior to the Leo Failure with generalised contacts for the lithologic units within the failure boundary; (b) Photograph of the post-failure slope with generalised key lithologic units within the failure boundary**

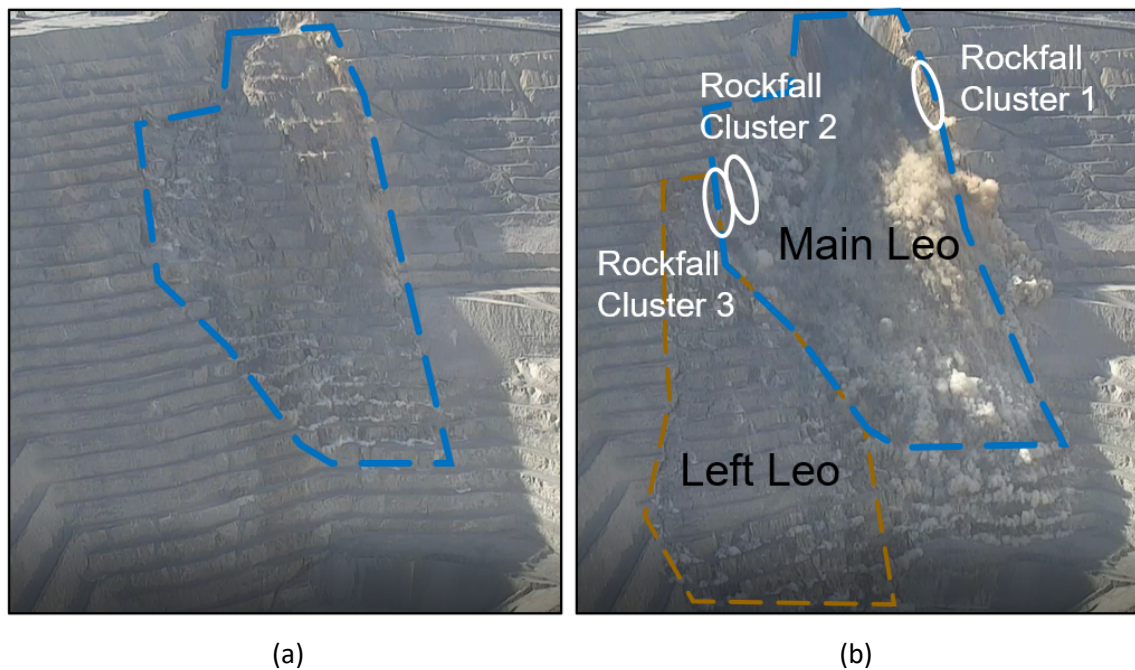
The Leo Failure occurred on May 31, 2021, in three stages (or modes), initiating at the crest and generally propagating from the west to the east as the mass moved downslope (Figure 3). A first stage of failure ('Main Leo' block or segment) is bound to the west by the Lark Bed (right-release) and to the east by an intrusive igneous contact of PQM with monzonite (left-release). The secondary and tertiary blocks ('Left Leo') followed downslope and to the west (downward and clockwise translation), into the void left by the Main Leo slide-mass (Figure 3). The total failure weight is approximately 19 million tonnes. Rockfalls were clustered on the side releases of the Main Leo failure boundaries (discussed in the next section).

Figure 3 **Photographs of the early stages of the Leo Failure. (a) Outline of the primary failure stage, Main Leo; (b) Outline of the secondary to tertiary failure stages, Left Leo, and locations of rockfall clusters prior to the failure**

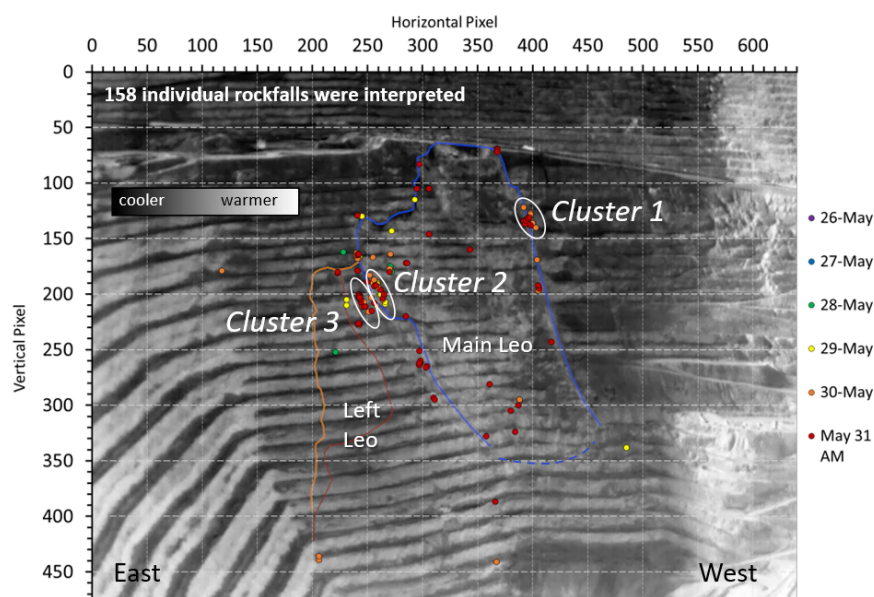
The estimated position of the origin of each of the 158 documented rockfalls are shown in Figure 4. The majority (≈ 60%) of rockfalls repeatedly originate from three primary areas (clusters) prior to the Leo slope failure and generally occur along the boundaries of the ultimate slope collapse with less than 10% originating from the centre of the Main Leo segment Figure 4. The right-most (west) cluster one appears to be coincident with the Lark Bed (a sedimentary contact reactivated as a fault), the future right-release of the Main Leo segment of the initial slope failure. Clusters 2 and 3 appear to be coincident with a location along the multiphase left-release of the Main Leo segment. Cluster 2 also appears to be positioned up-slope (within 30 m or 100 ft) of a previous one to two-bench failure. Rockfalls do not appear to originate along the farthest left-release, the Left Leo segment of the failure (tertiary failure-phase described in Section 3). Origins of rockfalls generally elucidate the ultimate head-scarp of the Main Leo failure but do not appear to define an initial break-out at the base of the slope failure.

Figure 4 Still image from the thermal camera at approximately 7:30 am, 31 May with locations of rockfalls occurring from 26 to 31 May. Also shown are the future slope-failure boundaries

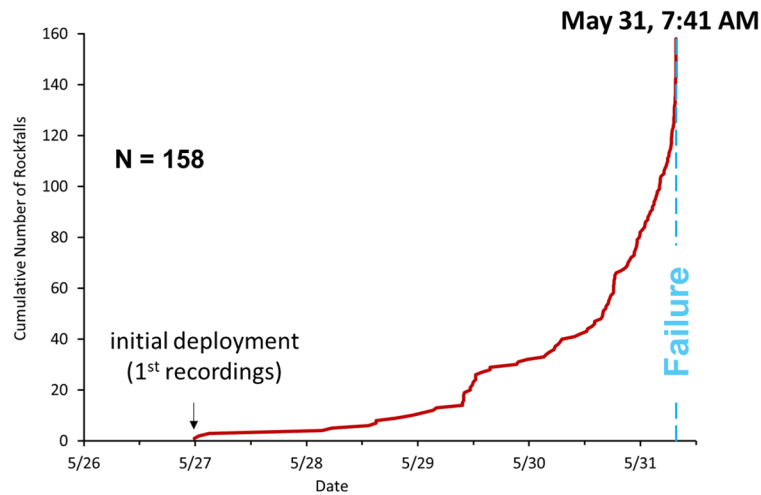
Plotting the cumulative total number of documented rockfalls versus time indicates that approximately 45% of the documented rockfalls occur within six hours of failure Figure 5. The day-by-day sequential occurrence of initial rockfall positions are shown in Figure 6, spanning the same pre-failure time-interval as Figure 5. Spatial clusters of rockfalls are discernible from May 27–30 and correspond to the abrupt accelerations in cumulative rockfall curve (Figure 5). In the early morning hours of May 31, rockfalls began to originate more frequently from the three clustered locations but also at new positions downslope, along the left and right

Figure 5   Plot of cumulative rockfalls versus time leading up to the Leo Failure

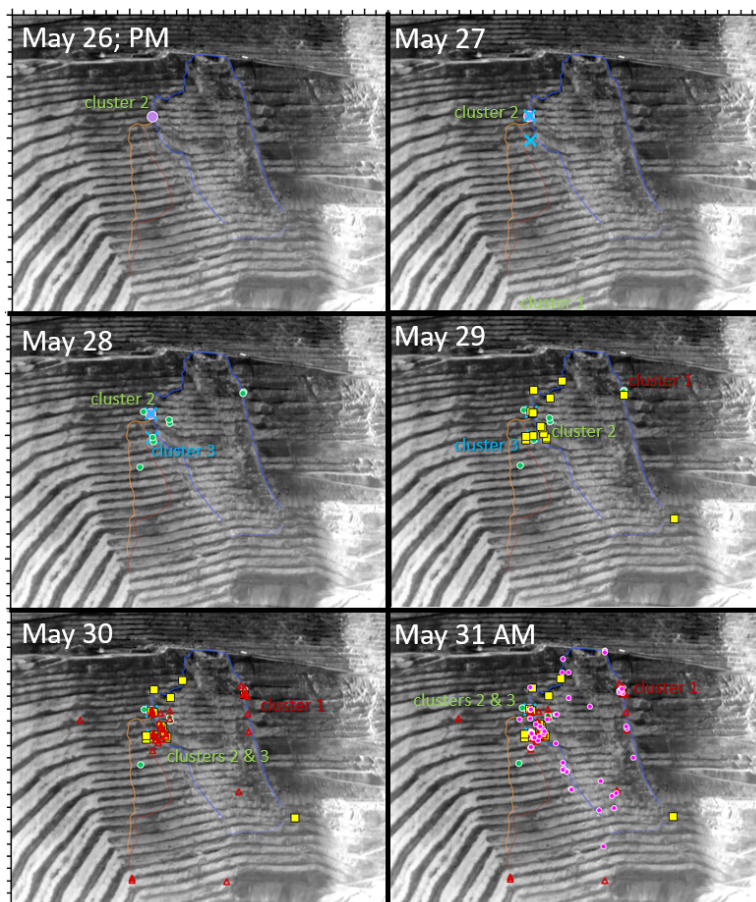
releases; up-slope along the future head-scarp; and downslope in the lower, central-portion of the Main Leo segment (Figure 6, 31 May am). Within the hour leading up to failure, the mean time between successive rockfalls is around 20 seconds, and within two minutes of failure, nearly a dozen rockfalls were documented.

Figure 6   Still image at 7:30 am on 31 May from thermal video with day-to-day addition of positions of rockfall origins for each day leading up the Leo Failure. The image is the same for each day shown

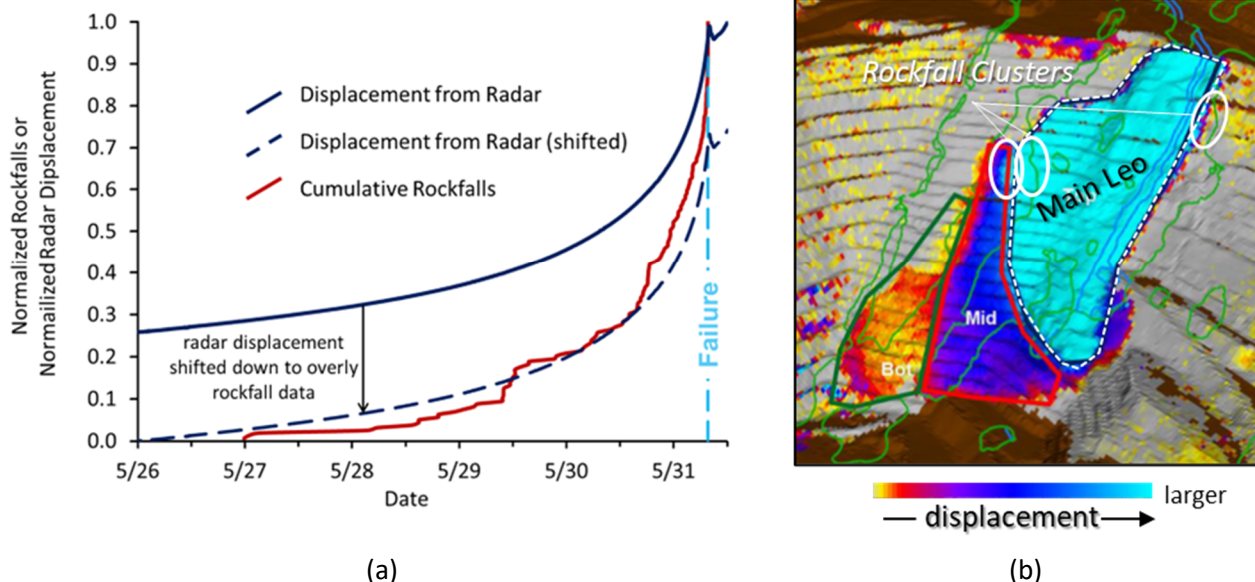
Plotting the cumulative total number of rockfalls along-side a radar-derived, displacement time-series (representing the entire Main Leo) indicates the documented rockfalls occur within the span of time characterised by the final, tertiary acceleration phase; i.e. the average of the Main Leo segment is smoothly accelerating (Figure 7). In addition, radar-displacement time-series for areas corresponding to the individual rockfall cluster areas are also smoothly accelerating, although the area of Cluster 1 exhibits a greater total displacement magnitude. Clusters 2 and 3 are positioned where there is a high, radar-derived displacement-gradient; i.e. displacement decreases abruptly laterally along-slope and across the future, failure boundaries.

Figure 7 **(a) Normalised cumulative rockfalls versus time for the primary, Main Leo Failure and normalised radar-displacement data for the Main Leo segment of the failure. (b) 3D perspective view of radar-displacement data with failure boundaries and rockfall cluster locations overlain**

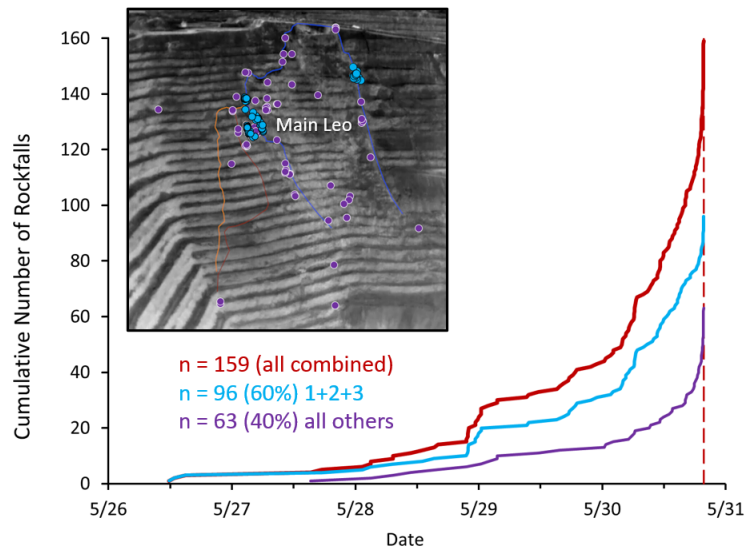
Cumulative rockfalls versus time for the sum of the combined rockfall clusters (sum of Clusters 1, 2, 3) indicates that the cyclical behaviour of the total cumulative rockfalls is governed primarily by the behaviour of the clusters (Figure 8). Plotting the cumulative rockfalls for the individual clusters indicates that Cluster 2 is the primary influence on the cyclical behaviour of total cumulative rockfall curve (Figure 9). Cluster 3 imparts a secondary influence on the cyclical behaviour with Cluster 1 having a relatively minor influence. Approximately twice the number of rockfalls originate from each of both Cluster 2 (N = 44) and 3 (N = 33) as compared to Cluster 1 (N = 19). The first rockfall identified in the video data initiates at Cluster 2, within the final few hours of May 26. An additional rockfall initiates from Cluster 2 just an hour later on May 27. In contrast, rockfalls do not appear to initiate at Cluster 1 until approximately mid-day on May 28, 1.5 days after recording began.

Figure 8 Cumulative rockfalls versus time curve representing the entire population of observed rockfalls (red); the population of rockfalls originating from any of the three cluster locations; and the population of rockfalls that do not originate from any of the three clusters identified (purple). Inset is a thermal image with the positions of rockfalls belonging to a cluster (blue) and those not belonging to a cluster (purple)

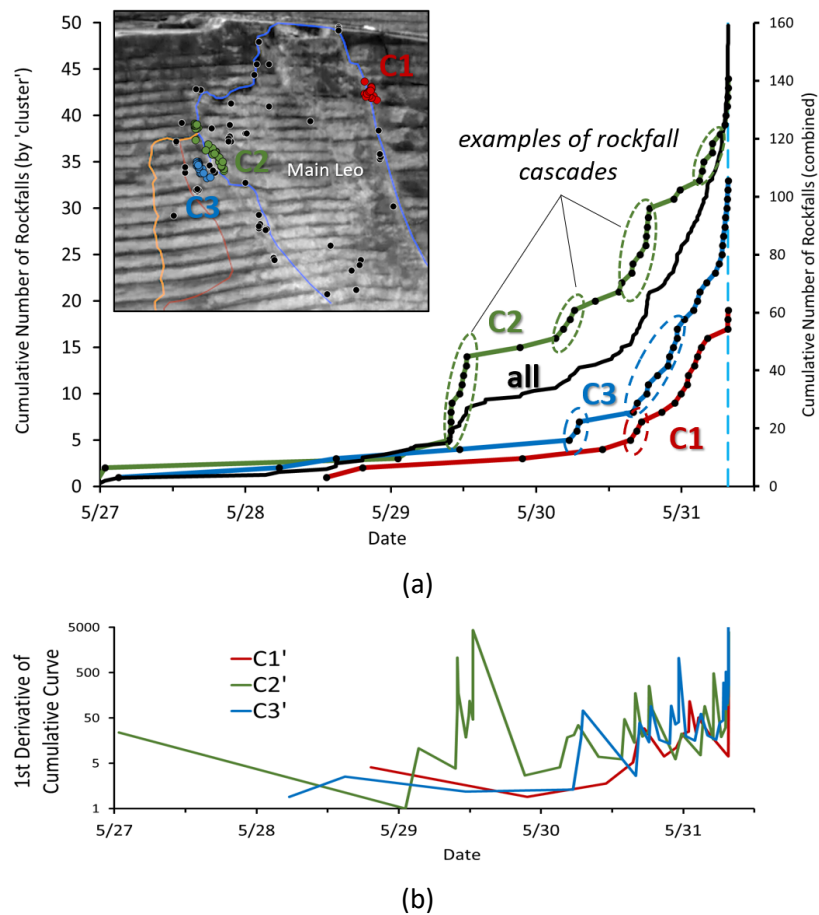
Relative to Clusters 2 and 3, the cumulative rockfall versus time curve for Cluster 1, located along the contiguous faulted-bedding right-release, generally exhibits a progressive acceleration of rockfalls up to the time of failure with perhaps one relatively minor abrupt acceleration cycle occurring during the afternoon of May 30. In contrast, a cumulative rockfall curve for Cluster 2, along a geometrically complex left-release, exhibits a series of at least three abrupt cycles of rapid rockfall accelerations (e.g. 1–1.5 per day to 70–75 per day). Cluster 3 also located along the geometrically complex left-release exhibits an abrupt acceleration cycle during the morning of 30 May and series of up to five high-frequency cycles beginning in the afternoon of 30 May and continuing to approximately 05:00 hrs on 31 May before the final rockfall acceleration leading to the time of failure at 07:31 hrs (Figure 9). A plot of the first-derivative of cumulative frequency curves for each cluster demonstrates both the higher frequency and magnitude of cyclical rockfall accelerations for Clusters 2 and 3 with respect to Cluster 1 (Figure 9).

Figure 9 (a) Cumulative rockfalls versus time curve representing the entire population of observed rockfalls (black); the population of rockfalls originating from Cluster 1 (red); Cluster 2 (green); and Cluster 3 (blue). Inset is a thermal image with the positions of rockfalls belonging to a Clusters 1-3; (b) Plot of the first-derivative for each of the three cluster curves in (a)

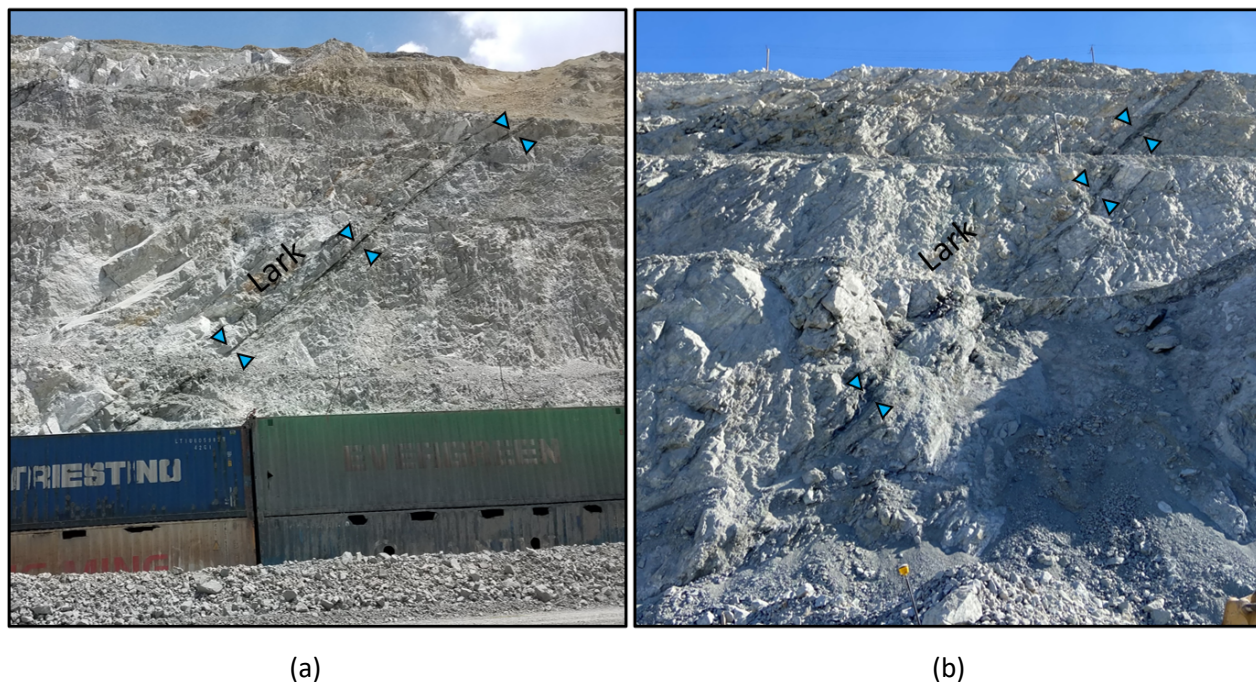
The Leo Failure occurred on May 31, 2021, in three stages (or modes) and in general, propagated from west to east as the mass moved downslope. The first stage of the failure (Main Leo) is bound to the west by the Lark Bed (right-release) and to the east by an intrusive igneous contact of PQM with monzonite (left-release). The Lark Bed is a relatively contiguous sedimentary, lithologic contact tectonically reactivated as a bedding-parallel fault (Figure 10). The Lark Bed is primarily a carbonate unit associated with an Upper Pennsylvanian succession of shallow-marine (upper-slope) siliciclastic and carbonate deposits. Deposition of the Lark occurred upon a low-relief seabed with no more than a few degrees of dip-variation over tens of km of depositional profile. These depositional surfaces are contiguous and often can be traced for tens up to approximately 100 km. More important, the original depositional continuity of the Lark Bed is much greater than the scale of the Leo Failure. The gouge within the core of the Lark bedding-parallel fault includes both clay-sized grains and clay minerals with relatively low strength values (see Section 3).

Figure 10   Photographs of the Lark bed and associated bedding-parallel fault captured from (a) the 5840 bench and (b) the 5590 bench. The opposing blue triangles denote examples of where the exposed fault can be readily observed in the bench face. Each bench is approximately 15 m (50 ft) tall. The photographs document the occurrence and continuity of the fault, at a spatial scale of over 150 m, in both the strike and dip directions

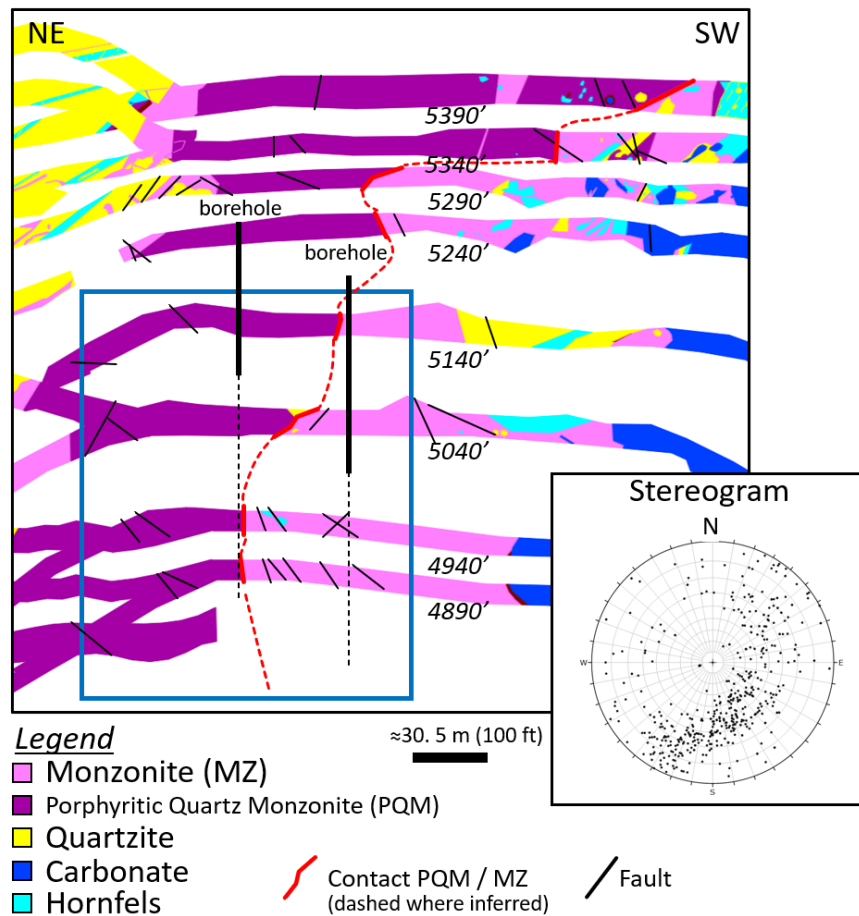
The cyclical accelerations of Clusters 2 and 3 and the greater number of rockfalls are interpreted to represent precursory, damage accumulation related to brittle strain localisation along sub-surface geometric asperities associated with a geometrically complex system of lithologic contacts, structural discontinuities, and variable distribution of rock mass strength. As the 'step-path' along the future left-release evolved, through a complex

Figure 11   **Pseudo geologic-section of bench-face geologic mapping in the vicinity of the structurally complex intrusive igneous contact and spatially coincident left-release of the Leo Failure. At this location, the Main Leo, left-release generally follows the contact between MZ and PQM. The elevation increases to the top of the pseudo section. The bench mapping characterises the geology over 150 m in the vertical direction and 200 m in the horizontal direction. The inset is a lower-hemisphere stereo plot of poles to all structural discontinuities identified in both the surface mapping and borehole data for both PQM and MZ rock units. The borehole traces are dashed where they descend below the section elevation. The blue rectangle indicates the area from which Rockfall Clusters 2 and 3 originate. See Figure 2 for the location of this figure**

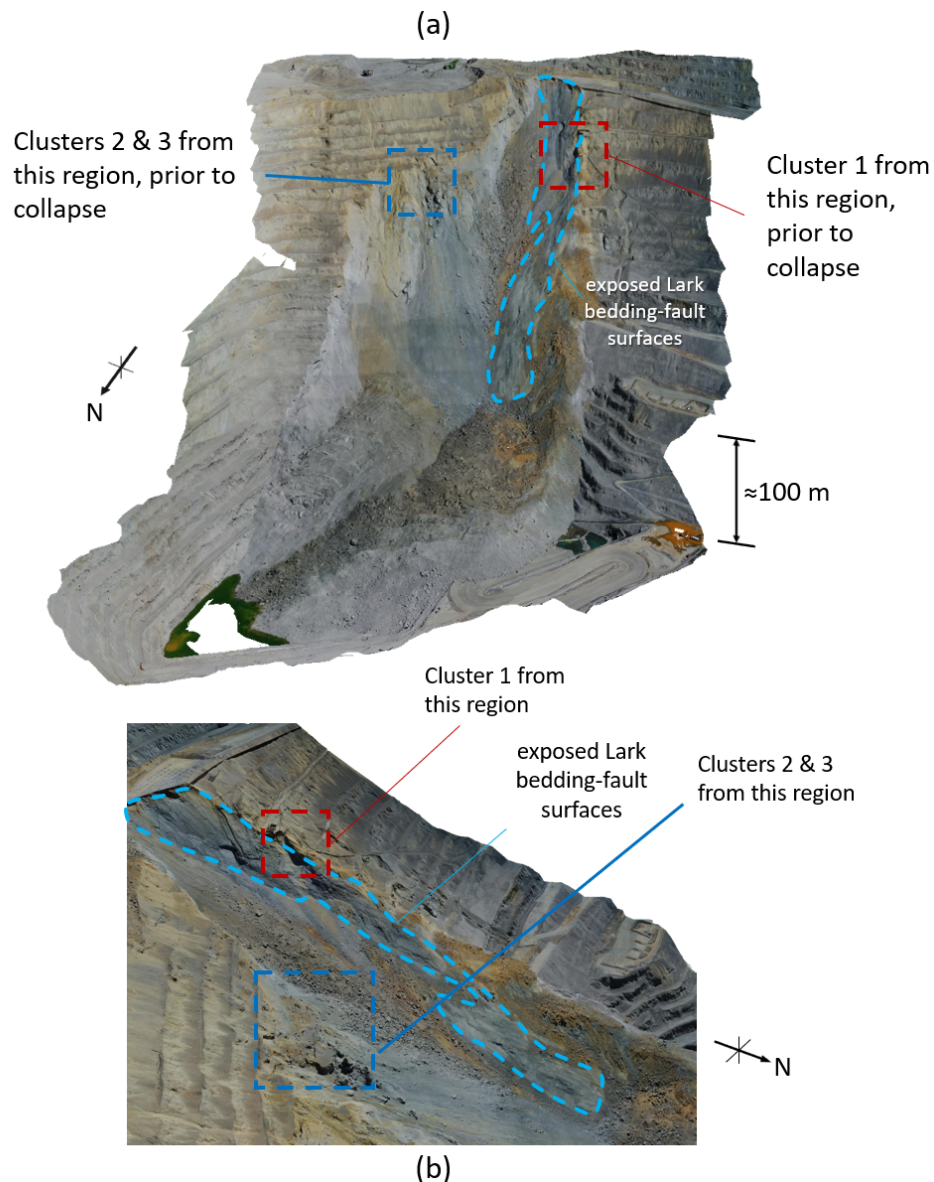
We interpret the relatively late and relatively low number of rockfalls along the right-release to be associated with either strain softening or creep-strain along an inherited, clay-rich sedimentary contact reactivated as a quasi-planar fault (Figure 12). The faulted sedimentary contact is weak and relatively smooth and strain accommodation could occur without the need to localise significant brittle strain and accumulate damage such that rockfalls occur. Cluster 1, the exception, overlies the sole portion of the failure slide-surface that exhibits geometric irregularity. In addition, the cumulative rockfalls versus time curve exhibits a relatively smooth acceleration and lacks abrupt cyclic accelerations when compared to the cumulative rockfall curves

Figure 12 3D perspective views of the Leo Failure captured from aerial 3D photogrammetry collected in the hours following collapse. (a) View of the failure with locations of identified rockfall clusters. (b) View from the east (left side) of the Lark bedding-parallel fault, sliding surfaces. Note the pervasive striations developed and exposed on the quasi-planar sliding surface
