# Tailings decommissioning options at Mount Nansen, Yukon, Canada<sup>©</sup>

Y.T.J. Kwong *CANMET Mining and Mineral Sciences Laboratories, Natural Resources Canada, Canada*

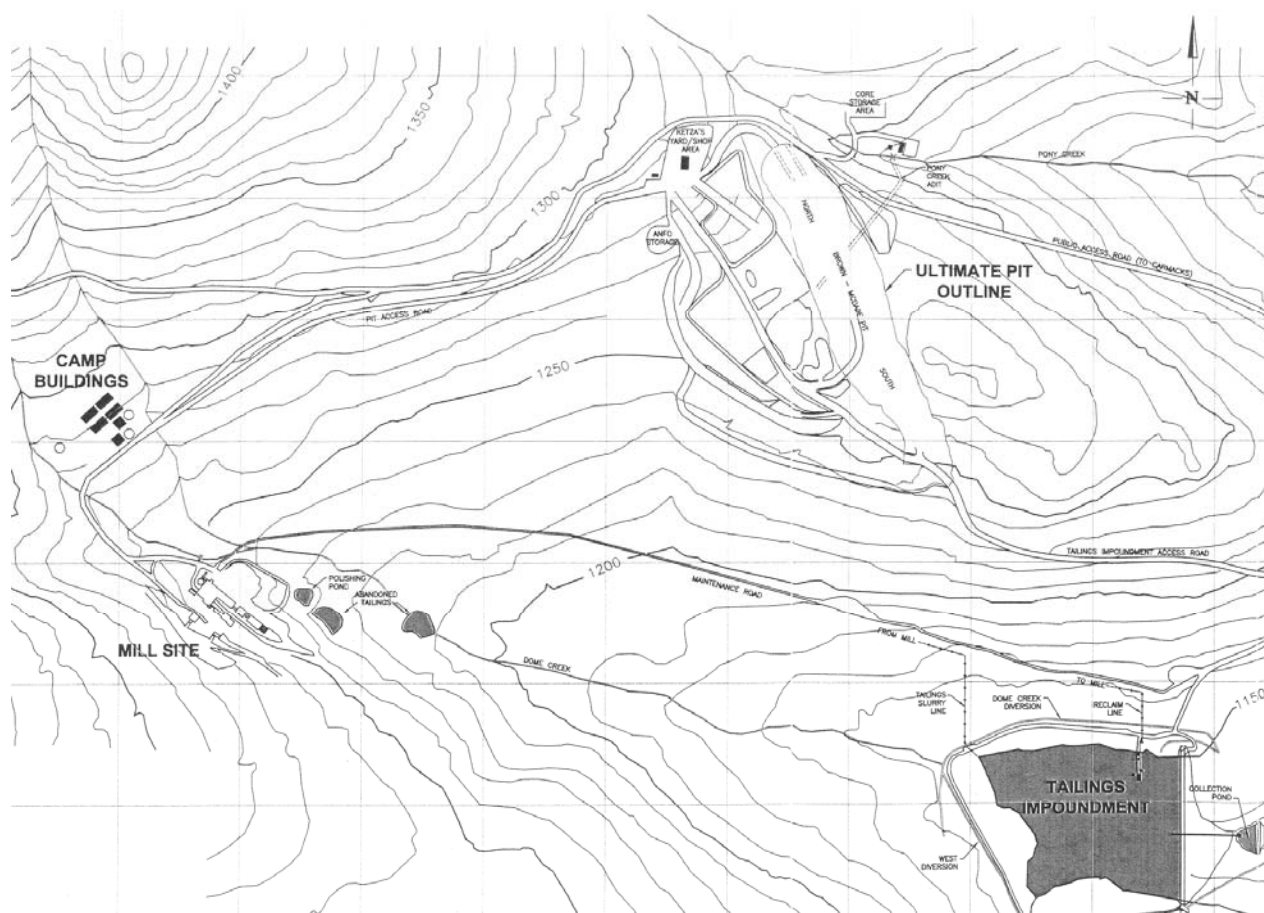
Figure 1 shows the layout of the Mount Nansen Mine. The tailings impoundment, measured about 290 m by 210 m, is located approximately 1 km down-gradient and southeast of the Brown-McDade open pit. It lies in the Dome Creek drainage system and is bound to the east by an earth dam and the other sides by diversion ditches redirecting the surface flow downstream. The dam, keyed into the underlying permafrost, consists of a geosynthetic clay liner installed with a compacted sand embankment. The original dam design required the construction of a 50 m tailings beach along the upstream face of the dam at the start of operations to provide the primary seepage barrier (Klohn Crippen Consultants Ltd, 1995). The designed beach was not installed until late into operation, after elevated pond water levels had occurred. This led to high seepage rates (by as much as an order of magnitude higher than that anticipated in the design), gradually thawing the frozen foundation permafrost soils. In response to physical stability concerns, the operator constructed a toe berm in 1997.

**Figure 1** Layout of the Mount Nansen Mine showing the location of the tailings impoundment relative to the open pit and local drainage systems
