Waste rock dump rehabilitation to a new level – Telfer WD13 constructed mesa landform

J.A. Mifsud *Care of Our Environment, Australia*

E. Ryan-Reid *Newcrest Mining Limited, Australia*

M. Wealleans *Newcrest Mining Limited, Australia*

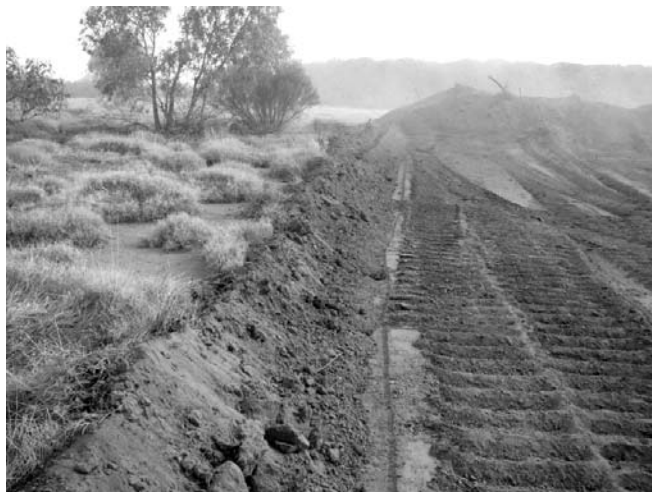
A D10 bulldozer was used to push the top 25 cm soil to a local stockpile within the surveyed toe into stockpiles (Figure 7). The intention was to harvest as much topsoil as possible with the least amount of

Figure 7 Topsoil harvesting

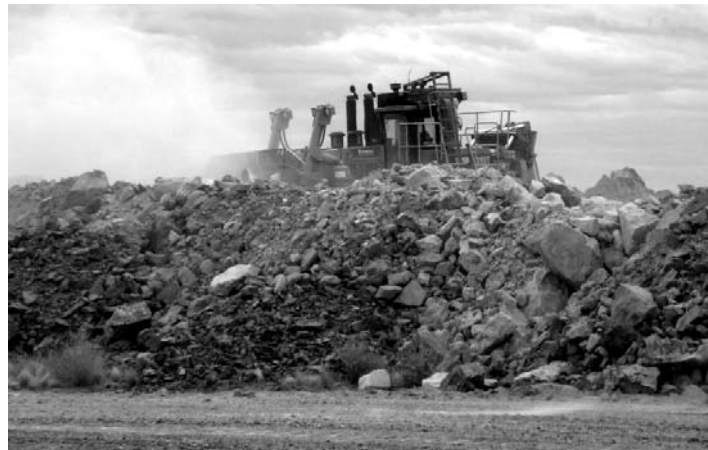
A D10 bulldozer was used to relocate waste rock that had been paddock dumped during mining operations (Figure 10). Very large rocks, some the size of a small car were relocated to the Pit 13 access ramp. The remainder were either placed strategically for later use as hummock material on the dump surface or incorporated in the perimeter bund.

Figure 10 D10 bulldozer used to push waste rock stockpiles

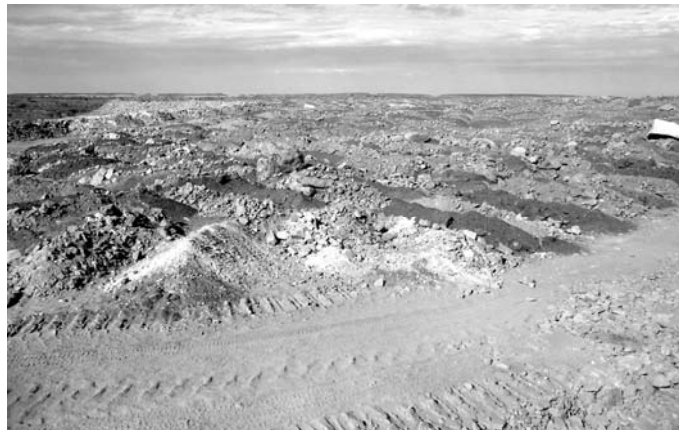
Loaders (988 and 966) were used to construct the soil and waste rock hummocks on top of WD13. The loaders and dump trucks worked efficiently together in constructing the hummocks to the design criteria. The hummocks were placed on the weed free surface fitting to the existing topography, Figure 13.

Figure 13 Surface soil and waste rock hummocks

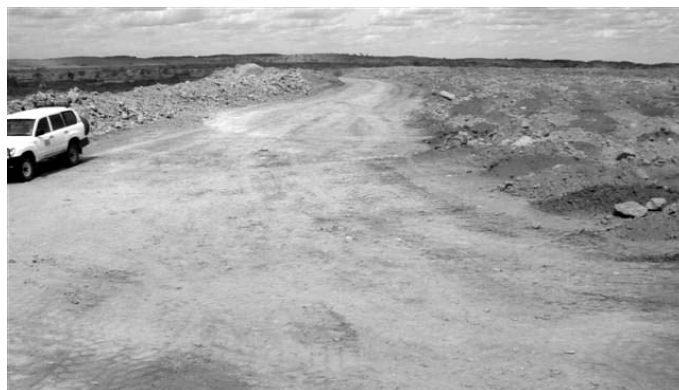
A 3 m wide access track with two turn-around points was built with a grader to allow access to Telfer personnel and contractors for site inspections and rehabilitation monitoring (Figure 14). The access track was built on the inside of the perimeter bund as shown in the construction plan. The track should allow access to light vehicles but is not suitable for trucks.

Figure 14 Access track turnaround point (between perimeter berm and hummocks)
