# Effective ground support system design to manage seismic hazard in a high stress diminishing pillar at a Vale mine

A.R. Punkkinen *Vale Limited, Canada*

N.R. Mamidi *Vale Limited, Canada*

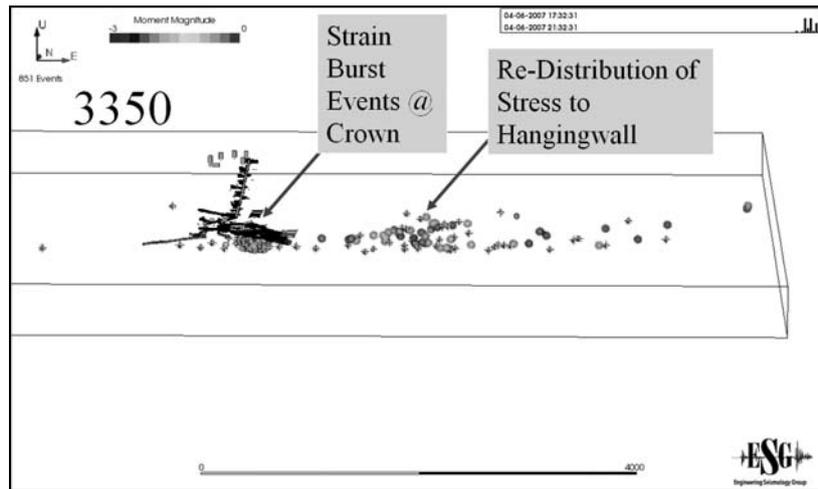
The influence of this dyke could be occasionally seen in the microseismic data. During extraction of stopes in the vicinity, it was apparent that the stiff dyke was a mechanism for re-distribution of stress along it into the hangingwall. Always occurring following strainbursting at an open panel, the majority of these events were found to be of a larger magnitude than the local strain events themselves (refer to Figures 3 and 4). This was particularly true with earlier stopes mined in the pillar, notably 7716 and 7776 Panels.

Figure 3 April 6, 2007 seismic activity following 3350–3540 Level, crown blast

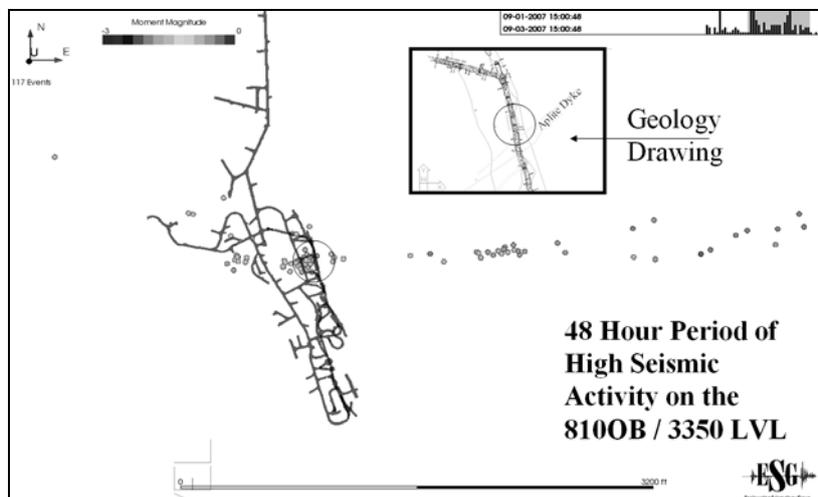
Figure 4 Sept. 1–3, 2007 seismicity during 3350–3540 Panel 7776 mining (not directly blast related)

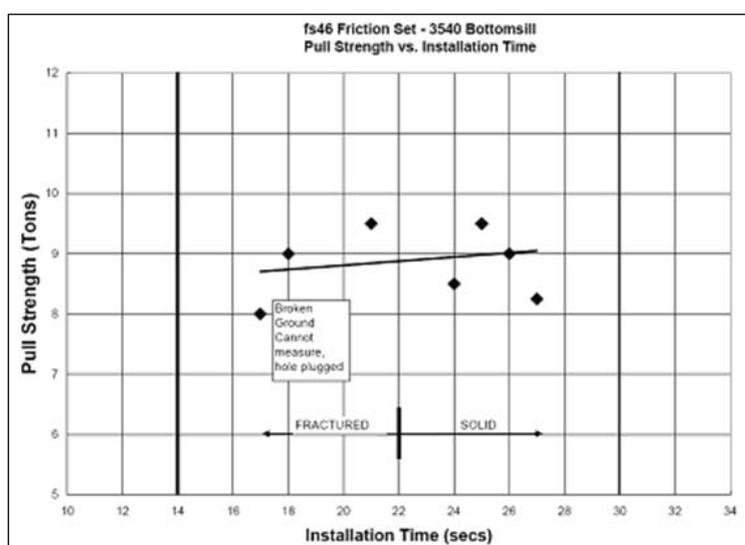
**Figure 5** Pull testing results of FS-46 bolts

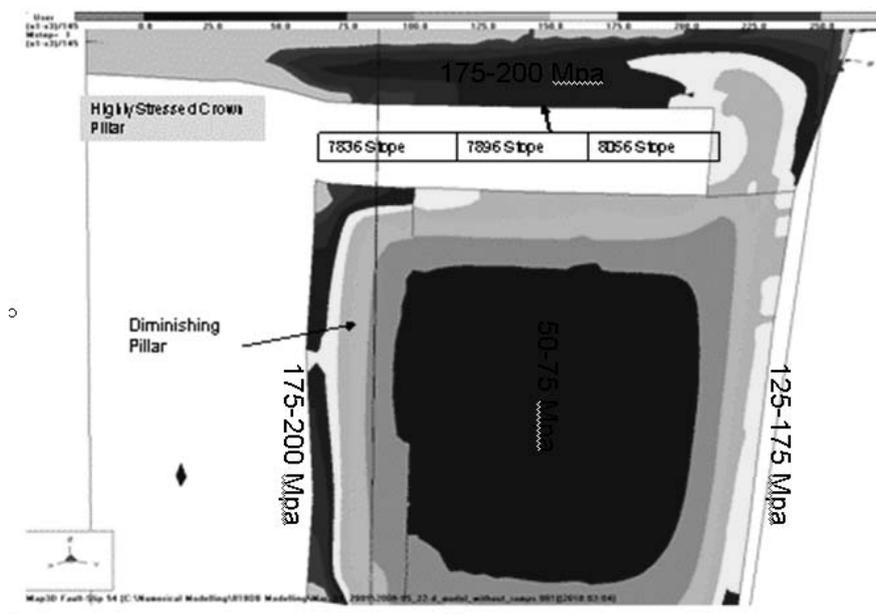
A deviatoric stress limit of 70% of the uniaxial compressive strength was used to indicate failure. An UCS value for the ore averages approximately 115 MPa, with surrounding Metasediments at 140 MPa. Stiff aplite dyke material can vary from 200–240 MPa and is most likely to burst violently when loaded to failure. Zones of high deviatoric stress, low confinement with large displacement can be identified as failed zones (refer to Figure 8 showing stresses prior to the extraction of 7896 Stope). For the ore zone, the failure zone is inferred at 80 MPa. Behaviour of the support was visually observed where large displacements were recorded by the instrumentation.

Figure 7 Deviatoric stresses ( $\sigma_1 - \sigma_3$ ) at diminishing pillar and crown pillar

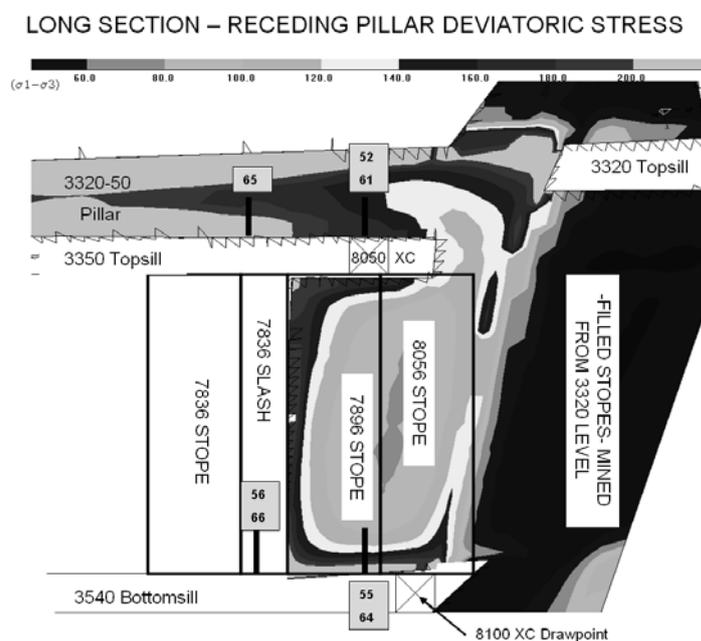
Two stopes (7836 and 7896) were extracted following the installation of the new support system and instrumentation (refer to Figures 8–10). All locations had a single DETECT MPBX and cable installed within one meter of each other to accurately measure and compare load versus displacement. Node/anchor locations were set up at 1.2, 2.4 and 3.6 m intervals for 3.6 m cables (3350 Level) and at 1.2, 2.7, 4.3 and 6.1 m for 6.1 m cables on 3540 Level. All instrumentation was recessed 0.5 m up into the borehole (+0.5 m to physical anchor locations). One DETECT cable on 3350 Level was destroyed from the onset, its twin, #65 (a 6.1 m, multi point borehole extensometer) could only be installed 4.4 m into a drill hole, three load meters remained operational inside the hole.

**Figure 8** Monitoring locations and deviatoric stress level ( $\sigma_1-\sigma_3$ ) at the final mining step

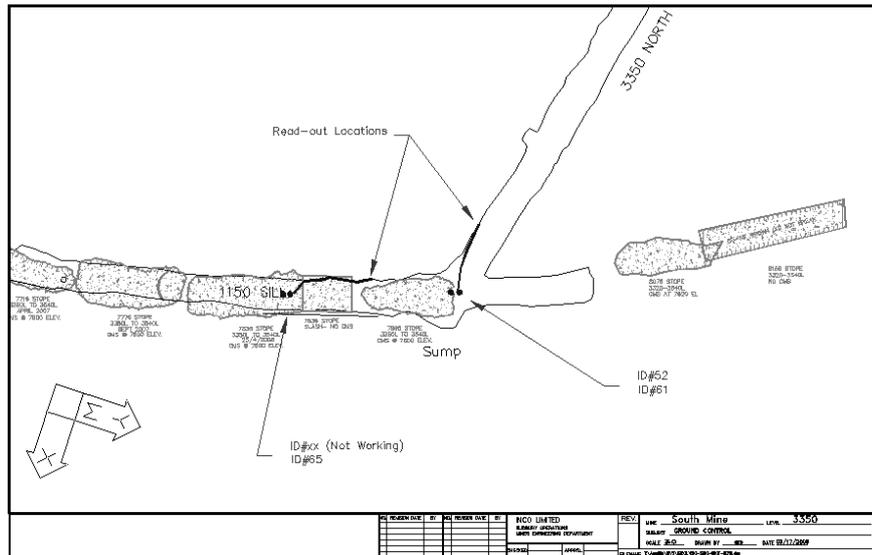
Figure 9 3350 topsill monitoring locations

An event registering a magnitude of 2.6 Mn occurred 13 March 2008 resulting in damage in the 3350 topsill area (refer to Figure 15 ‘topsill location’). The proper protocols and investigations were completed following this event. Most damage was observed in the walls of the topsill access drift. For a distance of approximately 40 m, shotcrete was observed as having peeled from both walls and cracked along the back, with increasing intensity to the sill drift intersection. This event resulted in damage to both mechanical as well as friction bolts at intermittent locations. The topsill had been reconditioned November 2007 to February 2008 with secondary support in the form of #4ga mesh installed with 2 m length, (fs46™) friction set bolts installed over arches and shotcrete and remained in good shape. The source location of the seismic event plotted within the stope. The stiff arch and enhanced yielding ground support system combination performed well.

Unfortunately, instrumentation had not yet been installed in the topsill area nearest the panel when the 2.6 Mn event occurred March 13, 2008. Only minor changes were recorded on the topsill location further away from the source location of the event. This in itself was interesting as most damage in the form of peeled shotcrete occurred beyond the panel area where screen had been installed over the shotcrete arches.

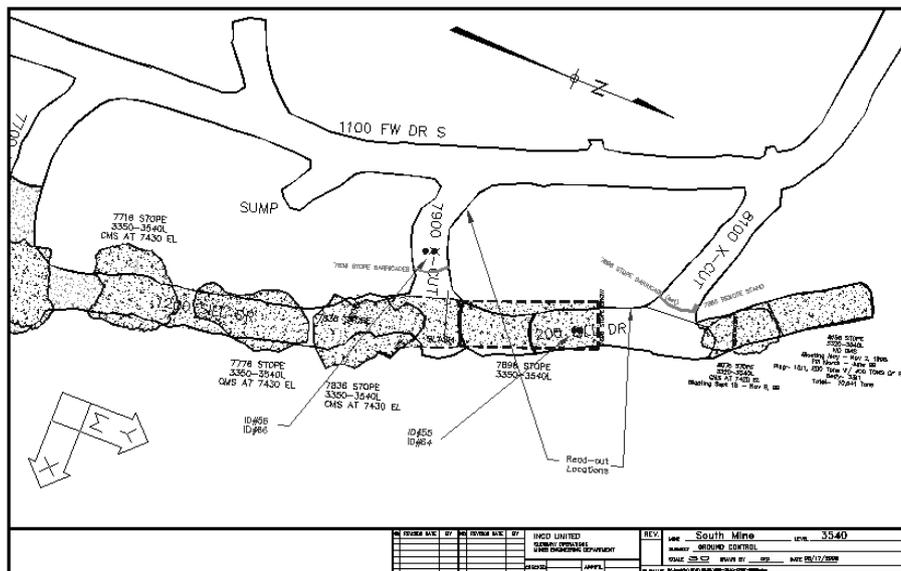
Figure 10 3540 bottomsill monitoring locations

The event resulted in a rockburst which destroyed MPBX #64 with displacement at the brow and wall corner at the bottomsill. By this point, the original arch-shaped bottomsill drift contour as shown in Figure 15 had extensively deformed (refer to Figure 16). Ground conditions were at a point that it was decided that the remaining ore in the stope was to be mucked out remotely from a safe location at the remote stand.

The majority of the displacement was from the brow itself. In essence, the brow burst into the unconfined opening of the stope. The yielding-over-stiff ground support system once again protected the opening from greater damage. Only the wall corner was rehabilitated, the brow area was left unsupported and remaining stope mucked out remotely from 15 m back.

With the first 7896 production blast in late 2008, MPBX #64, now situated two meters from the open stope, measured extensive displacement. All four readings increased to over 90 mm. The shotcrete under mesh was severely shattered and radial cracking of shotcrete could be observed with visual bulking of the back near the east shoulder. There was no damage to any of the (fs46™) friction set bolts. They were holding as per design, at this point, #4 gauge strands were squeezing under the face plates. The 2.6 Mn event occurred just as the stope approached crown position.
