# Performance of dynamic support system in highly burst-prone ground conditions at Vale' s Copper Cliff Mine - a case study

## Abstract

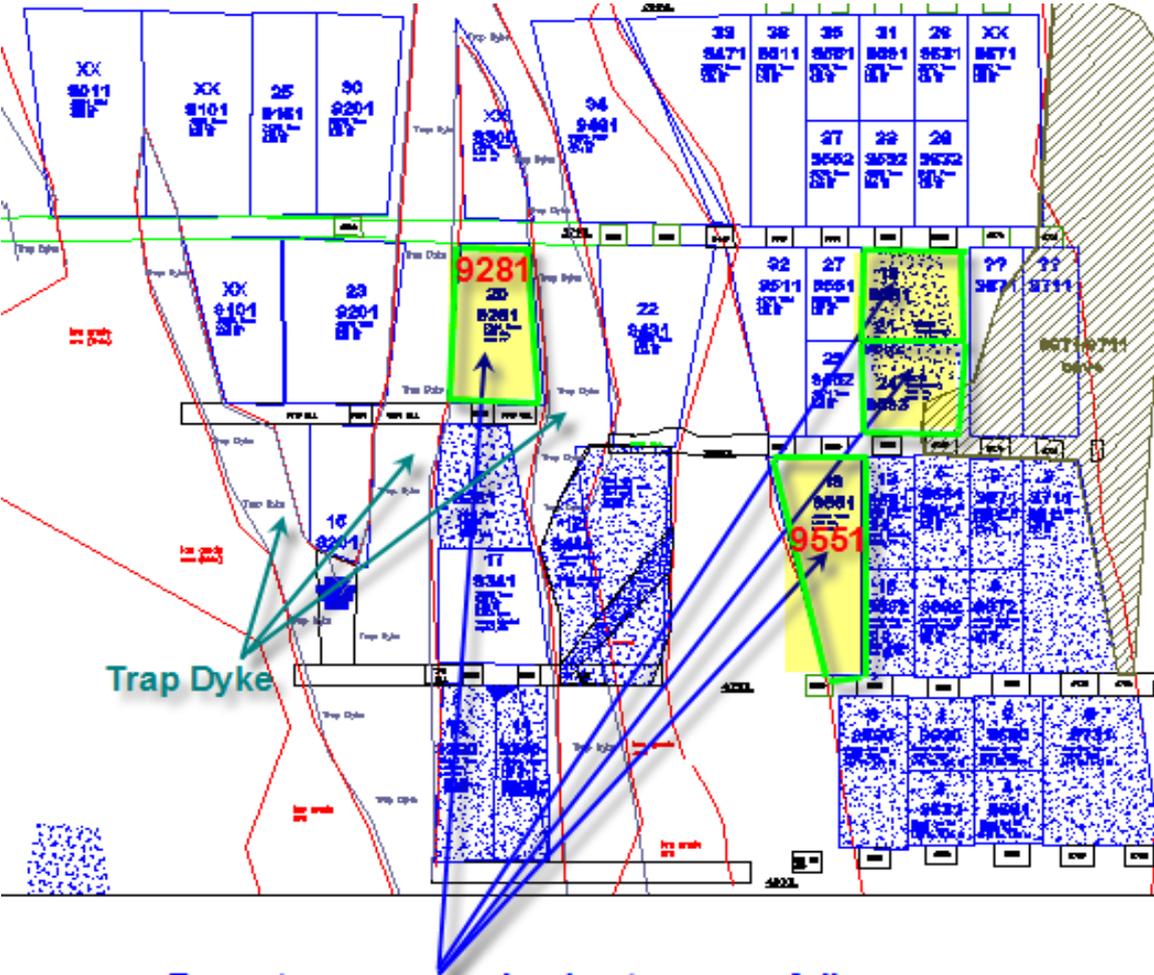
Figure 8 Long-section of the stopes mined after the 3.8 Mn event in the vicinity of Trap Dyke in the 100/900 OB at Copper Cliff Mine

After introducing the burst-resistant system at Copper Cliff Mine, mining in the 100/900 OB was resumed. Four stopes were mined out successfully without any significant damage. The stopes that were mined out in the vicinity of Trap Dyke these were the i.e. burst-prone ground conditions in the 100 and 900 orebodies and are shown in Figure 8.

**Four stopes were mined out successfully after introducing the dynamic support system in the 100/900 ore body.**
