Cockatoo Island stage 3: seawall failure and remediation

P.K. Wong *Coffey Geotechnics Pty Ltd, Australia*

Abstract

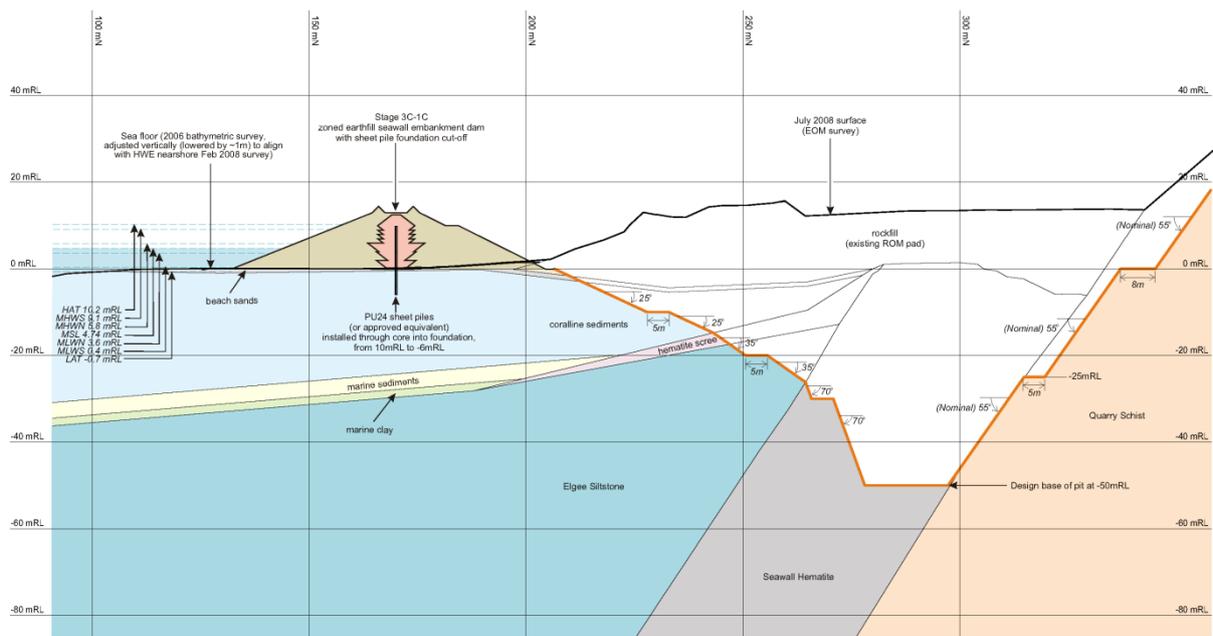
Figure 2 Geological section and proposed seawall and mining profile

The site of the seawall was located about 50 m offshore, which had a seabed level at approximately RL 0 m Cockatoo Island Data (CID). The site was underlain mainly by a thick (20 to 30 m) layer of soft coralline sediment (silty clay with coral nodules) beneath a thin (1 to 2 m) layer of beach sand and coral debris as shown in Figure 2. The coralline sediment has the behaviour of soft clay, having relatively low permeability, with its thickness increasing seawards. The coralline sediment was underlain by marine sediments or hematite scree layer (landward side); these layers have higher permeability than the overlying coralline sediment, and were originally expected to provide basal drainage during the consolidation process (see Section 3 for further discussions). An important aspect of the site was that it has a maximum tidal range of about 11 m ranging from RL 0 to 11 m.

The original seawall design comprised a rockfill embankment with armour rock on the seaward batter and a central clay core. However, due to the lack of suitable material on site that would meet the core specification, a steel sheetpile was designed to be installed along the central core centreline when the embankment construction reached RL 10 m. The embankment had design batters of 2.5H:1V on the seawards side and 2H:1V on the landward side, with staged construction to allow consolidation of the underlying soft coralline sediment, and sufficient strength gain in the foundation to maintain stability during construction. The position of the seawall was driven by a limited offshore lease boundary which governed the seaward toe extent, and the need to minimise the footprint on the landward side to enable maximum extraction of the hematite ore. Whilst embankment stability during construction was important, long-term stability of the seawall was just as critical because the seawall eventually formed the barrier against the ocean to enable open pit mining to be conducted safely to RL -50 m. Factors of Safety of 1.3 and 1.5 were chosen as design values for the construction case and long-term case respectively. A typical geological profile of the site, proposed geometry of the seawall and the proposed mining operation is presented in Figure 2.

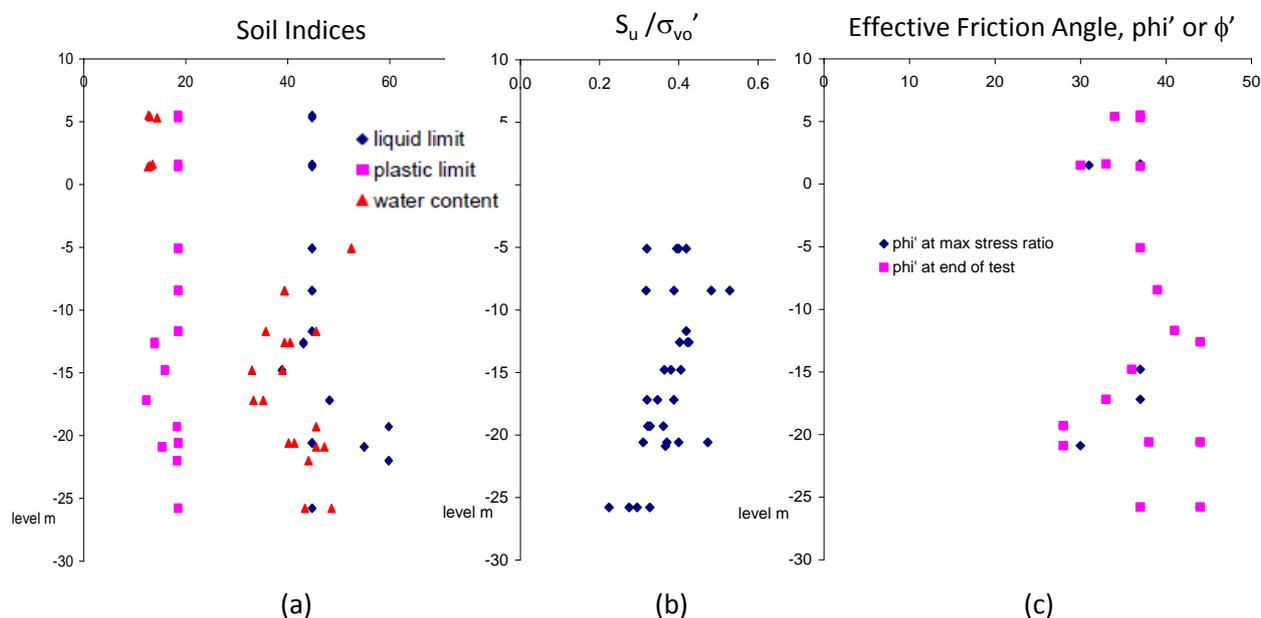
Figure 6 (a) soil indices; (b) S_u/σ_{vo}' ratios; (c) effective friction angle

Results of soil indices and measured ratios of undrained shear strength to in-situ vertical effective stress (S_u/σ_{v0}'), from laboratory staged triaxial consolidated undrained tests with pore pressure measurements, are presented in Figures 6(a) and (b) respectively. The test results above RL 0 m represent the placed core material while those below RL -5 m represent the coralline sediment. Figure 6(a) shows the in-situ moisture content of the coralline sediment to be generally close to the Liquid Limit (typically 45 to 60%). Figure 6(b) shows a reduction of S_u/σ_{v0}' from about 0.4 near the top of the coralline sediment layer, to about 0.25 at the bottom of the layer. The reduction of S_u/σ_{v0}' ratio with depth was inferred to be indicative of

over-consolidation near the top of the layer, and reaching a normally consolidated state at the base of the layer.

The measured friction angles from the staged triaxial tests are shown in Figure 6(c), showing friction angles typically more than 35° with the occasional test results between 27° and 30° for the coralline sediment.

These results are somewhat lower than the pre-failure investigation results shown in Figure 6(c). It is not clear whether the difference is caused by strain softening effects, or natural variability in the coralline sediment. To be prudent, it was decided to adopt a friction angle of 29° for the coralline sediment prior to

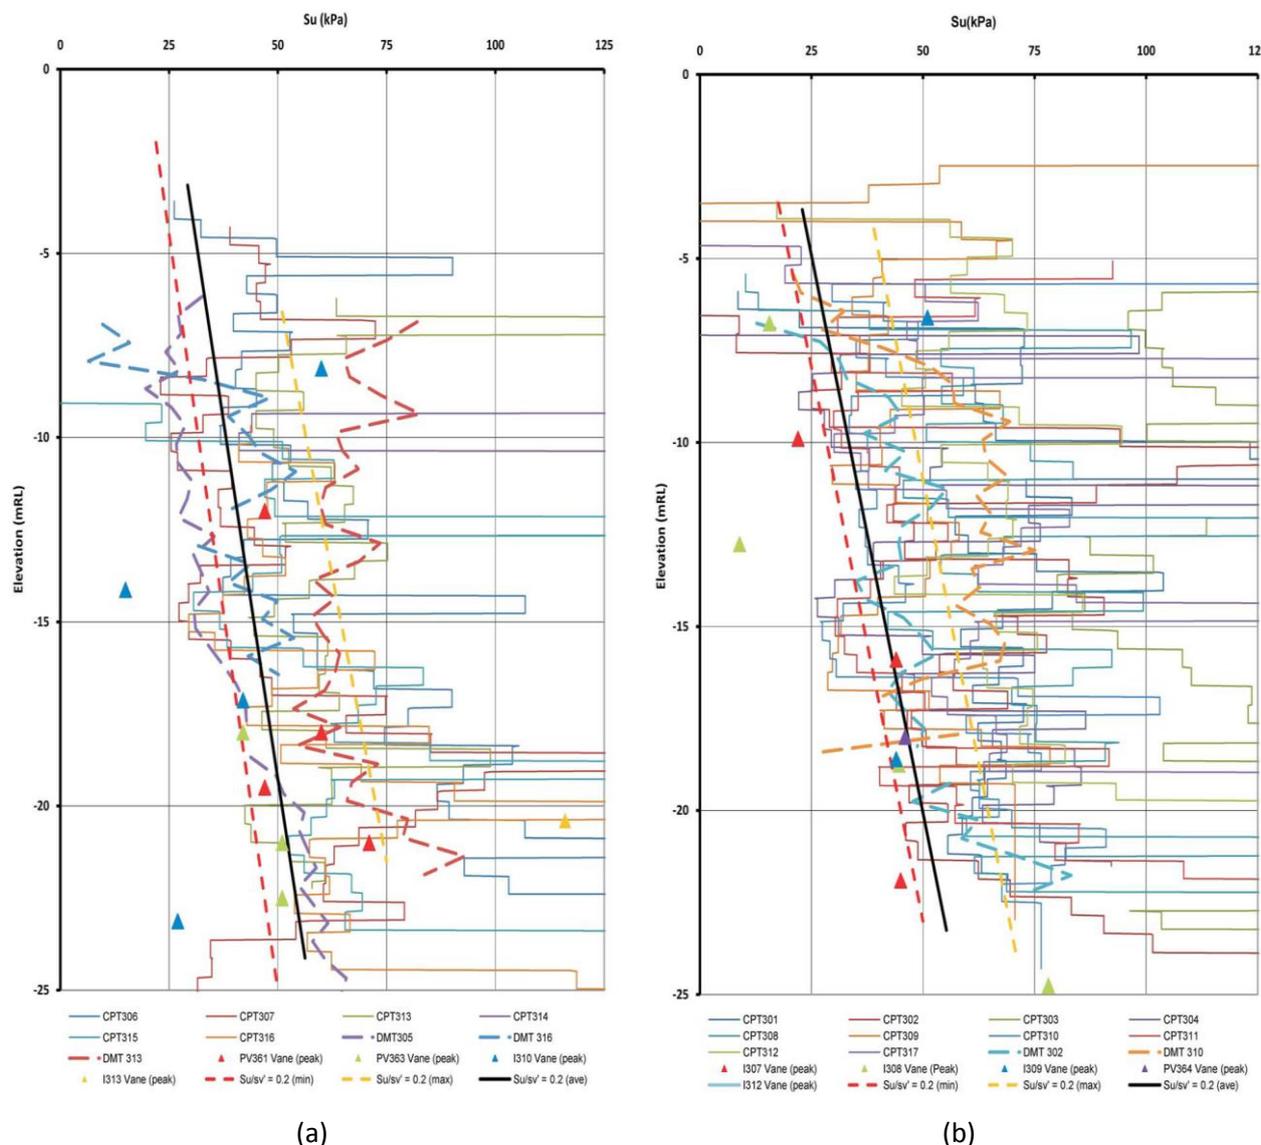
Figure 8 (a) measured S_u profile (failed area); (b) measured S_u profile (outside failed area)

Undrained shear strengths of the coralline sediments were measured from CPT and DMT tests with calibration using the vane shear test results as shown in Figure 8. There is a considerable scatter of results, with the areas outside the failed area having several (CPT interpreted) S_u profiles that are higher than those within the failed area. This may be partly attributed to variability in material properties, but may also be attributed to some of the areas outside the failed area having different drainage properties and thus having experienced a greater degree of consolidation than within the failed area (see Section 4.2). However, there is little difference in the measured vane shear strength results at the lower range of

measured results. Therefore, when the embankment was of sufficient height to cause the coralline sediments to become normally consolidated, a common S_u/σ_{vo}' ratio of 0.2 was adopted for the remedial works design. This ratio is consistent with the value of 0.21 quoted by Mesri (1975) and 0.21 ± 0.015 (for Plasticity Index >20%) quoted by Ladd and DeGroot (2003).

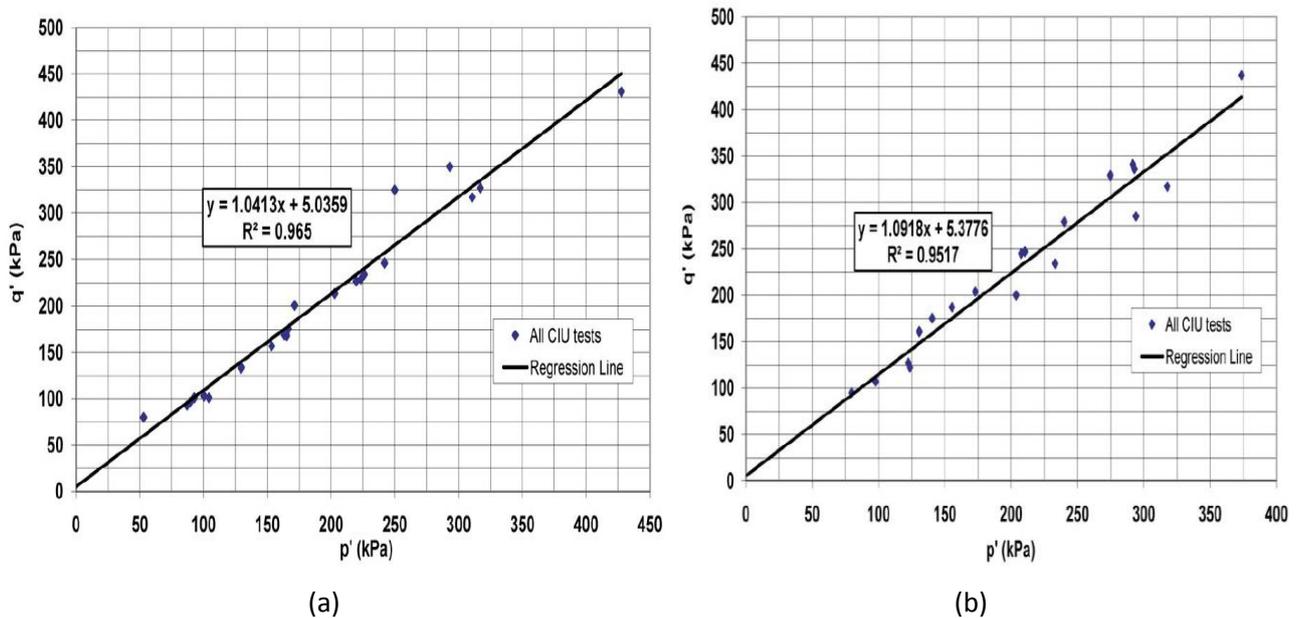
Figure 9 (a) p' - q' plots (failed area); (b) p' - q' plots (outside failed area)

Cambridge p' - q plots of CIU test results from samples recovered from within and outside of the failed area are presented in Figure 9. The lines of best fit to the data in Figure 9 result in a low cohesion. If it is assumed that the cohesion is zero, and the lines are drawn through zero, the effective friction angle, ϕ' becomes 23 to 32° for individual tests and an average of 29° when the two sets of tests were combined. The three K_0 CIU tests gave an average effective friction angle of 30.9°.

failure and outside the failed area. Within the failed area, a reduced residual friction angle of 25° was assessed using the methodology described in Khalili et al. (1996).
