Slope stabilisation program at West Gully, PT Freeport Indonesia

Abstract

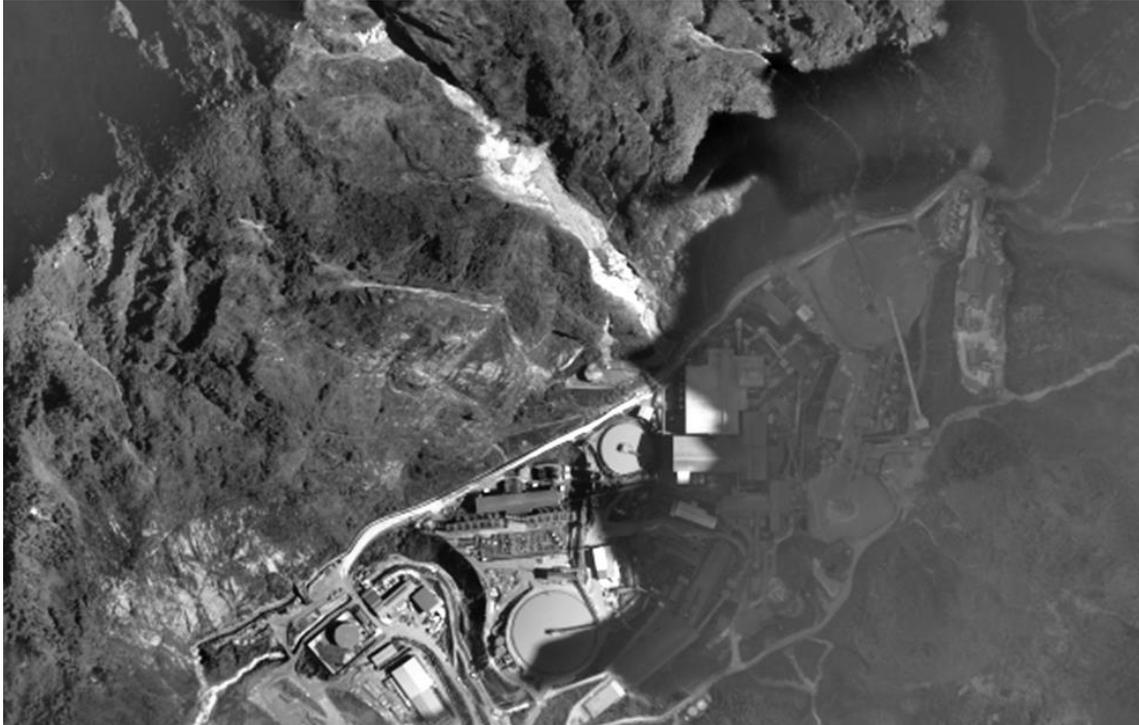
Figure 1 Plan view of Mile 74 area, location of critical infrastructures as mill processing plant, maintenance shops, offices, and power plant (LiDAR image taken 2012)

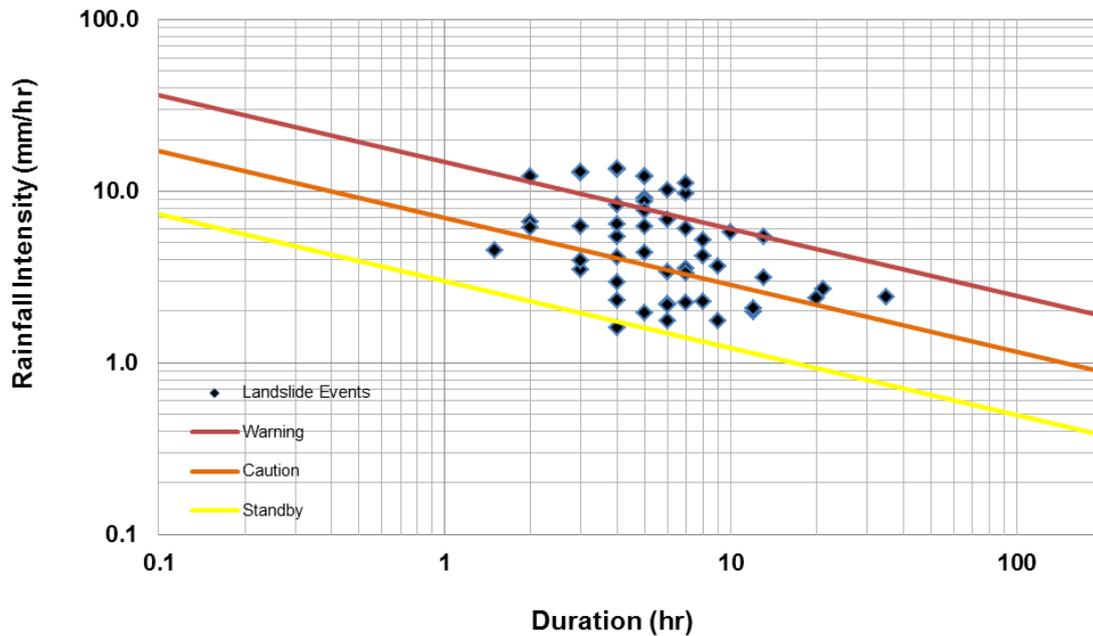
Figure 9 The rainfall intensity – duration control for the highland area PT Freeport Indonesia

It is obvious that rainfall has a significant role in the rockfall events or failures within this area, so its effect needs to be quantified. Referring to Caine (1980), the rainfall intensity – duration control for shallow landslides and the debris flows thresholds for highland areas were developed as practical working criteria. (Figure 9). The critical rainfall threshold is 14 mm/hour and 96 mm/24 hours, and to increase safety lower thresholds were adopted as working criteria, i.e. 12 mm/hour and 30 mm/24 hours.

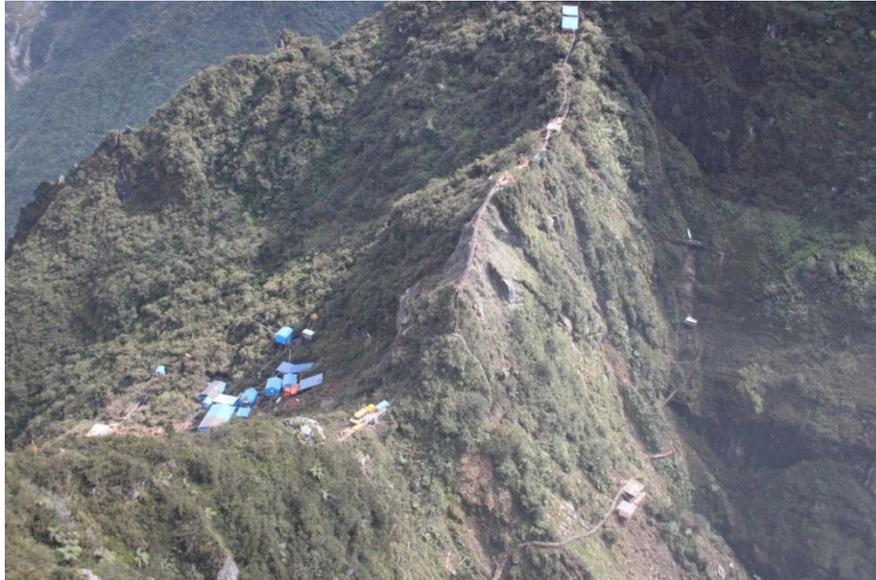
Figure 10 Camp facilities at the other side of West Gully to support the rockfall risk mitigation project

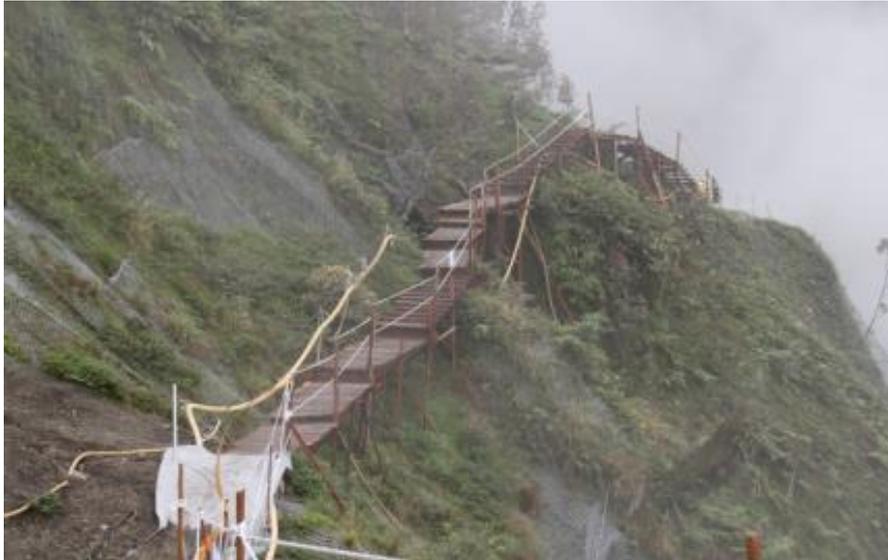
Figure 11 Walkways are a safety initiatives to reduce the risk of accidents and speed up mobilisation time to 15%

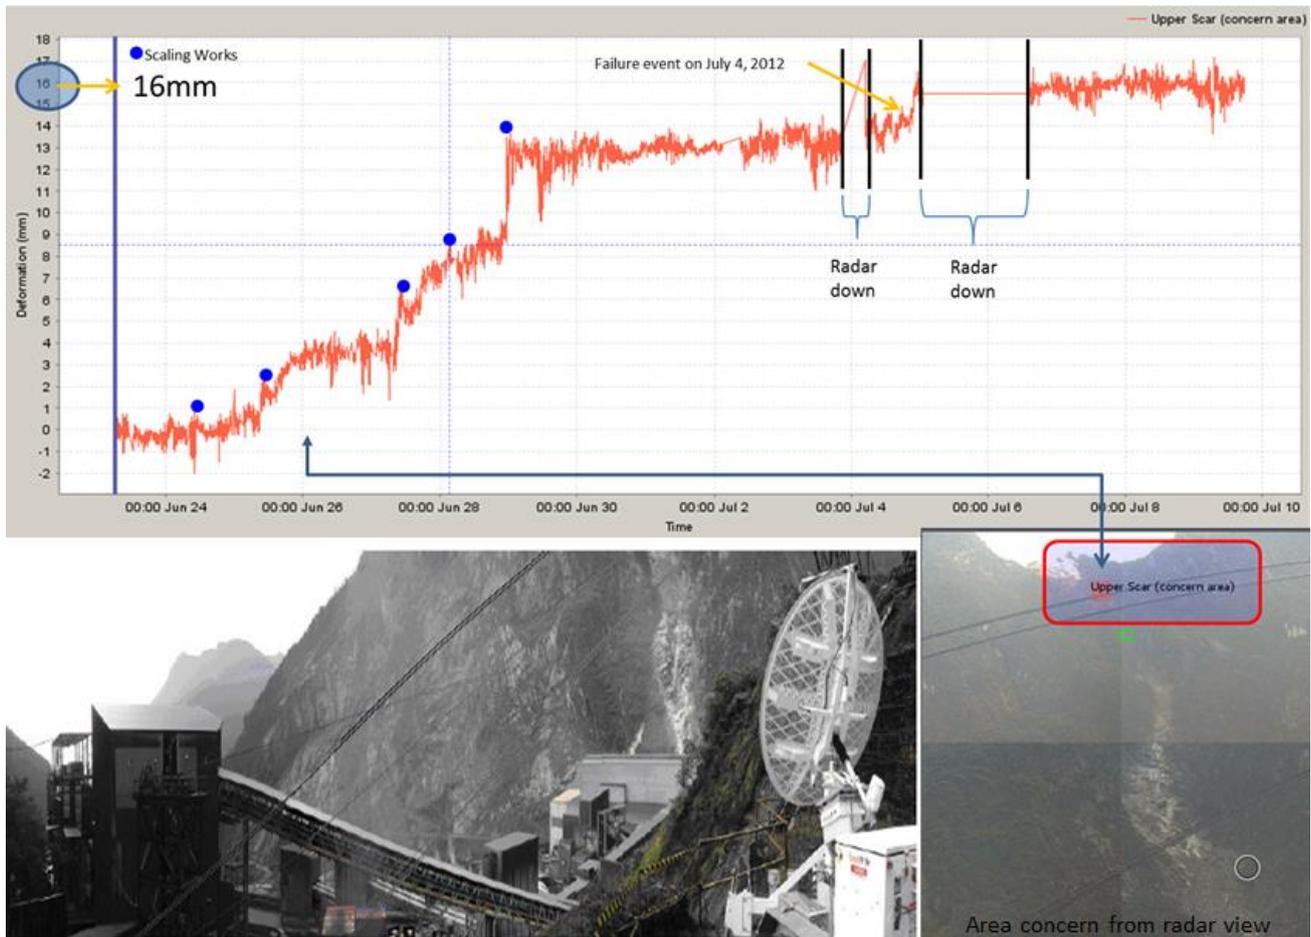
Geotechnical monitoring is critical to provide early warning to workers of instability issues in this area. For this purpose two radars monitoring devices were deployed to monitor the main problem area (Figure 12).

Figure 12 Dedicated radar monitoring to monitor the West Gully slope
