# Short-term solutions to squeezing ground at Agnew Gold Mine, Western Australia

## Abstract

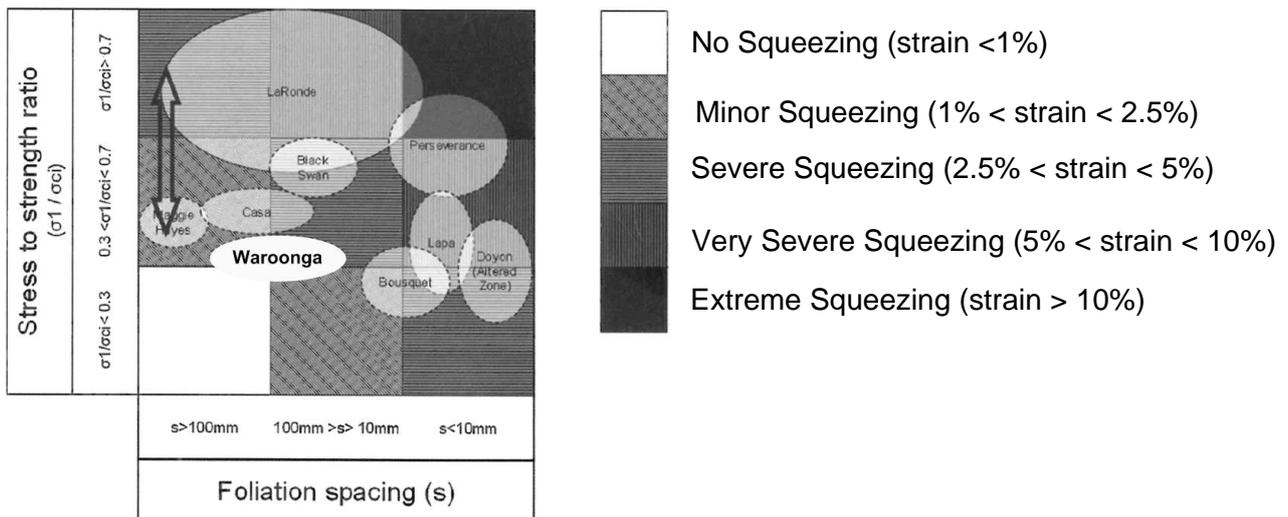
Figure 1 Squeezing potential of Waroonga underground complex after Mercier-Langevin and Hadjigeorgiou (2011)

Historically Lode 1 has experienced problems associated with squeezing ground, with Mercier-Langevin and Hadjigeorgiou (2011) placing the operation within the minor to severe squeezing range of the hard rock squeezing ground index (Figure 1). No significant deformation/squeezing ground has been observed during mining between 2008 and 2013.

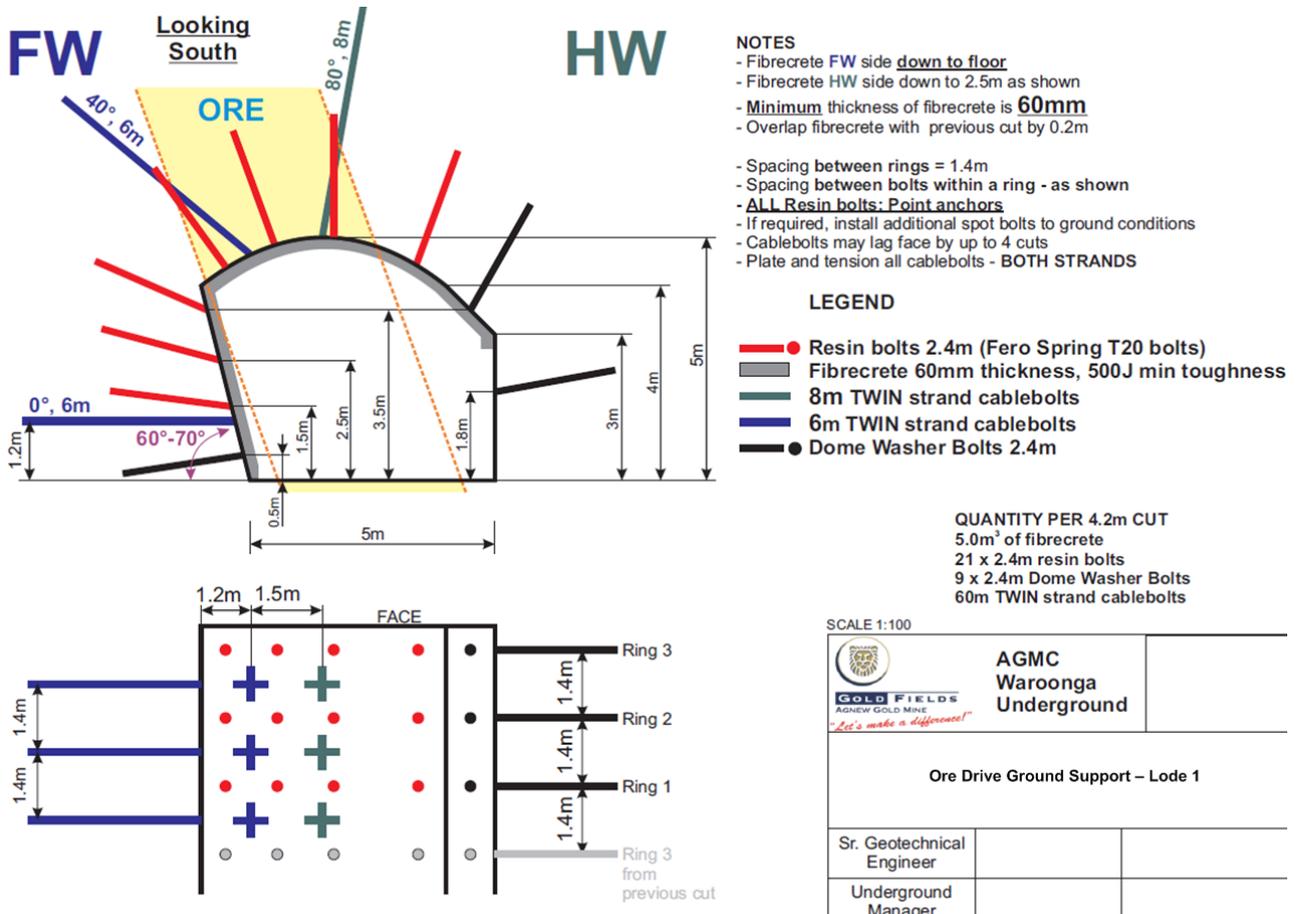
Figure 2 Lode 1 ore drive ground support

Primary ground support in ore drives consists of 60 mm of high toughness fibrecrete (FC) applied from the FW floor to  $\approx 2.5$  m above HW floor, pinned with a combination of 2.4 m resin bolts and friction stabilisers. Secondary support consists of six 6 m and three 8 m cable bolts per cut installed on a four cut lag with the development face (Figure 2).

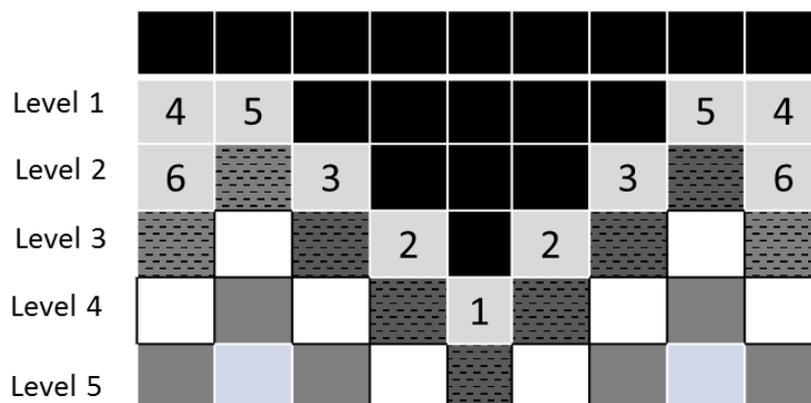
Figure 3 M front schematic

During 2014, Lode 1 transitioned from a V mining front to an M, or inverted double V, mining front (Figure 3); no deviation from expected ground conditions was observed during transition. When

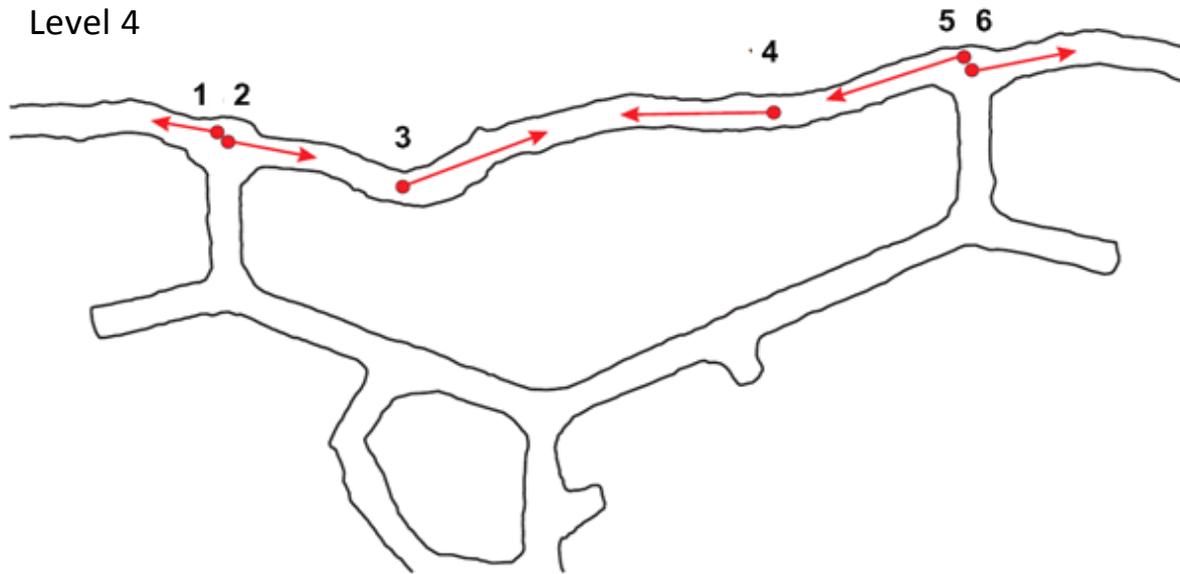
Figure 8 Illustrative photo monitoring locations

Photo monitoring stations were set up in each of the effected levels at strategic locations (Figure 8) and have proved to be a useful tool in tracking visible deformation and changes in profile. Photo monitoring has proved valuable in areas which have gone through initial deformation and been rehabilitated (Figures 9 and 10) in allowing each activity stage to be documented from set locations. It has also proved a useful visual tool when communicating changing conditions and hazards to underground personnel.

However, problems have been encountered in obtaining consistent picture quality and in maintaining exact locations as deterioration means wall markings have been obscured/destroyed. In order for photo monitoring to be more than a visual tool/tracking system, equipment capable of producing images for use
