# Capping of a surface slurried coal tailings storage facility

DJ Williams *The University of Queensland, Australia*

G King *New Acland Operations, Australia*

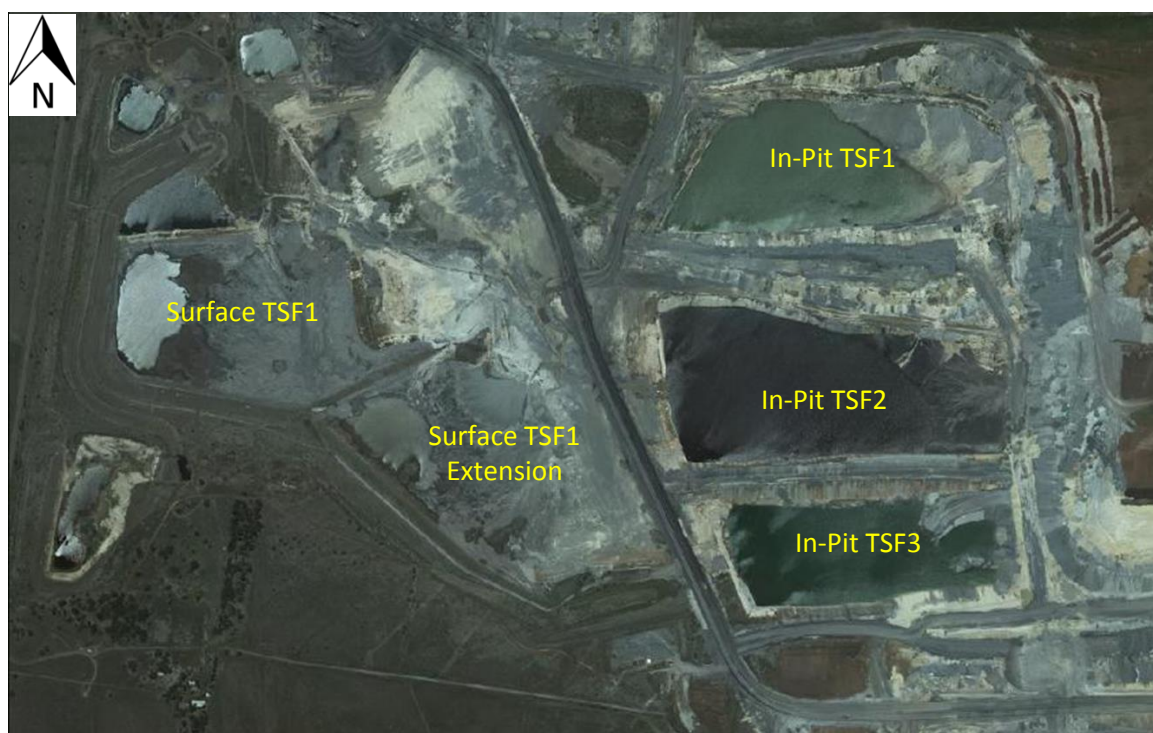
Figure 1 New Acland surface and in-pit TSFs (aerial photograph taken on 12 March 2013)

Sometime after the cessation of tailings deposition, following surface crusting, spoil was dumped from haul trucks into the surface TSF from the northern and eastern upper tailings beach. However, this resulted in bow-waving of the crusted tailings. Spoil placement was stopped when a 1 to 1.5 m high bow-wave overtopped the bund dividing TSF1 from TSF1 Extension, and approached the southern external wall of TSF1. Subsequently, New Acland committed to more effectively capping the surface TSF.

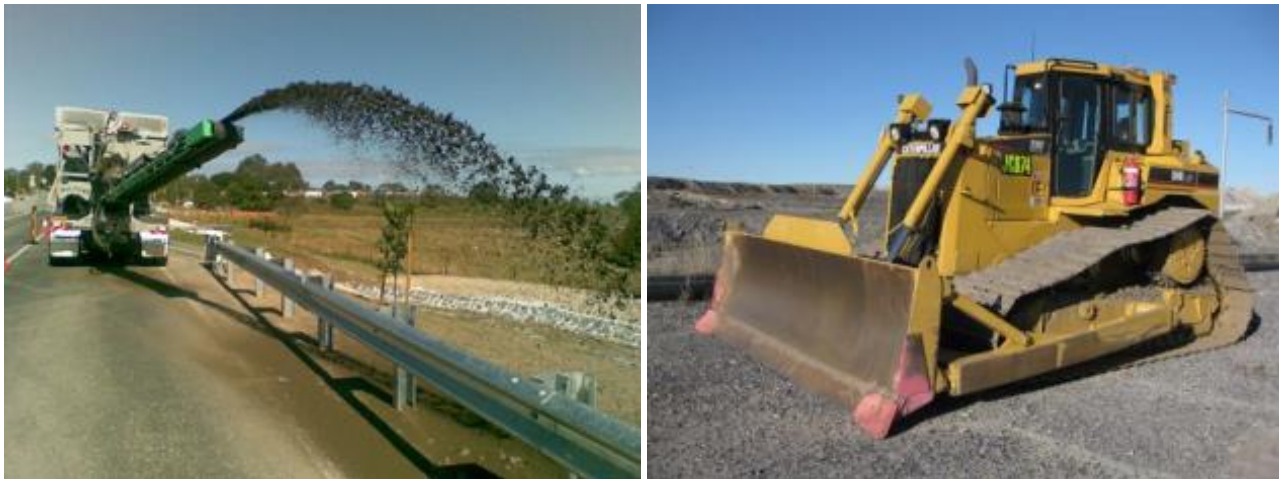
- Placement of coarse reject hydraulically which was dismissed due to the infrastructure required.
- Placement of coarse reject by a Rockslinger (Figure 2(a)), which was trialled and found to have insufficient reach. Also, the Rockslinger would have to operate from the southern embankment crest of the TSF which was considered too narrow for safe operation.
- Pushing coarse reject by D6 Swamp Dozer which was adopted (Figure 2(b)).

Figure 2 Alternative capping methods: (a) Rockslinger, and (b) D6 Swamp Dozer

The D6 Swamp Dozer (Model CAT D6R III LGP, with an operating mass of 21.7 t) exerts an average track bearing pressure of 35 kPa, equivalent in bearing pressure to about 1 m height of fill. This needs to be taken into account in addition to the height of fill placed, to ensure safe operation on the crusted tailings.

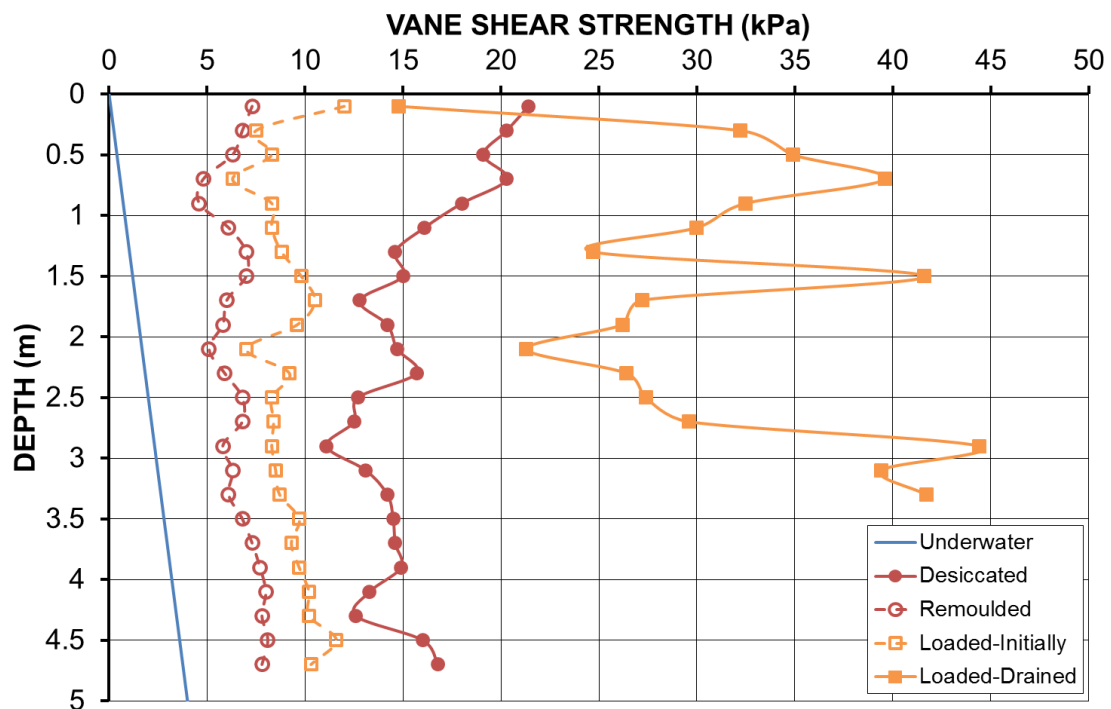
Equation (1) assumes that the vane scribes a cylinder, with uniform stresses generated on its vertical sides, reducing to zero at the axis of rotation of the vane. Figure 3 shows a number of shear strength profiles with depth measured by the first author in crusted coal tailings at Ulan Coal Mine in New South Wales. The underwater profile represents consolidation of the coal tailings due to their self-weight alone (based on their low specific gravity of about 1.8), assuming that the tailings always remain underwater. Self-weight consolidation of the coal tailings results in a liner increase in shear strength of about 0.8 kPa/m depth.

Figure 3 Vane shear strength profiles with depth for Ulan coal tailings

The measured desiccated profile represents the peak vane shear strengths obtained on initial shearing using the vane, and shows a number of remnant crusts on intermediate layers of tailings that were exposed and underwent desiccation. Note that desiccation due to solar and wind drying drops off exponentially with depth and has little effect below about 1 m depth. The subsequent deposition of fresh tailings on these desiccated crusts caused some reversal in their shear strength. Overall, the desiccated profile has a peak vane shear strength averaging about 15 kPa. The measured remoulded profile represents corresponding remoulded vane shear strengths obtained after several revolutions of the vane, which average less than

half the peak values. The remoulded profile corresponds to the shear strength available should a bow-wave be initiated due to rapid overloading of the crusted tailings.

The loaded-initially profile was measured within 12 hours of a 4 to 5 m high layer of spoil being placed on the desiccated tailings (Figure 4), which caused remoulding of the tailings accompanied by the formation of a bow-wave, and a drop in vane shear strength towards the previous remoulded profile. The loaded-drained profile was measured about one week after spoil placement, and shows a dramatic increase in the peak vane shear strength to an average about 30 kPa, twice the desiccated profile and over four times the remoulded profile. In the loaded-drained profile, the drop in shear strength towards the surface is due to the desiccated near-surface tailings having a much-reduced (unsaturated) hydraulic conductivity than the near-saturated and less consolidated tailings at depth. Hence, the near-surface tailings are incapable of draining the excess pore water pressures from the more permeable tailings at depth, and they wet-up and soften somewhat (Figure 3).

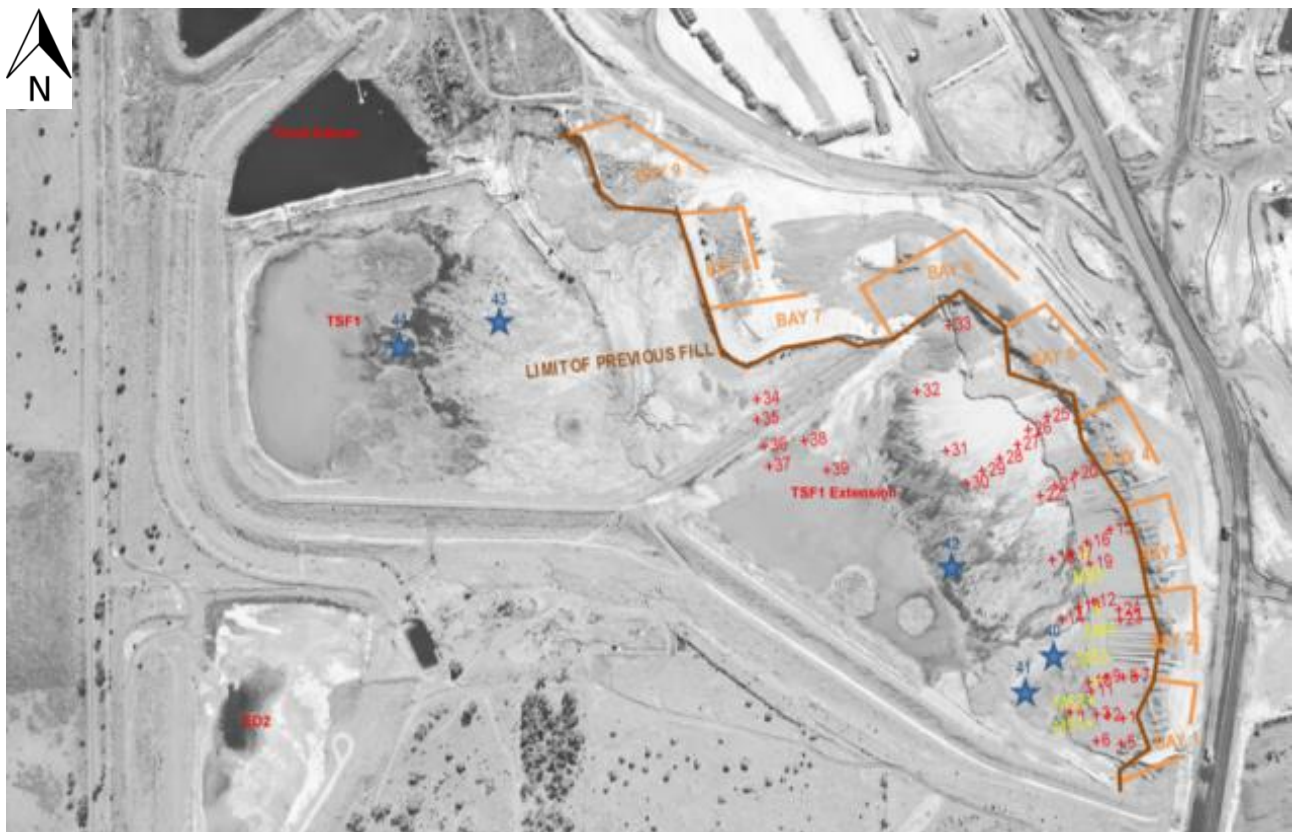
The locations of the initial vane shear tests carried out in early May 2012 are shown in Figure 6, with the locations of all vane shear tests carried out in three stages from May to October 2012 shown in Figure 7, which are mainly confined to the more accessible parts of TSF1 Extension. Figure 6 shows the raised crest of the old bow-wave, which was induced by the previous capping using spoil dumped from haul trucks, the nearby southern reeds, and the northern reeds and pond. The peak and remoulded vane shear strength profiles with depth corresponding to the locations shown in Figure 6 are presented in Figure 8.

Figure 7 Vane shear test locations in three stages from May to October 2012 (+ \* ★)

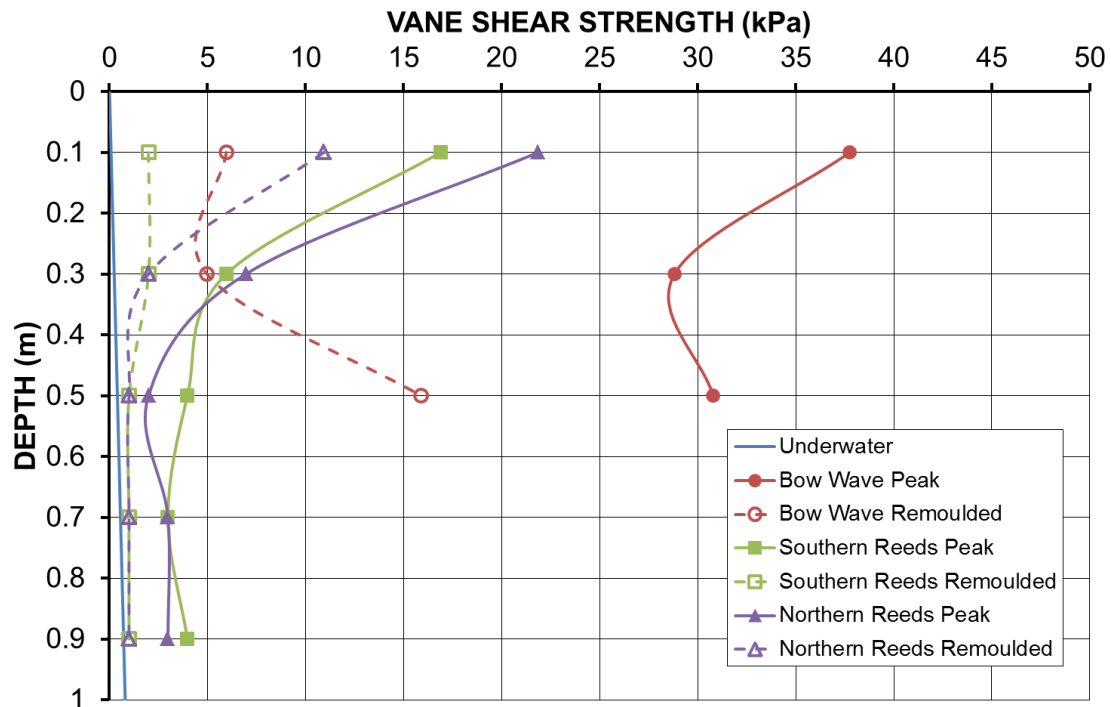
Figure 8 Selected peak and remoulded vane shear strength profiles with depth

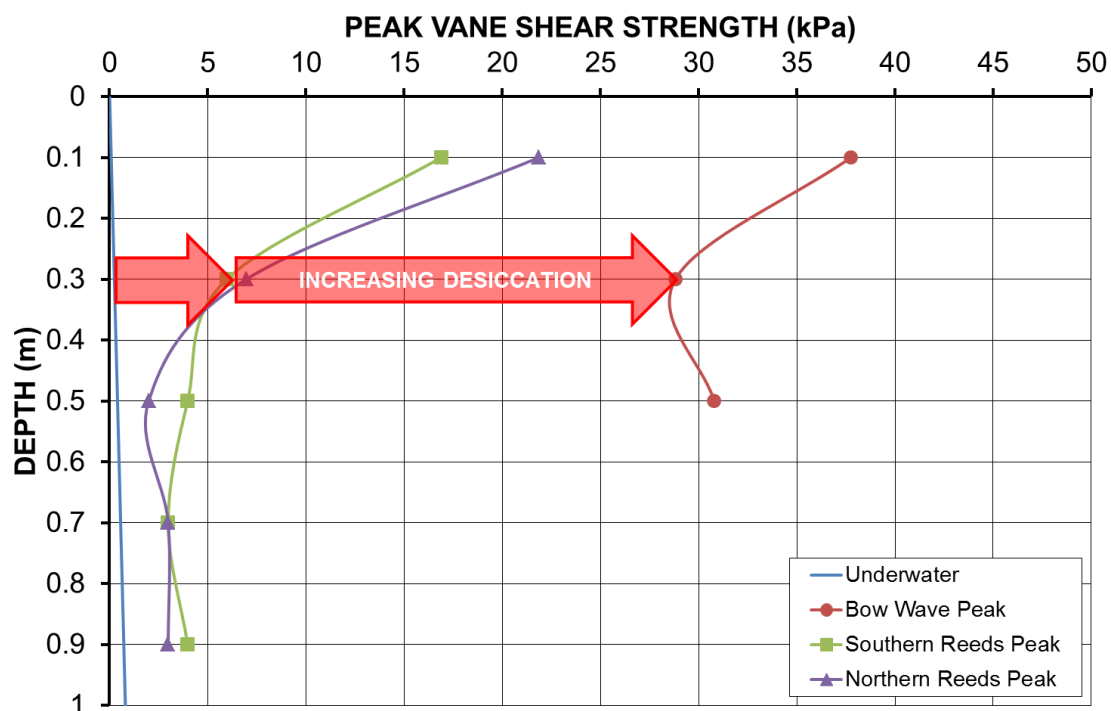
The effects of increasing desiccation from the underwater (never-desiccated) state on the peak vane shear strength profiles are presented in Figure 9. The safe fill heights corresponding to the peak vane shear strength profiles in Figure 9, estimated using Equation (2), are presented in Figure 10. Note that the underwater case cannot support the D6 Swamp Dozer or any fill, and is not included. Clearly, the well and deeply-desiccated old bow-wave areas would readily support fill placed by a D6 Swamp Dozer, while the thin surface crust at the northern and southern reeds would struggle to support the D6 Swamp Dozer and any fill it pushes, and surcharging from the edge of this area would be required to drain and increase the shear strength of the tailings at depth.

Figure 9 Effects on peak vane shear strength of increasing desiccation

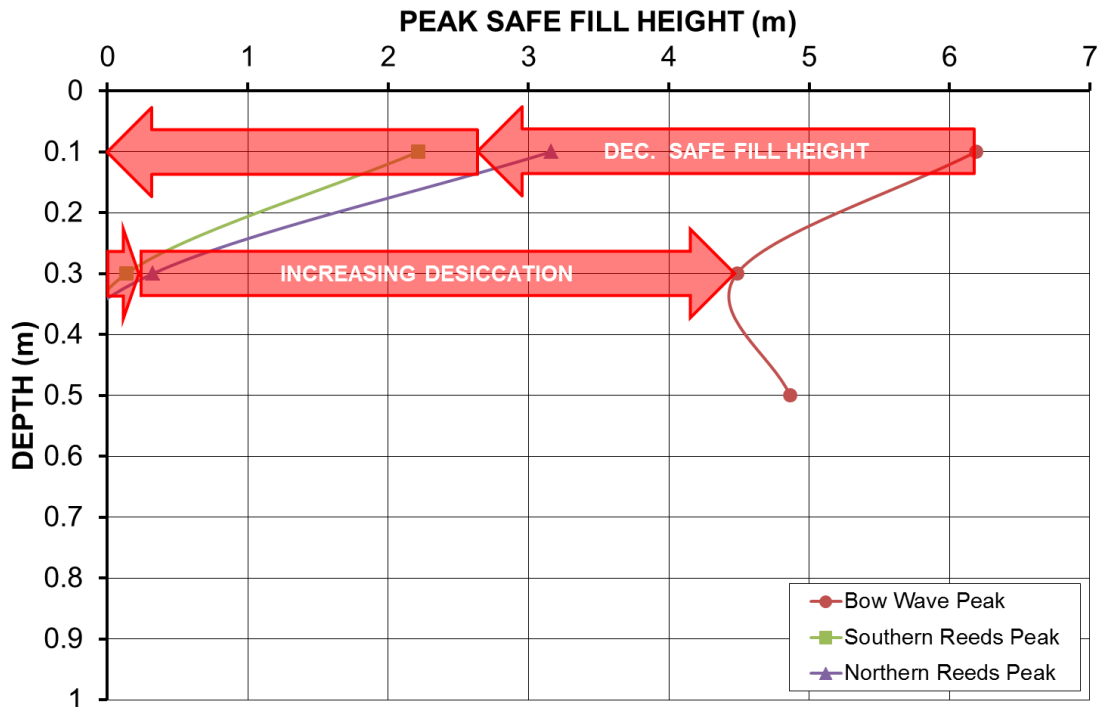
Figure 10 Safe fill height corresponding to peak vane shear strength profiles

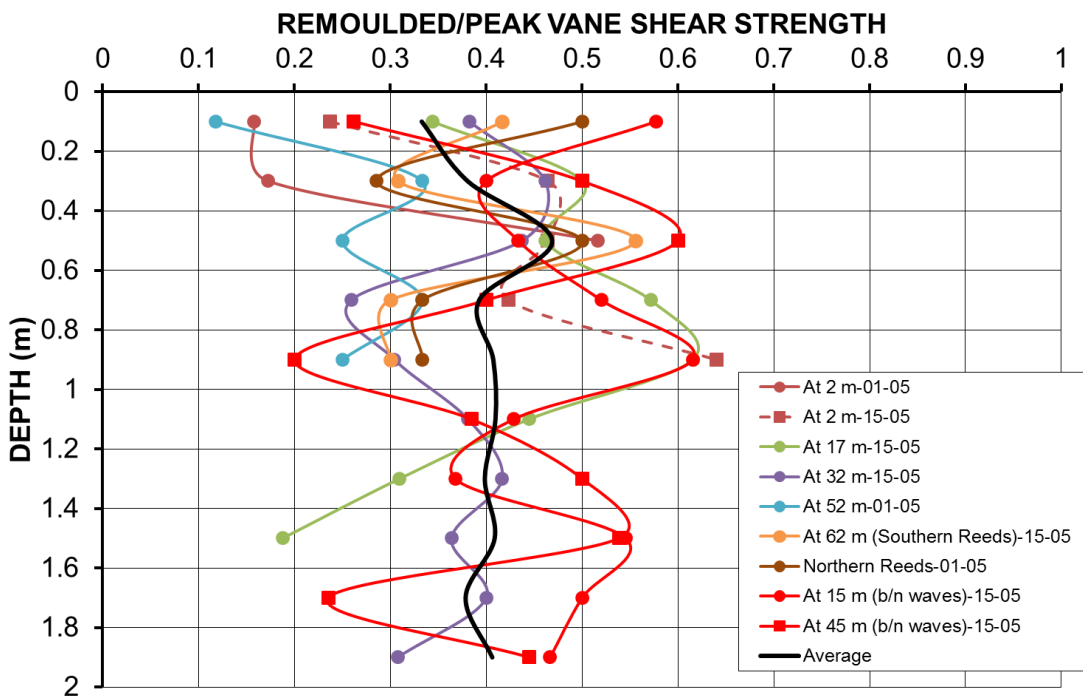
Typical ratios of the remoulded to the peak vane shear strength of tailings with depth are shown in Figure 11, indicating an average ratio of about 0.4, translating to a 60% reduction in tailings shear strength, and hence bearing capacity, should remoulding and bow-waving be induced.

Figure 11 Typical ratios of remoulded to peak vane shear strength of tailings with depth

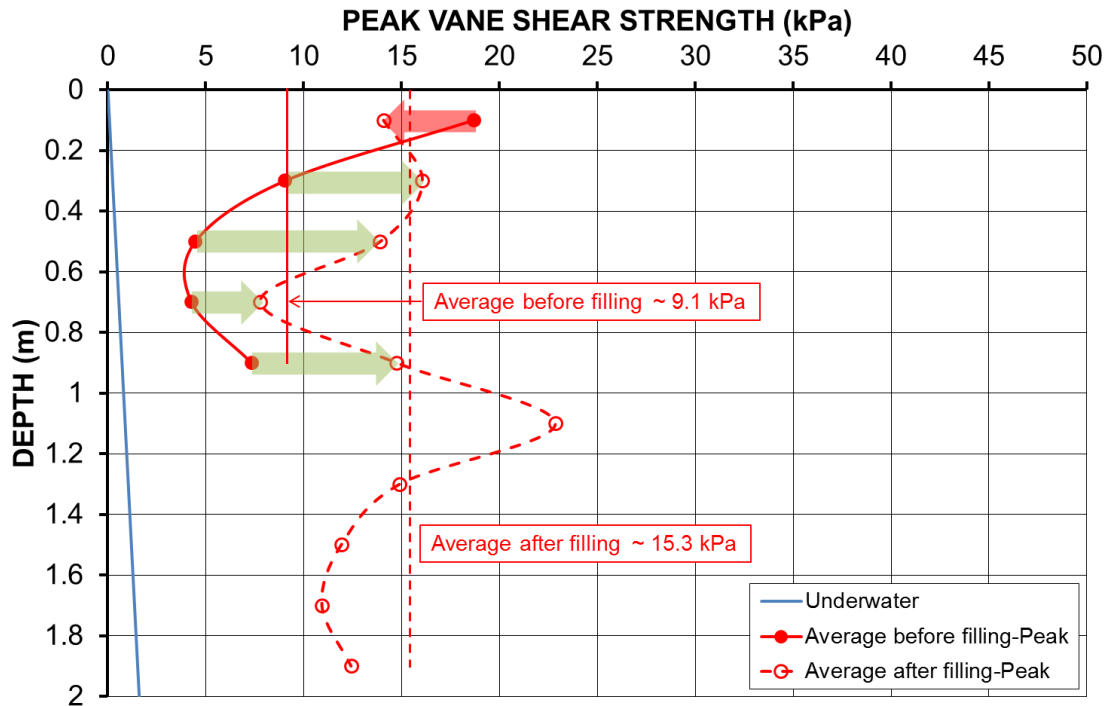
On the placement of the initial capping layer (typically about 1 m deep in an effort to avoid bow wave failure), excess pore water pressures are induced in the tailings, raising the water table (often to the surface). These excess pore water pressures dissipate through drainage to the surface, resulting in a general increase and greater uniformity of the peak vane shear strength profile with depth (Figure 12). The increased peak shear strength, averaging 15.3 kPa in Figure 12, would allow an additional fill height of almost 2 m to be safely placed using the D6 Swamp Dozer.

Figure 12 Increase in peak vane shear strength due to dissipation of excess pore water pressures

Note that the successful placement of the initial capping layer over a large area of the tailings surface leads, on the drainage of the excess pore water pressures generated, to an increase in the shear strength of the tailings to full depth, eventually by 10  $H$  kPa (from Equation (5)). Once the initial capping layer has been placed over the entire surface area of the tailings, any potential for bow-waving on the placement of additional fill is restricted by this initial capping layer. This, and the induced increase in the shear strength of the tailings, makes the placement of additional fill relatively straight-forward, allowing a D9 Dozer to be employed to place a second thicker layer of coarse reject at a far faster rate, at lower cost.
