# Managing the onset of accelerated deformation in capital development at Agnew Gold Mine

**CR Moulding** *Gold Fields Australia Pty Ltd, Australia*

**RM Stephenson** *AMC Consultants Pty Ltd, Australia*

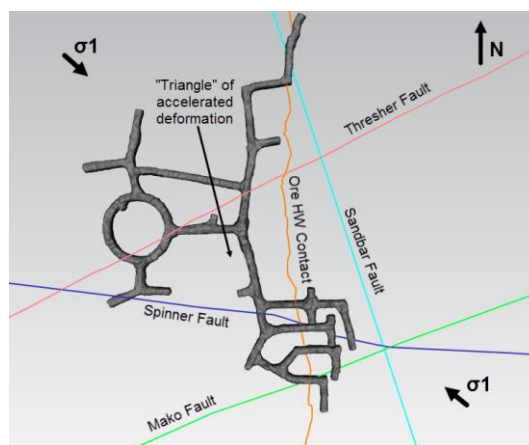
The level accesses intersected the faults with the access drives placed sub-parallel to the dominant north–south bedding. Due to the level layout, development intersections and pillars intersected these faults regularly. As stoping progresses, the rock mass between Thresher and Spinner Faults became damaged and was subjected to ongoing deformation and deterioration (Figure 3).

Figure 3 Fault structures and principal stress direction relative to mine design within Kim Lode

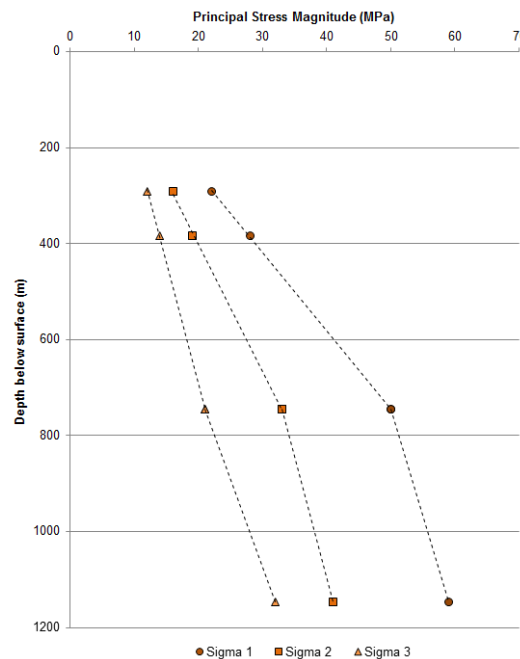
The interpreted in situ stress field was determined by the Western Australia School of Mines using the acoustic emissions (AE) stress measurement technique. Measurements were completed on diamond drill core obtained from 292, 383, 745 and 1,147 m below surface. The measurements indicate a bi-linear trend, which indicates a major principal stress of 61 MPa at 1,260 m below surface (Figure 5). This leads to a strength to stress ratio of 2.6 based on uniaxial compressive strength tests of the Skg unit. At these ratios of strength to stress the rock mass damage is expected to be high and will increase with depth.

Figure 5 Acoustic emission results for in situ stress against depth below surface RL

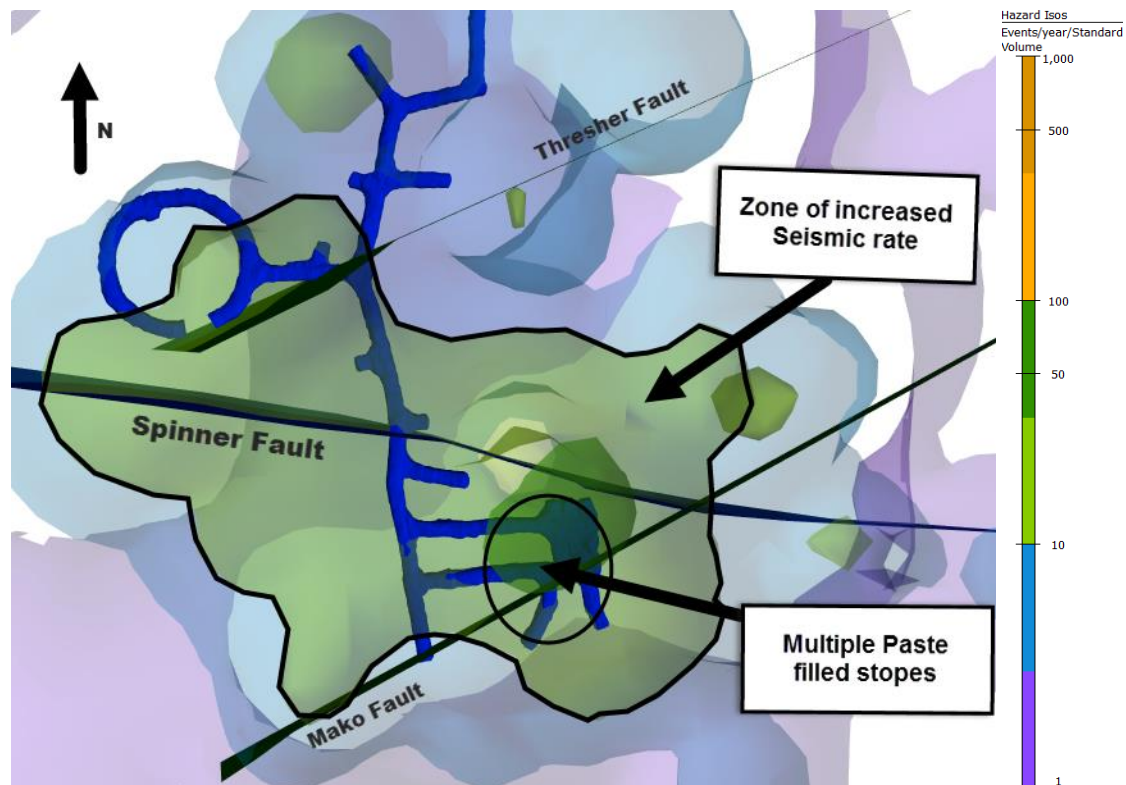
A hazard model to express seismic event frequency within the Kim levels was created based on 12 month data where all events were greater than -1.0 local magnitude. The model shows an increased rate of seismicity occurring in the south and central access drives, and the decline (Figure 13). The rate appears to

be amplified between Thresher and Mako Faults. This initially appears to correlate well in most areas with the damage mapping and numerical model results. However, damage between Spinner and Mako Fault has been limited.

Figure 13 Seismic hazard map indicating seismic rate within Kim Lode
