Lessons learnt from egress drift excavation through a minor pillar in an extraction level, Deep Ore Zone mine, Freeport Indonesia, Papua

SA Firmanulhaq *PT Freeport Indonesia, Indonesia*

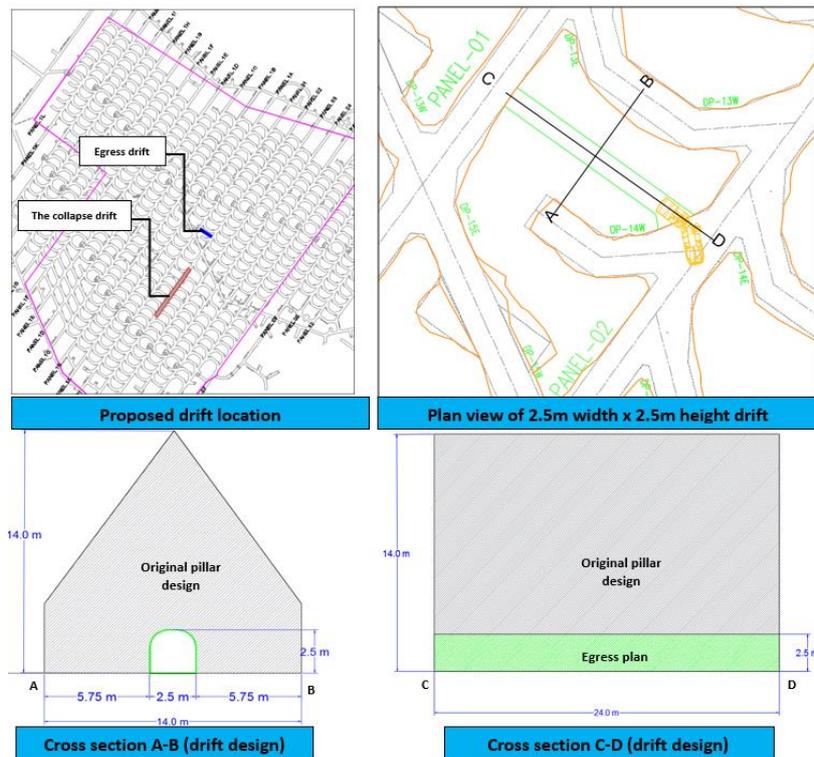
Figure 5 Lay-out design of secondary egress map plan (not to scale)

Prior to the commencement of excavation of the egress drift through a minor pillar between drawpoint 13W and drawpoint 14W, as indicated in Figure 5, selection of the pillar was based on pillar size, geology condition, condition of the working area, and there being no potential spill hazard. Geotechnical assessment and calculations had been undertaken to evaluate the actual ground condition of the core pillar. The main goal is to keep two accessible access ways for people in the panel. The panel is mined using the tele-remote LHDs, but people are still assigned for maintenance or other work, so in case of wet muck spill/mud rush, people can immediately evacuate through the egress drift.

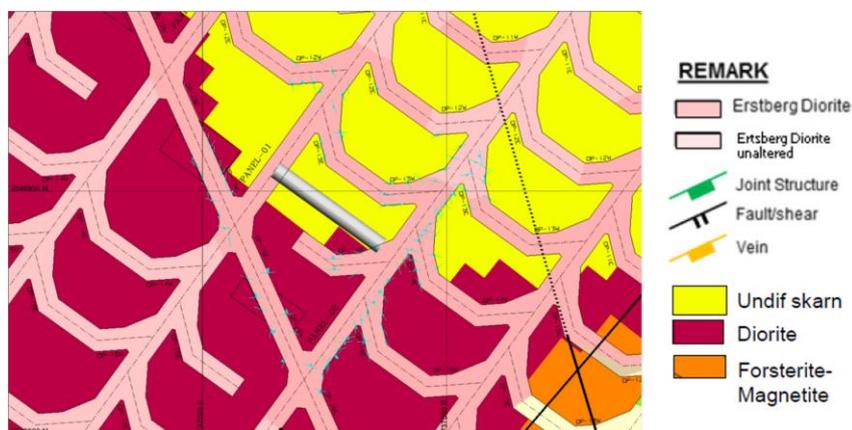
Figure 7 Geologic block model at the proposed area

Geological mapping and drilling data was used as input data into geotechnical modelling. The rock type at the proposed egress drift was diorite–undiff–skarn (Te) and is closed with a major fault (West Bound Fault), as indicated in Figure 7. Rock mass properties were estimated with RMR (Bieniawski 1989) with a value of 43 (fair rock) and using Q estimation (Barton et al. 1974) with a value of 15.3 (good rock). However, actual cell mapping is undertaken during excavation.

Although the drift was situated in an undiff–skarn environment, the rock type was still classified as diorite after reconciliation with actual observation and from borehole camera survey data.

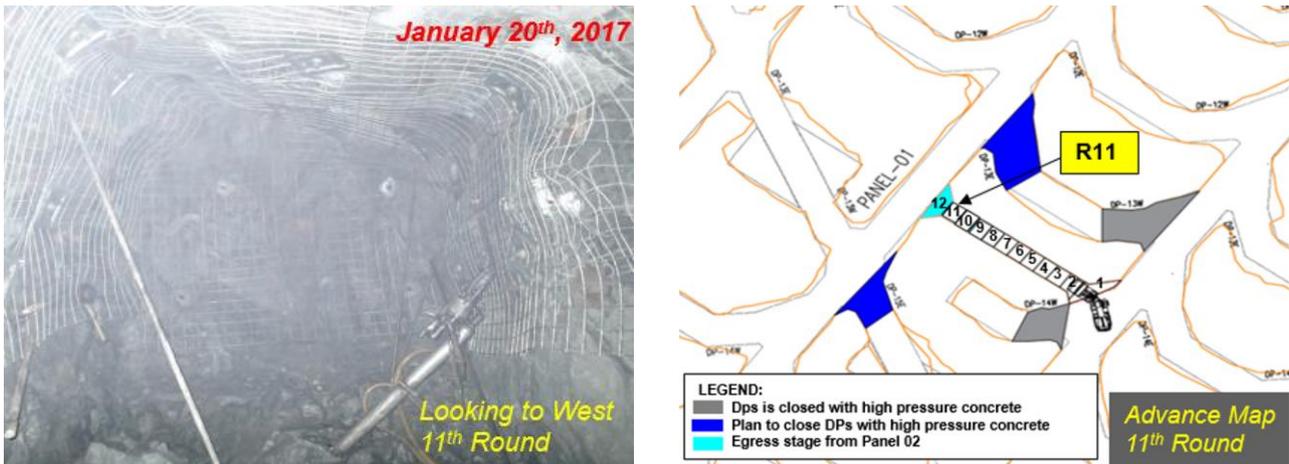
Figure 9 Working activity and sequence

The first round of blasting commenced on 1 December 2016 and was completed on 30 January 2017; excavation of the tunnel was completed within 61 days. Excavation was done by PT Redpath Indonesia with two crews working only on day shift. The ground support installation was completed in two stages. In the first stage, primary support was installed directly after blasting, then at the second stage, secondary support was installed after primary support completed in every 4.0 m advance. All of the ground support installation works are done manually with air leg drilling equipment. The working activity and sequence is shown in Figure 9.
