Managing decline deformation in an active sublevel caving operation

Abstract

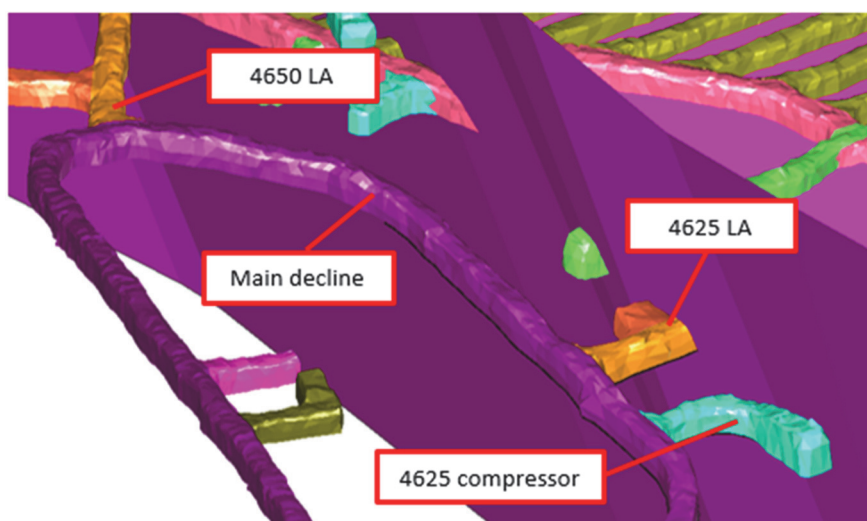
The risk assessment for mining the 4475 Level identified that the cave zone of influence would increase with the additional level, with development on the eastern abutment particularly impacted. At the risk assessment stage a rule-of-thumb cave influence zone of 70° from horizontal was used to identify areas of development at risk (Figure 4).

Areas of critical infrastructure plotting within or close to the projection were given a residual risk rating based on existing controls. Recommended actions to better identify the cave influence zone through non-linear modelling, interpretation of seismic data and monitoring were recommended, with the eventual requirement to bypass areas.

Figure 4 70° cave influence zone projection from the 4475 risk assessment highlighting potential interaction with the main decline around the 4650 to 4625 Levels

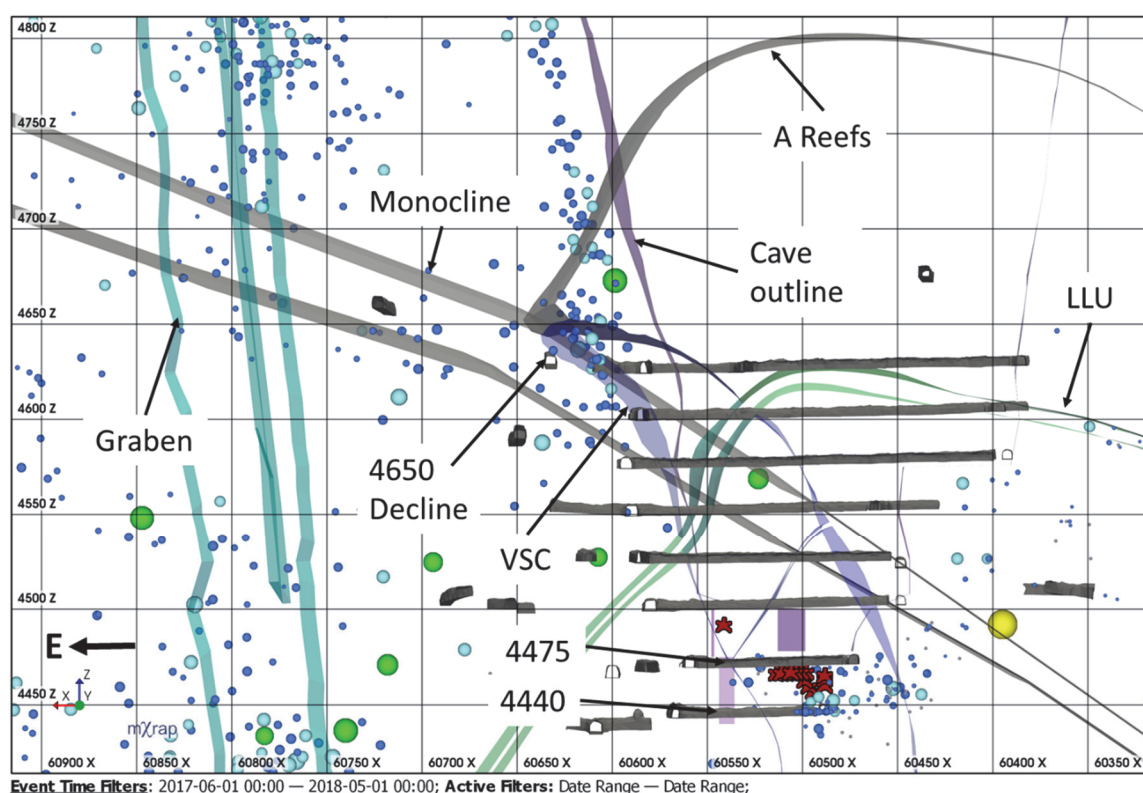
The focus of this study is on the area of eastern decline known as the 4650 to 4600 Levels, a 300 m long section running parallel to the cave, approximately 35 m to the east. It is situated in a structurally complex setting near the confluence of the monocline, A Reefs and vertical stockwork (VSC) structures (Figure 5).

The 4650 to 4600 Decline has experienced significant stress change over the excavation history. The 4650 was the initial SLC undercut level with the area experiencing elevated sub-horizontal stress as caving initiated. As the 4625 Level progressed north, the 4650 to 4600 Decline was located in the high stress northeast abutment, before additional sublevels extended deeper and further north shielding the decline.

Figure 5 Section through the 4650 Decline area showing the confluence of structures

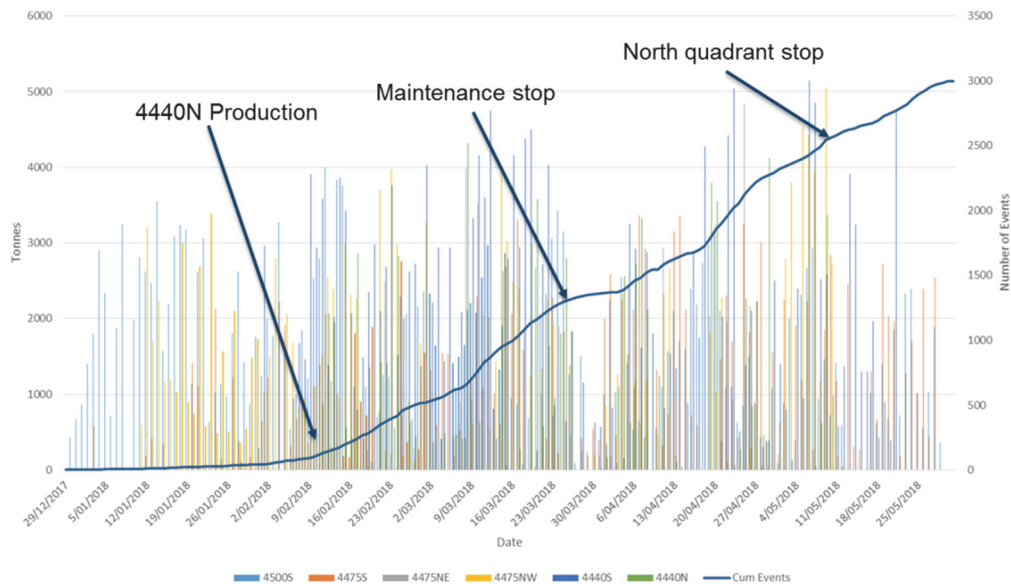
This link, that was further reinforced during the March 2018 underground maintenance shutdown, (Figure 13), enabled management to use draw control as an effective risk management strategy.

Figure 13 Plotting the 4440 S production suggested that draw from the central section of the SLC also affected the 4650 Decline

Plotting cumulative seismic events against production for each mining area enabled the influence of cave draw in each production area to be correlated to seismic activity rate (Figure 13). Based on this information, production in the 4440 S was also suspended. This was potentially caused by the interaction of the VSC contact with the SLC 4440 N and S production front and confluence of structures around the 4650 to 4600 Decline (Figure 15).

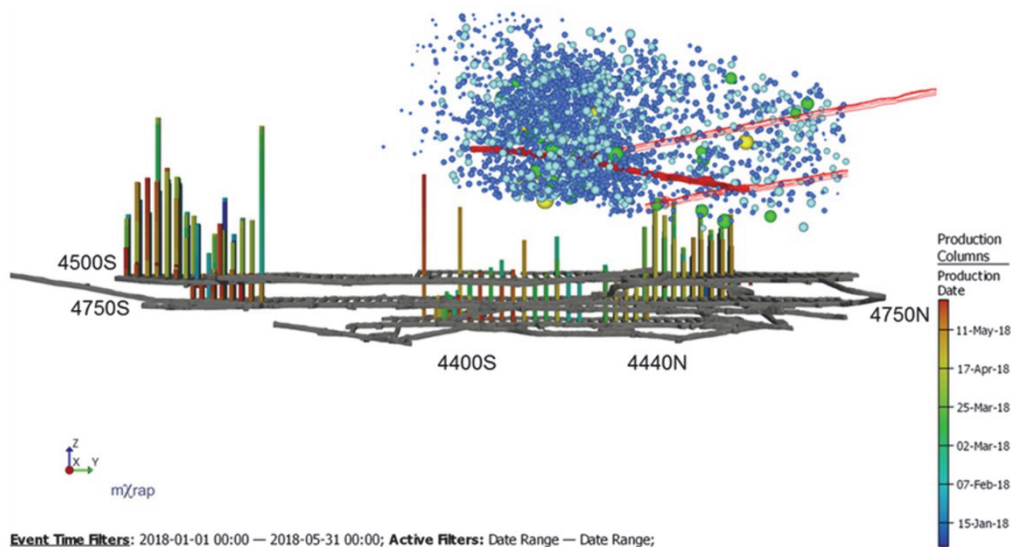
It was originally theorised that the northern production areas, 4475 N and 4440 N, were the major drivers for seismic activity rate and deformation around the 4650 to 4600 Decline and that the 4500 S, 4475 S and 4440 S production areas had minimal effect (Figure 14). In May 2018 the northern production areas were halted to reduce deformation, however, deformation and seismicity did not decrease as expected (Figures 12 and 13).

Figure 14 Location of SLC production between January 2018 and May 2018, 4650 Decline area (red) and volume filter of events around the decline are, looking west

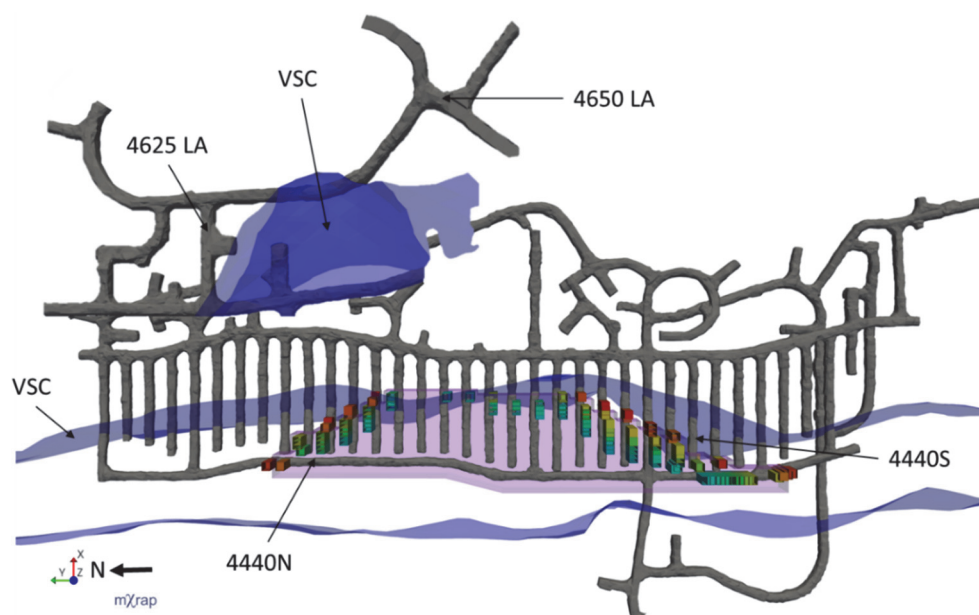
Figure 15 Location of production between January 2018 and June 2018 on the 4440 I-Level and 4650 to 4600 Decline area and VSC contact
