Corroded rock support issues: implementation of an investigation and rehabilitation program

JF Dorion *Raglan Mine, Canada*

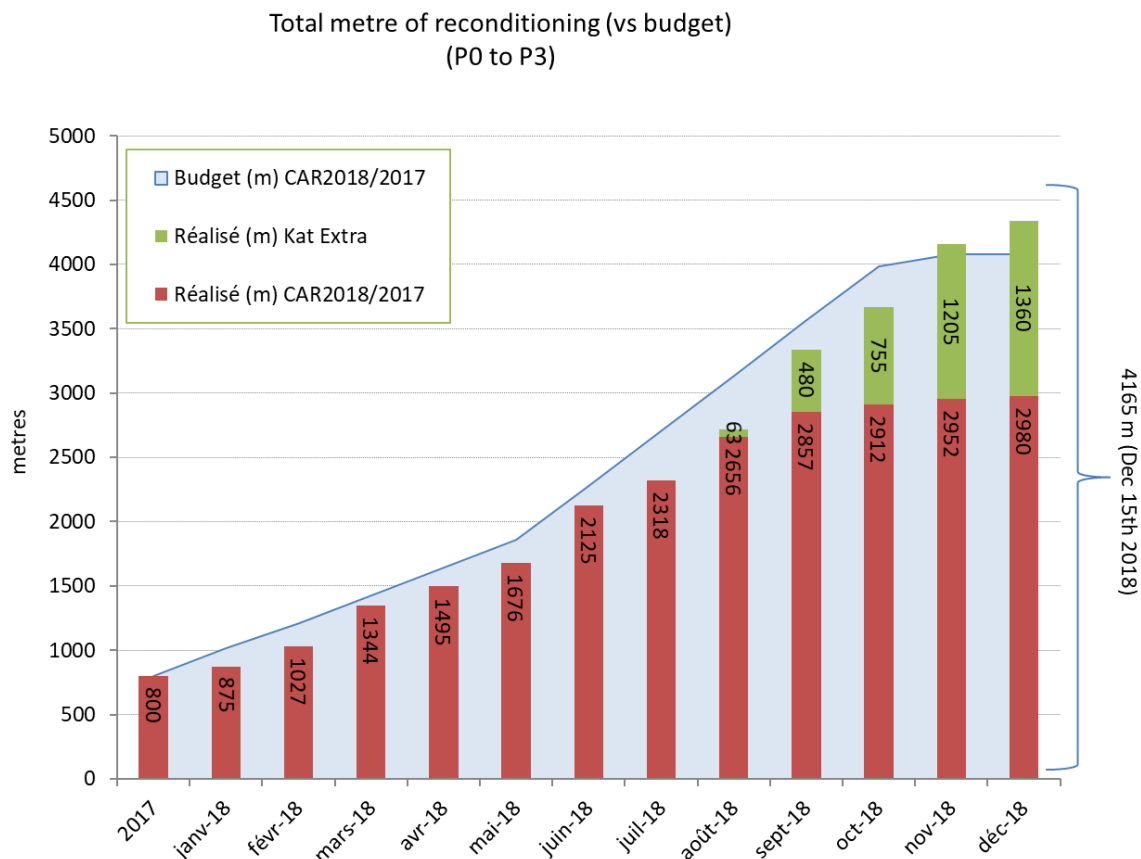
Figure 11 Graph of total rehabilitation metres compiled

Figure 11 shows the progress of work on a monthly basis. It is possible to follow the metres of rehabilitation carried out compared to the planned budget. The cost overrun is associated with additional requests added during 2018.
