Addressing pit wall instabilities in Africa's largest open pit copper mine

GC More O'Ferrall *First Quantum Minerals Ltd, Zambia*

Abstract

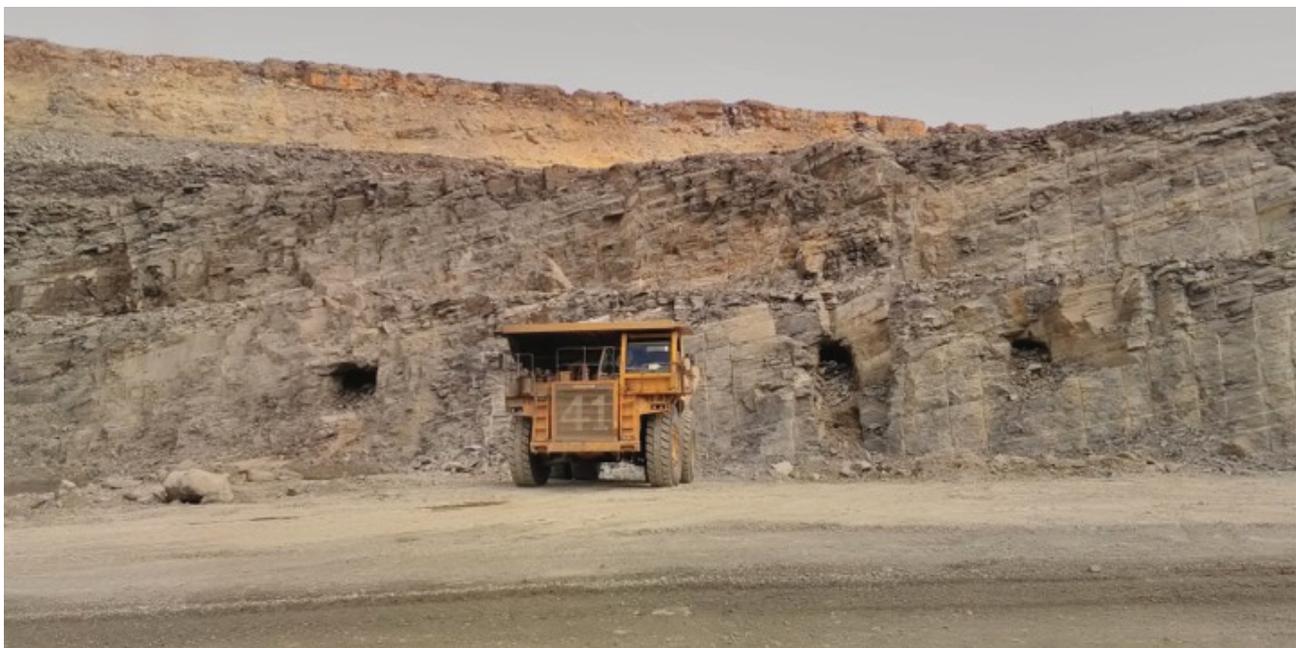
Historically, mining at Kansanshi Mine site was by underground mining methods. Historical underground workings have been intersected during the surface mining activities (Figure 2), and thus far have not posed any significant risks.

Figure 2 Tunnels intersected during surface mining

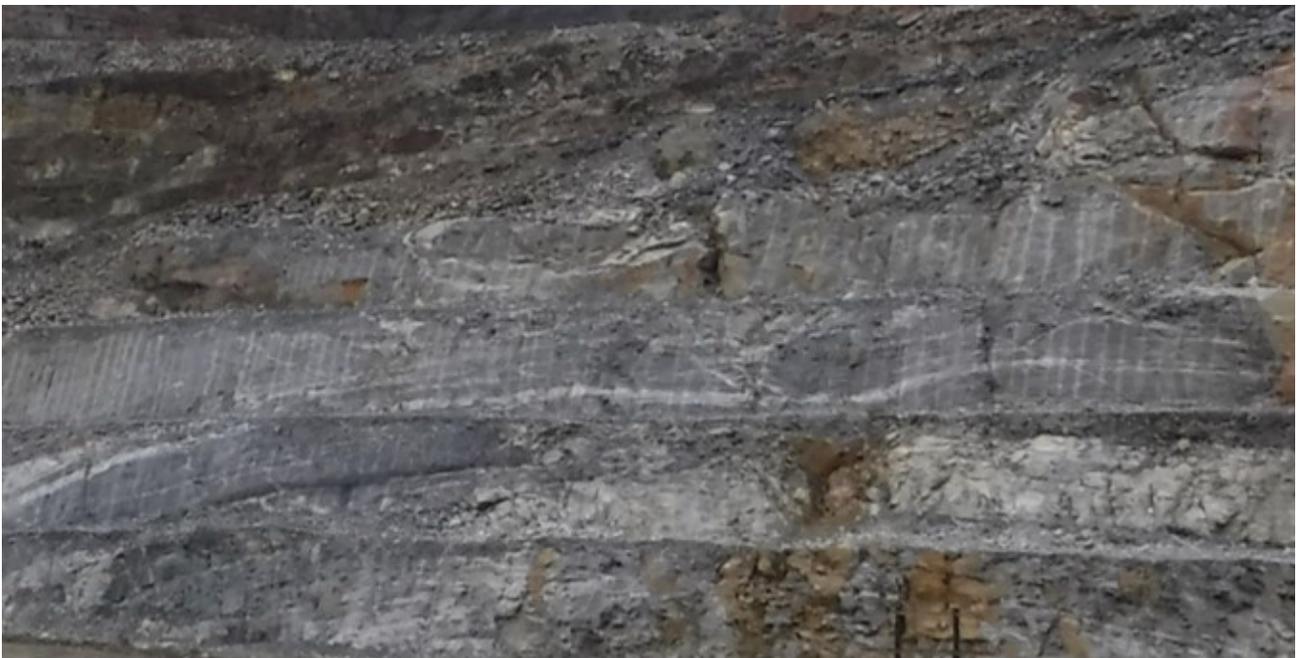
Fairly weathered and unweathered (i.e. fresh rock) wall geometry includes 10 m high benches with 7 m wide catch berms and a bench face angle varying between 75° to 80°. Approximately five benches have been excavated in fairly weathered material and three benches in fresh rock (Figure 5), and to date only localised instabilities, i.e. wedge or toppling, have occurred in these zones.

Figure 5 Ten metre high benches in phyllite
