Case study: analysis of a highwall toppling failure and development of a successful mine re-entry plan using RS2, RocFall and Dan-W at a coal mine in Canada

C Clayton Tetra Tech Canada Inc., Canada

A Bidwell Teck Coal Limited, Canada

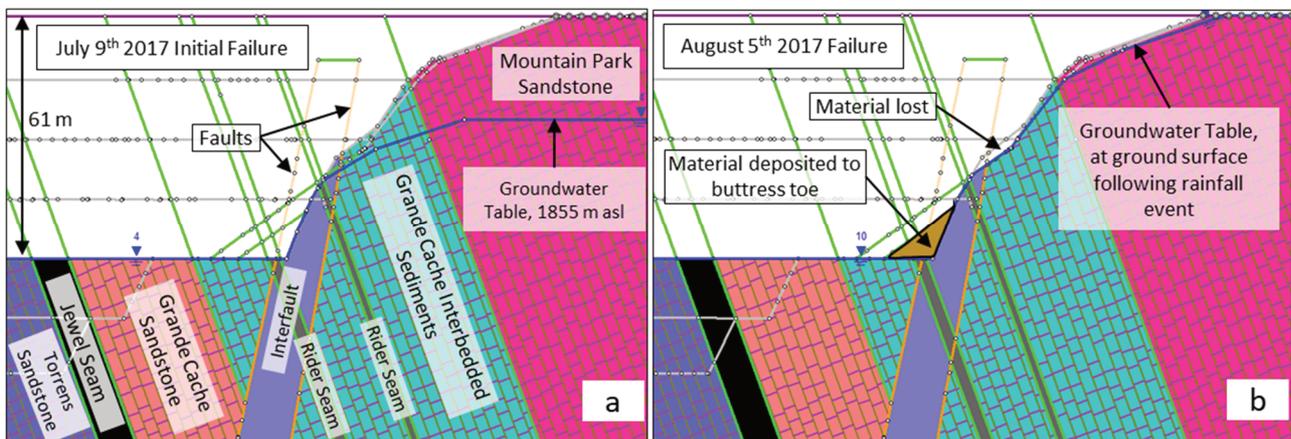
Figure 9 Models of the (a) 9 July 2017; and (b) 5 August 2017 failures

the existing failed material. An in-plane horizontal to vertical stress ratio $k = 1.5$ was assumed. A cross jointed joint network model was used to define the parallel bedding planes and orthogonal cross joints. The bedding planes are assumed to have infinite persistence while the orthogonal joints terminate against the bedding planes. The bedding was assigned a constant spacing of 3 m based on visual observation of obsequent scarps forming on bedding planes in the initial failure area at the crest of the slope. The cross joints were input as a random variable with a mean spacing of 3 m and a standard deviation of 2 m. The model includes two faults at the slope toe, which were modelled as joint boundaries. Shear stiffness was estimated based on direct shear testing at nearby sites. The normal stiffness was estimated as three times the shear stiffness. The rock mass between the two faults is highly disturbed and was not assigned a joint network. The groundwater table was assumed to be 35 m above the pit floor (1,855 m elevation) for the 5 July 2017 failure based on seepage observations and elevated to ground surface for the analysis of the 5 August 2017 failure based on the weather data which indicated two days of rainfall preceding the failure. The modelled excavation stages progressed to match the mining sequence preceding the failure. The forward analysis incorporated a fully loaded Komatsu 830 haul truck to represent a worst-case truckload during unloading of the crest area. This was simulated using two 2 MN/m line loads spaced at 7 m. Figures 9(a) and 9(b) illustrate the models used to simulate the 9 July (initial) and 5 August (second) failures, respectively.

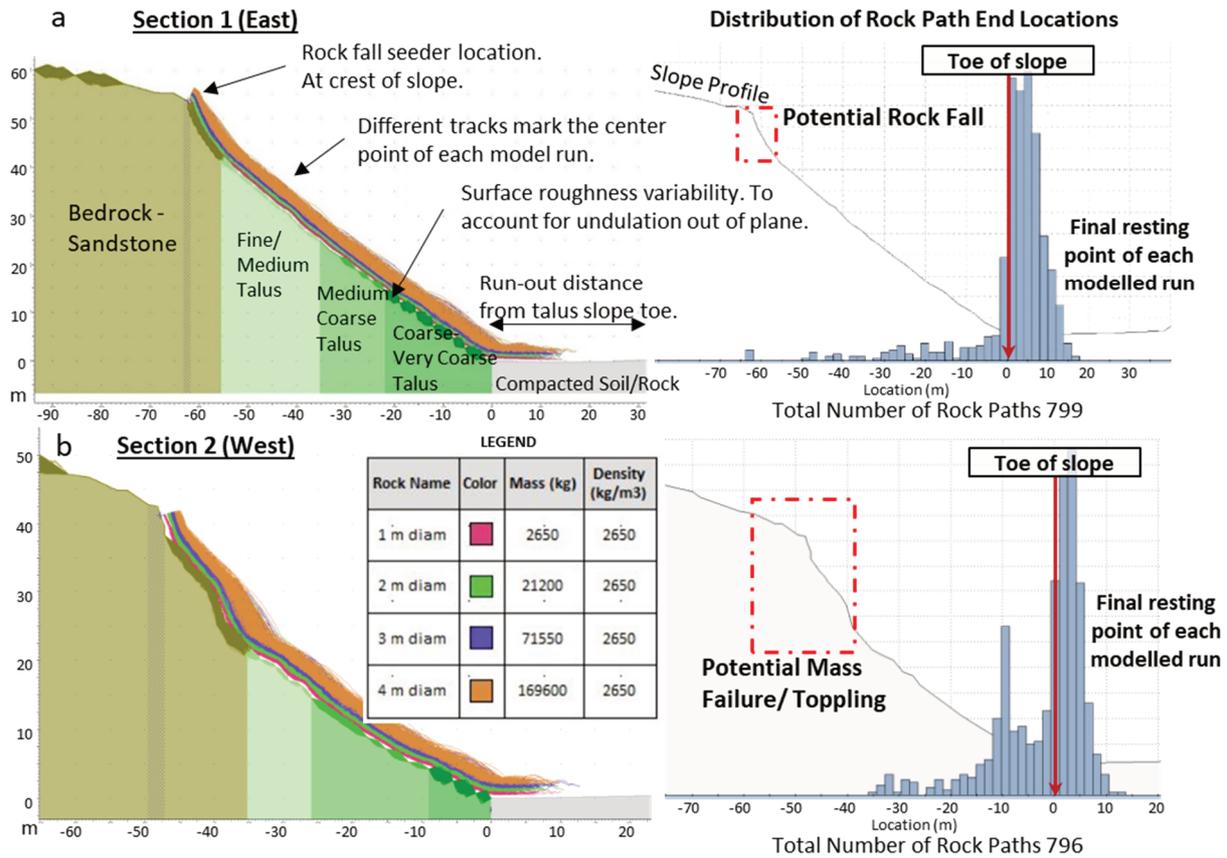
Figure 12 Rockfall travel distance back-analysis for (a) East; and (b) West areas

Analysis of rockfall trajectories, velocity and energy was completed using the software RocFall (Rocscience Inc. 2018). A back-analysis was used to calibrate the model input parameters against the observed rockfall travel. A forward analysis was completed following model calibration. The analysis was performed using the Rigid Body method, which models the mass, size, and shape of each block and accounts for the falling rocks' interaction with irregularities of the slope profile using a slope roughness variability. Two cross sections were selected: one through the eastern rockfall hazard area and one through the western toppling hazard area. The slope was divided into five materials for modelling as shown in Figures 12(a) and 12(b). These materials were: bedrock at the crest of the slope, fine to medium talus in the upper talus material, medium to coarse talus, coarse to very coarse talus in the lower talus material, and compacted soil to rock at the toe of the slope. Angular sub-orthogonal block sizes of 1, 2, 3 and 4 m in diameter were used. A seeder was placed near the crest of the slope to simulate toppling of discrete blocks, and an initial rotational velocity of -20 (°/s) was applied.

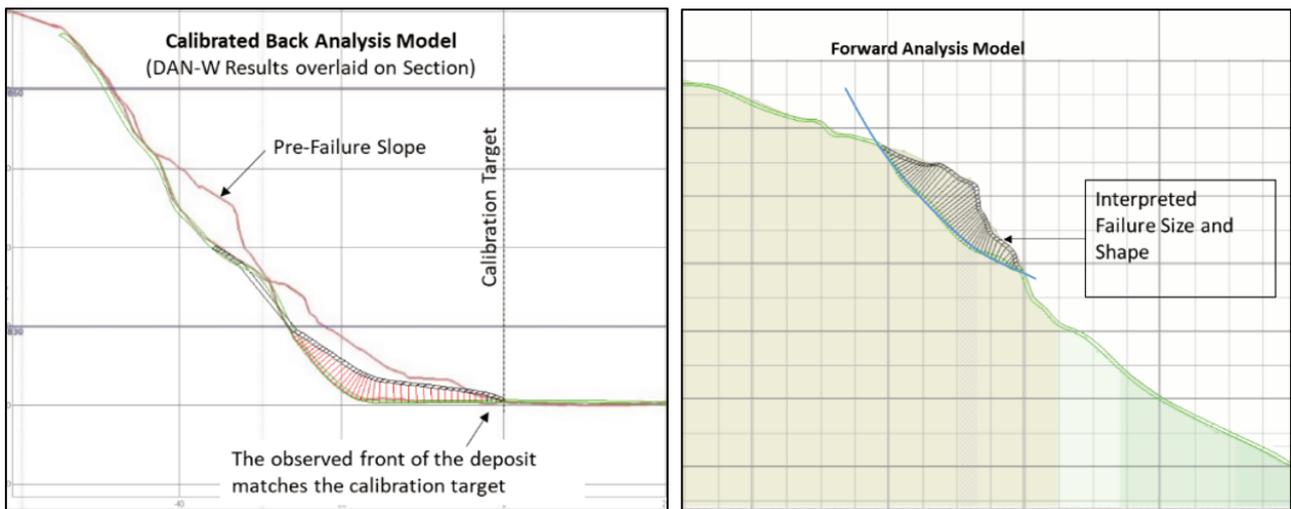
Figure 14 Calibrated debris runout back-analysis model of (a) 9 July 2017 failure; and (b) Forward analysis model

The back-analysis determined that the runout distance and shape of the failed material matches best when using the Voellmy rheology with a frictional coefficient of 0.65 (33°), internal friction angle of 36° (based on the angle of repose of the talus cone) and a turbulence coefficient of 500 m/s^2 , as shown in Figure 14. The Voellmy rheology produces a less elongated nose of the debris deposit compared to the frictional rheology. Vertical slices resulted in a more fluid-like behaviour of the failed mass; normal slices were more representative of the actual behaviour. The sensitivity to the internal friction angle is low, however, the sensitivity to the pore pressure coefficient (R_u) is high.
