# Characterisation of a rock slope showing three weather-dominated failure modes

**Keywords:** rock slopes, failure modes, weather triggers, remote sensing, material susceptibility

### 1.1 Site C018

Site C018 is a 500 m long, 60 m high rock slope along a section of Highway 837 that parallels the Red Deer River at the base of the Red Deer Valley, as shown in Figure 1. This slope is predominantly in a weak, poorly

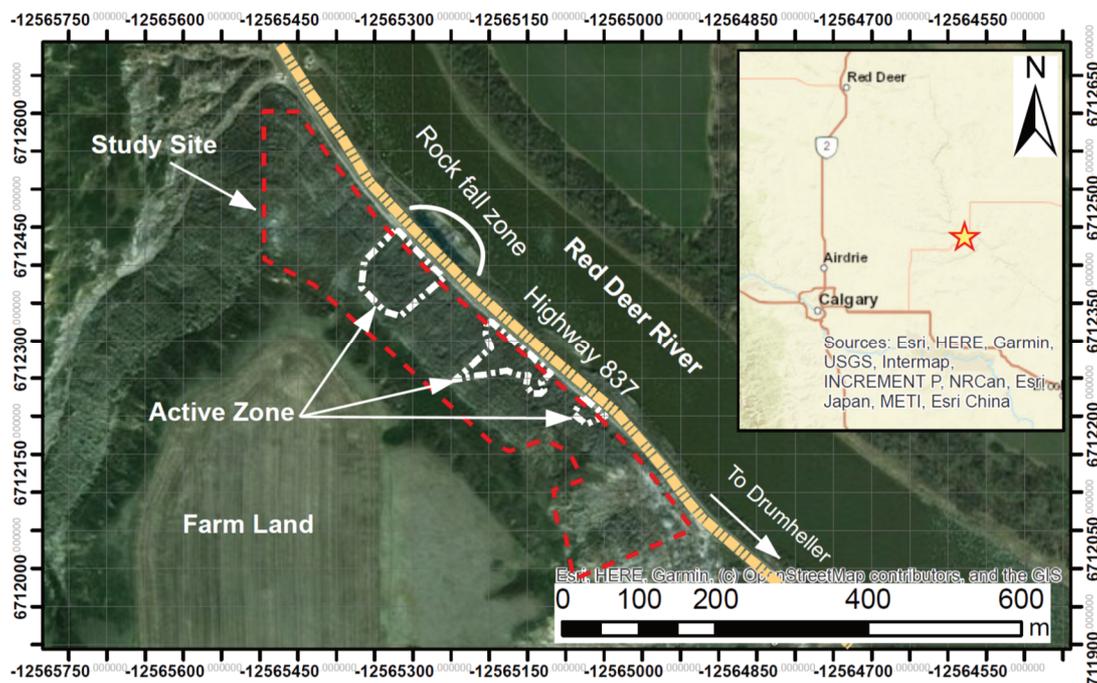
Figure 1 Location and plan view of site C018 in the province of Alberta, Canada. White dashed line shows the currently active areas of instability. Red dashed line shows the extent of investigation
