Monitoring and managing large deformation pit slope instabilities at a British Columbia copper mine

Abstract

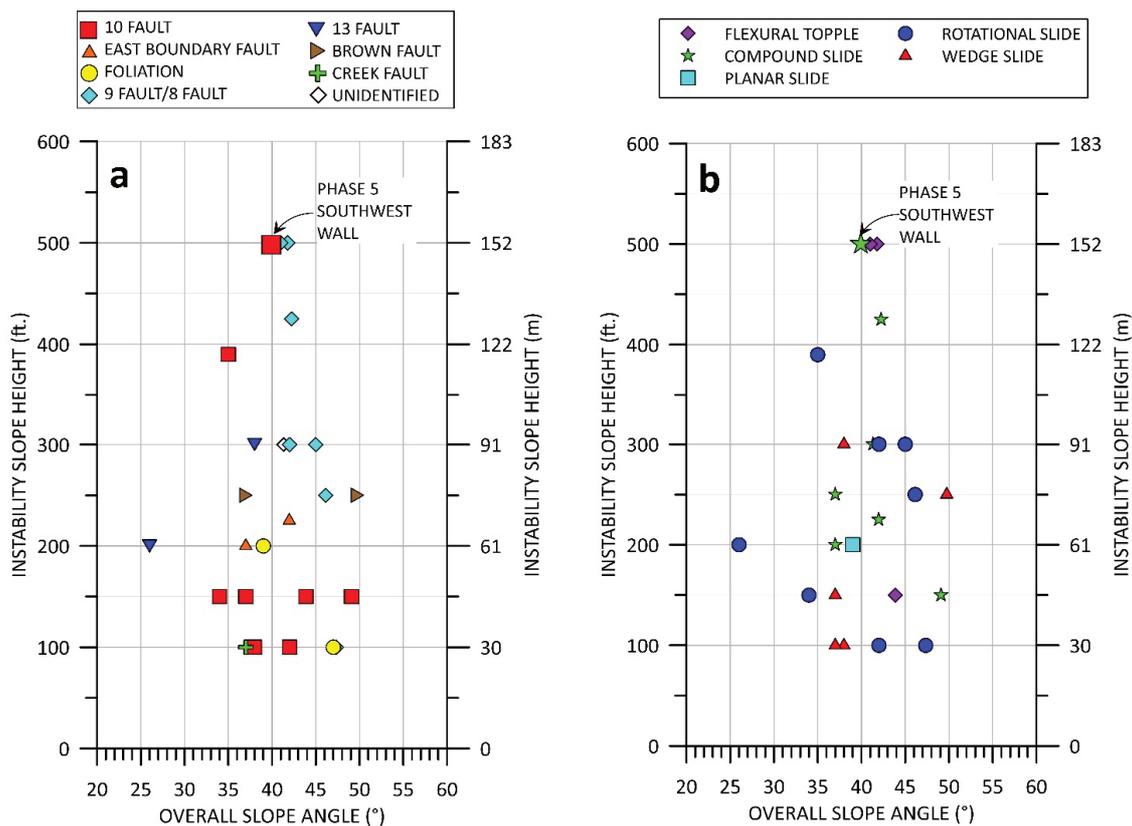
Figure 1 Empirical slope height versus slope angle relationships for instabilities in Granite Pit sorted by: (a) Major geologic structure; and (b) Interpreted failure mode

Figure 1a illustrates the slope height and slope angle relationship by associated major geologic structures within the geological model associated with the instability. 10 Fault is the most influential geological structure in the Granite Pit and has contributed to eight of the instabilities presented in the database. 10 Fault is a large, low-angle (dip of 20 to 30°) geologic structure with a thick gouge core and a damage zone wider than 30 m (Mostaghimi & Kennedy 2015) in some locations.

Multi-bench instabilities have occurred in the Granite Pit with failure modes ranging from simple large-scale wedge, planar, and toppling to more complex failure modes. Figure 1b illustrates the slope height and slope angle relationship based on the interpreted instability mechanism following Hungr et al. (2014). The term 'compound slide' has been assigned to instabilities demonstrating more than one type of failure mechanism and 'rotational slide' has been assigned to instabilities that were interpreted to occur in a weak rock mass.

- 10 Fault was associated with the greatest number of the instabilities and the widest range of failure modes, occurring in-pit slopes with overall angles as low as 33°.
- Instabilities have occurred for a wide range of slope heights (30 m to 150 m) and slope angles (26° to 50°).
- All but one of the instabilities occurred for overall slope angles greater than 33°, suggesting that pit walls in Granite Pit that encounter major structures do not perform well when slopes steeper than this are excavated. Extensive slope monitoring will generally be required.
- The instability with an overall slope angle of 26°, occurred in a slope with waste rock overlying weak and faulted bedrock.

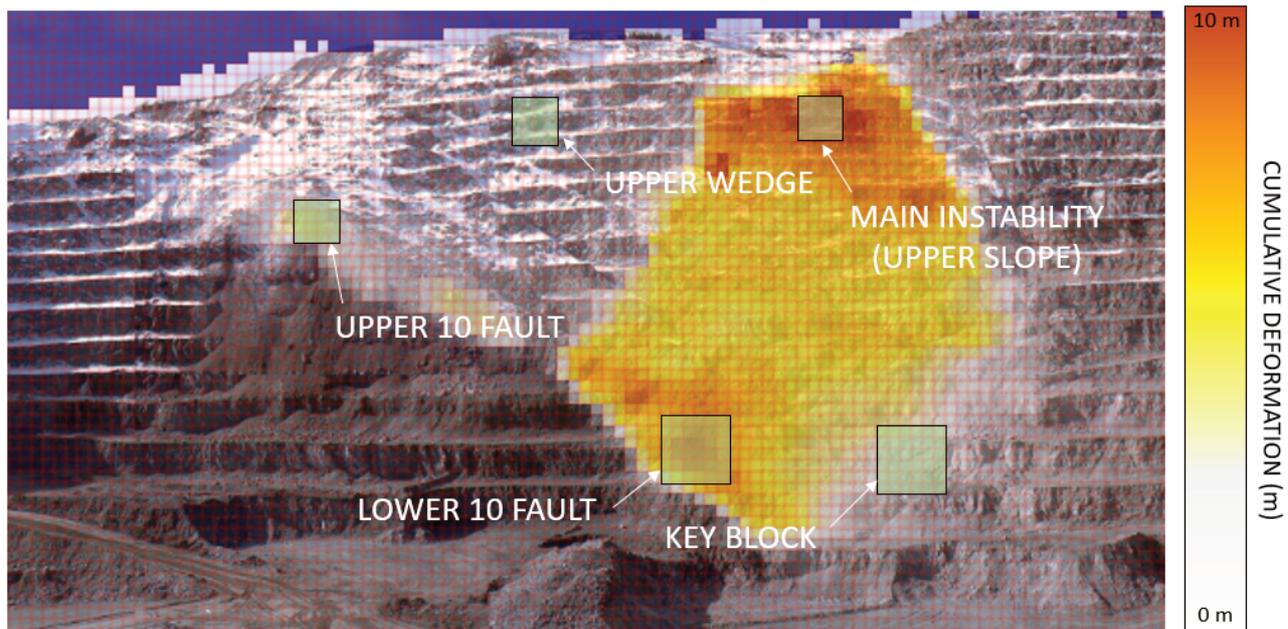
Figure 6 Slope monitoring areas overlain on the slope stability radar cumulative deformation measurements from March 15, 2017 to April 5, 2017
