Engineering geology investigation and numerical modelling design of the Ramp 12 highwall

B Roache *Mining One Consultants Pty Ltd, Australia*

AR Johnstone *BHP, Australia*

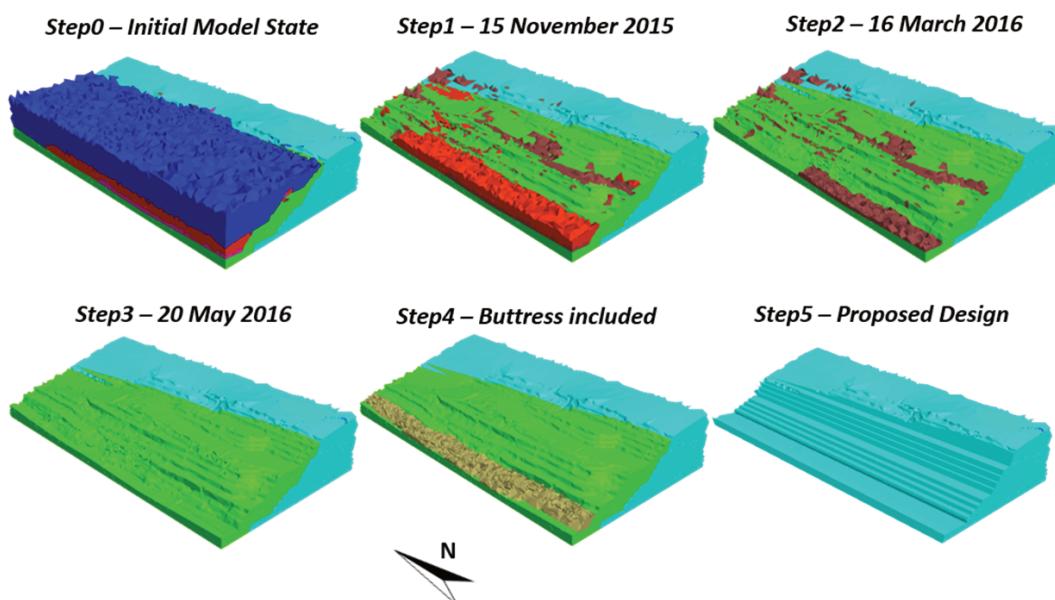
Three mining steps were simulated in the back-analysis, following an initial mining state, as shown in Figure 6.

Figure 6 Ramp 12 highwall slope numerical model steps
