The Kiruna seismic event: important insights from the geotechnical model

Abstract

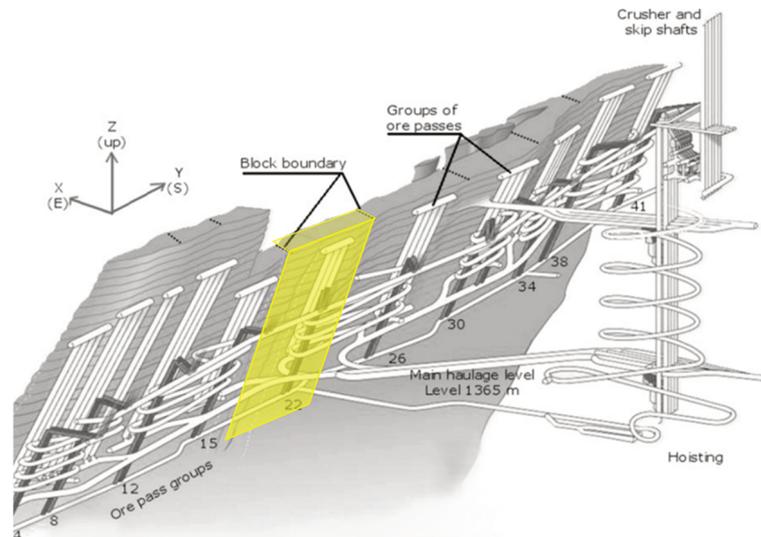
intermediate-mafic volcanic units. In addition, B22 contains late crosscutting diabase dykes, and geometrically complex bodies of dyke porphyry (DP). The hypocentre of the seismic event was interpreted to be located at or very near the intersection between the stiff DP dyke and the crush zone. A central question is to what extent do the dyke porphyries act as pillars to support the block. And another question follows, what led to the significant seismic event?

Figure 1 Sketch of the Kiruna mine orebody, with production area Block 22 of Kiirunavaara Mine highlighted. Three ore passes are located within the block. The event's hypocentre is interpreted to be located at the northern orepass

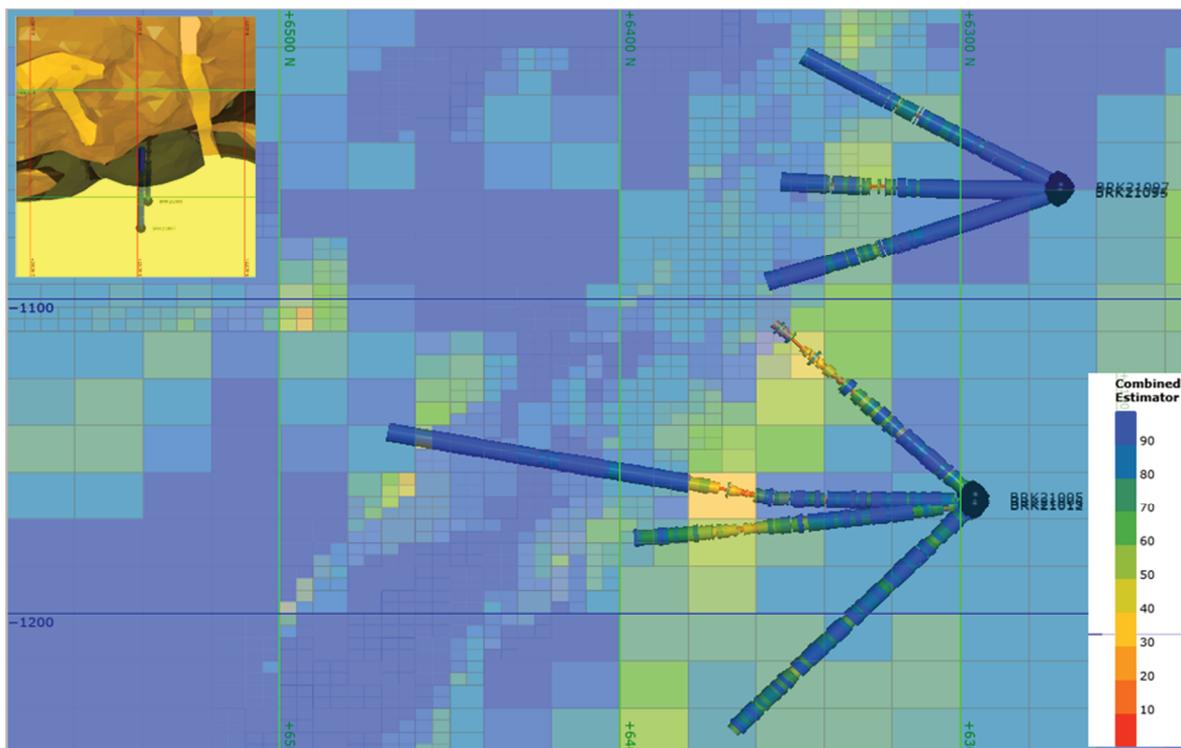
Figure 5 RQD block model cross-section of B22 at Y2100 with drill holes BRK21005, BRK21006, BRK21012, BRK21013 from lower level, and drill holes BRK21094, BRK21095, and BRK21097 from the upper level. RQD shown on drill trace and model. Inset, plan section showing drillhole positions with yellow footwall units, dark ore, and orange hanging wall units

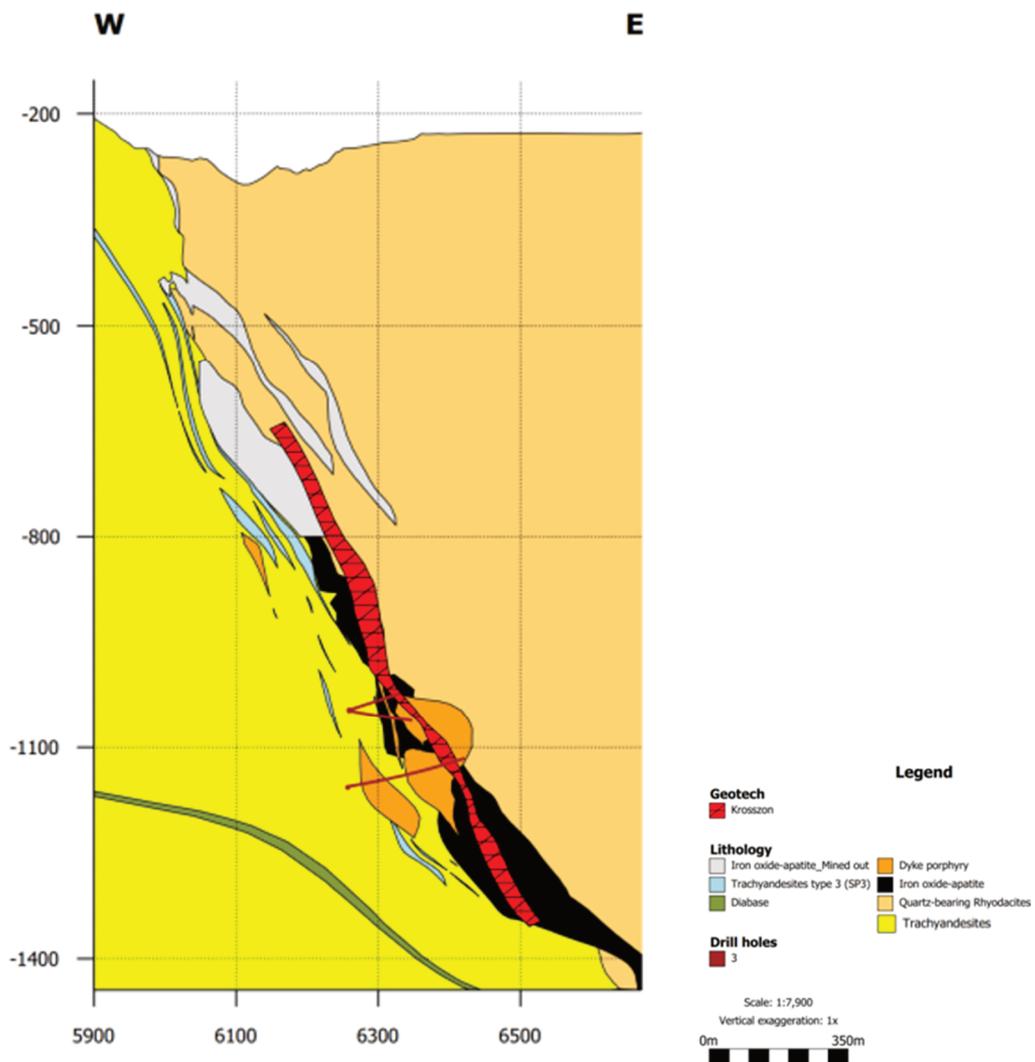
The crush zone strikes subparallel to the orebody. In the south of Block 22, it starts 100 m deep in the footwall and travels north to obliquely cut the orebody (Figure 6). At the intersect between the orebody and crush zone the orebody is heavily brecciated, and drilling shows regular core loss. Complex lithological geometries of the orebody and dyke porphyries are significant in Block 22 (Figures 6 and 7).

Figure 7 Vertical geological section at Block 22, Y1935, Drillhole traces in brown. Legend as in Figure 2
