# Estimate of ground support response under dynamic loads at El Teniente mine, Codelco, Chile

MS Celis *Codelco, Chile*

RA Parraguez *Codelco, Chile*

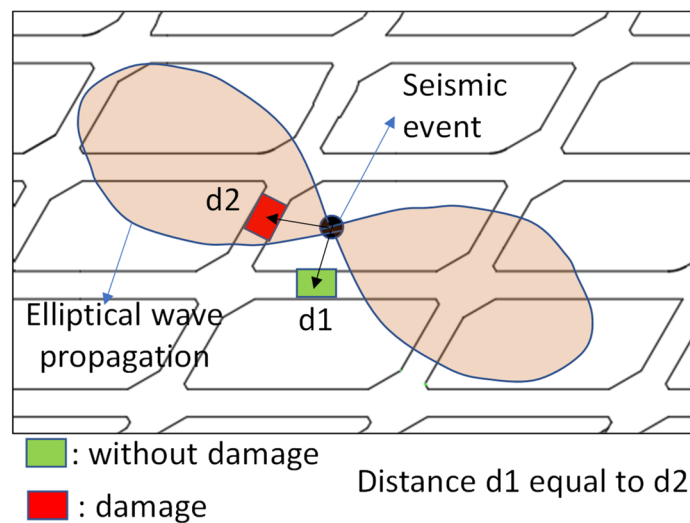
**Figure 6 Elliptical wave seismic event propagation**

Historically, what has been seen is that the distribution of damage on the ground does not follow a defined pattern. This can be associated with the fact that the seismic wave propagation is not circular but rather elliptical (Figure 6), which means that points located at the same distance from the source of the event have different responses (with or without damage to the support system). Other factors also affect this last point, such as the orientation or size of the drifts and their local condition in terms of geological characterisation or state of the installed ground support.

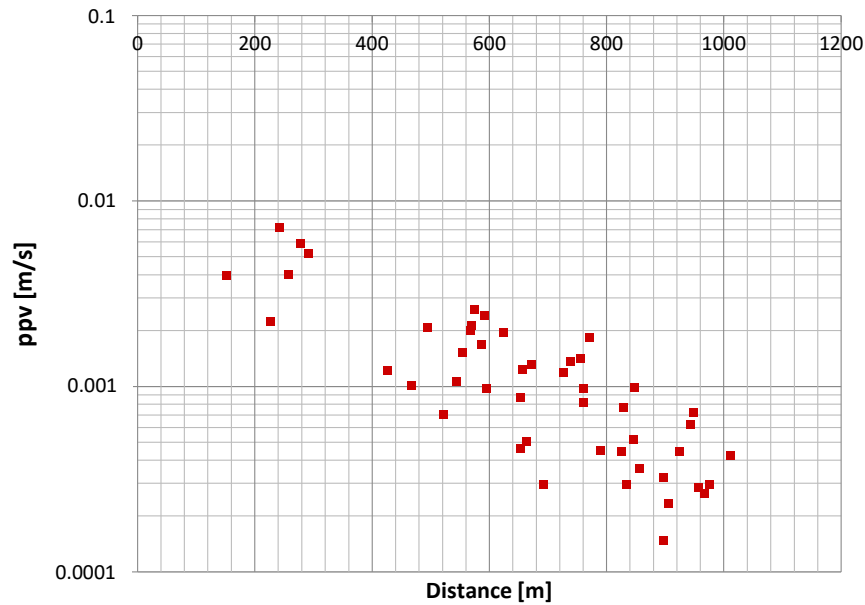
**Figure 7 Graphic distance versus magnitude**

The geophones particle velocity ( $ppv$ ) readings are shown as an example in Figure 7.

The damages occur in the ‘near field’, that is, at a distance less than 50 m from the focus of the event for which there is no reading from the geophones as they are installed far from the mining to avoid being damaged.

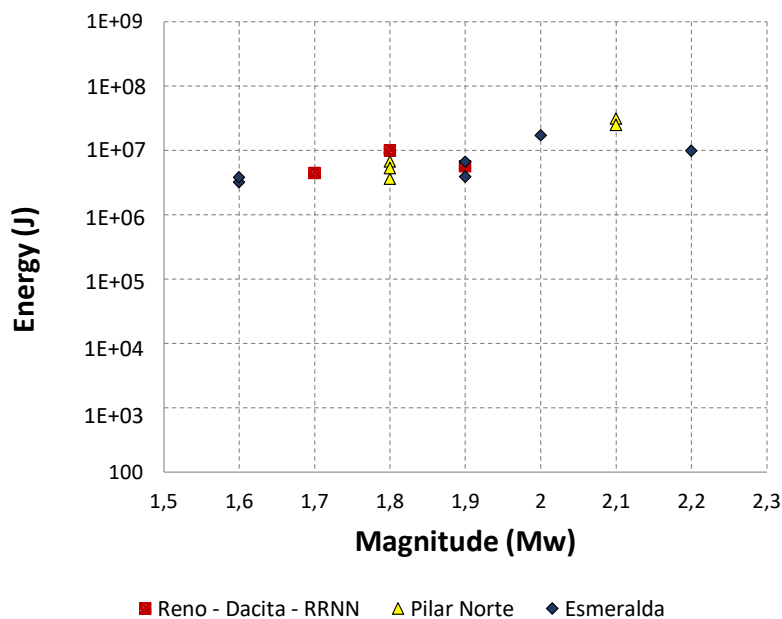
**Figure 8 Support failure statistic**

To evaluate the ground support response, the values in Table 3 are considered with the relationship between the magnitude and the energy of events for which damage has been recorded in the support described in Table 1 at El Teniente mine, as shown in Figure 8.

Figure 8 considers only rock bursts as of October 2015 due to a change in the event processing system.

- The statistics of combinations of the rockburst events magnitude–energy (Figure 7) shows that for an event of  $M_w 1.4$  and energy of  $2.6 \times 10^5$  J such as that of this rockburst, no damage happens in the bolts, mesh and shotcrete ground support as the one installed by design.
- Therefore, the occurrence of the damage is explained by the sliding of the rock mass through geological structural planes parallel to the drift that creates shear stress in the bolts, limiting the capacity of the support (FS around 0.9), which explains the failure observed in the field.
