Stabilisation of open pit wall movements detected by InSAR using horizontal drains

P Ramakrishnan *SkyGeo, Netherlands*

J du Toit *First Quantum Minerals, Zambia*

Abstract

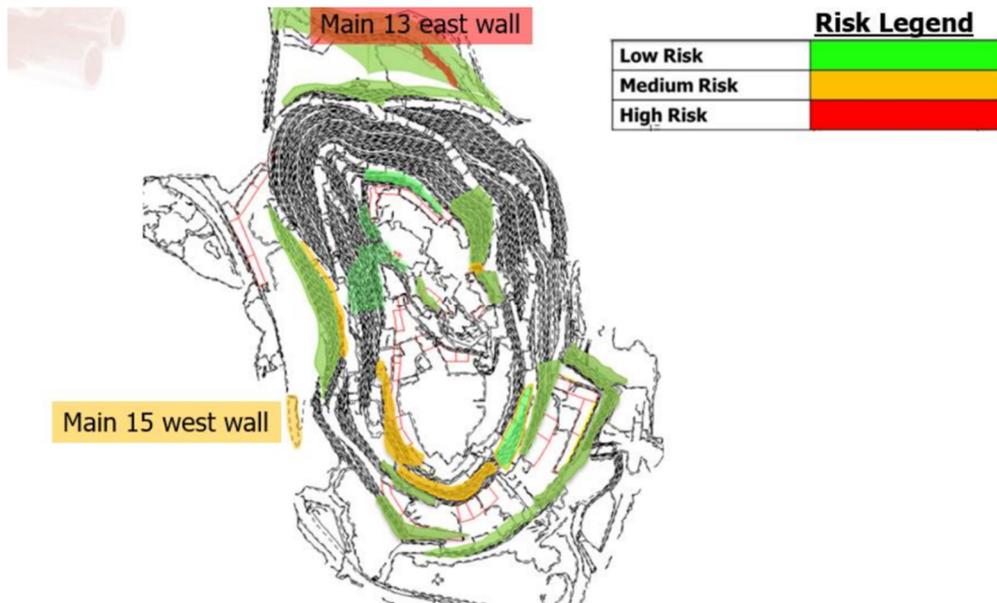
At the onset of the EWS monitoring in June 2022, the hazard levels of Main Pit were classified as shown in Figure 6. The M15 west wall was denoted to be a medium-risk zone due to observed daylighting structures.

Figure 6 Example of a hazard map for the Kansanshi Main Pit (First Quantum Minerals 2022)

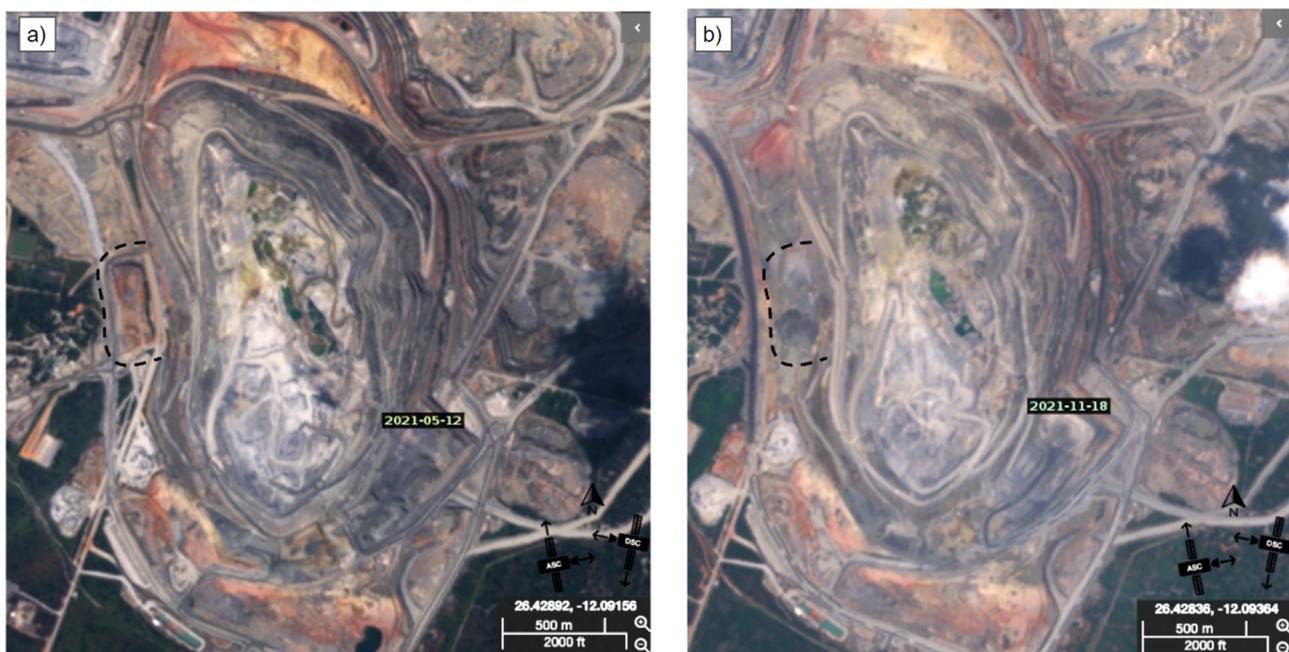
However, the current area known as the M15 west wall of Main Pit exhibited consistent displacement over the two-year period. This was of interest because the underlying area was originally a region just beyond the pit crest that housed a waste-rock dump, as illustrated by optical satellite imagery from Sentinel-2 in Figure 7.

Figure 7 Sentinel-2 imagery showing the active mining and pushback of Main Pit's west wall between (a) May 2021 and (b) November 2021

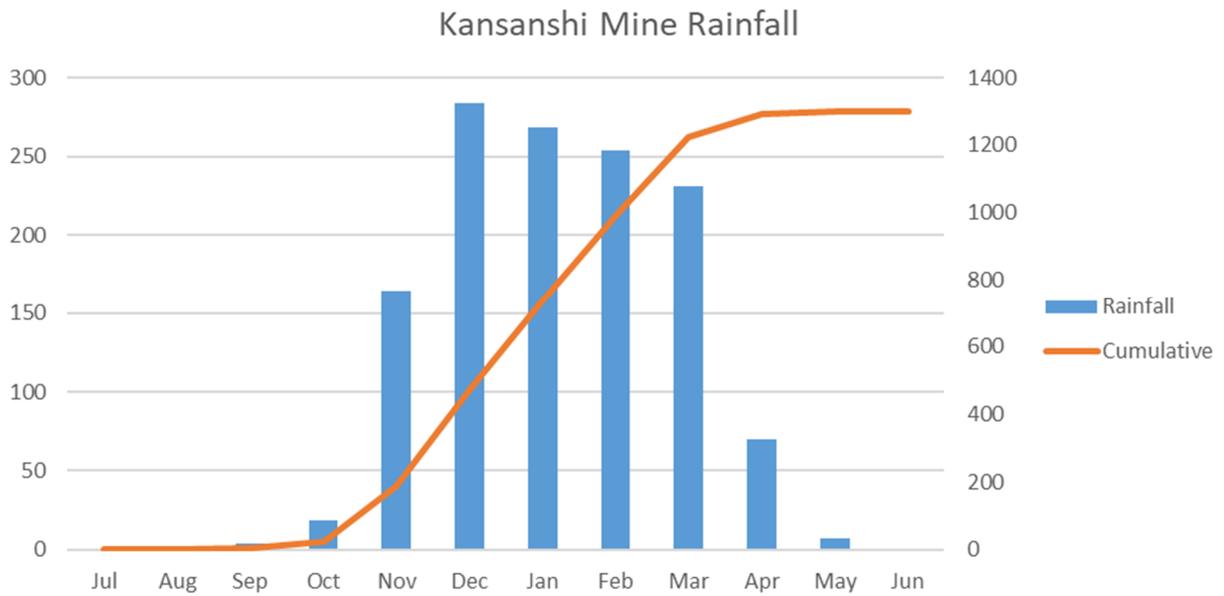
Zambia is classified as having a sub-tropical climate, which is characterised by seasonal rainfall. The wet season typically occurs between October and April. The average annual rainfall is approximately 1.3 m/year with the evaporation of approximately 1.1 m/year. Figure 14 shows the typical rainfall figures for the Kansanshi mine, measured using onsite instrumentation.

It was well noted that despite the impact of the rainy season, displacement rates did not return to pre-intervention levels, indicating that the slope had been successfully stabilised. This is highlighted in Figure 13 where the displacement rates stabilise around -56.3 mm/year with a further reduction to -40.3 mm/year, which is in sync with the abatement of the rainy period.

Figure 14 Cumulative and monthly rainfall (mm) for Kansanshi mine
