Stabilisation of open pit wall movements detected by InSAR using horizontal drains

The M15 west slope of Main Pit at First Quantum Minerals' Kansanshi copper–gold mine in Zambia is an actively mined eastward-facing wall. This study highlights the early warning provided by a monitoring service based on interferometric synthetic aperture radar (InSAR). Displacements were detected along the slope face, prompting an intervention using horizontal drains.

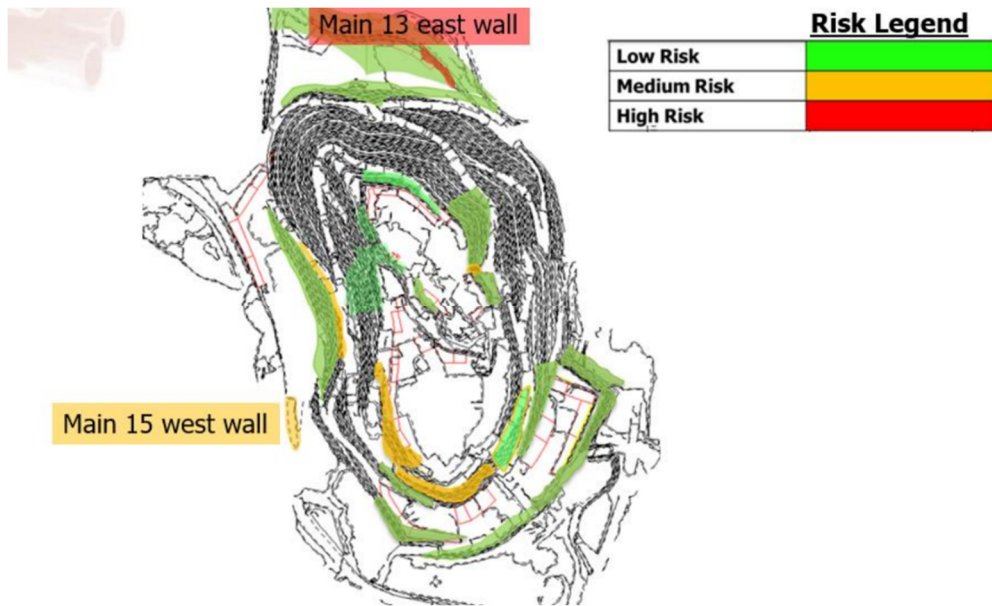
At the onset of the EWS monitoring in June 2022, the hazard levels of Main Pit were classified as shown in Figure 6. The M15 west wall was denoted to be a medium-risk zone due to observed daylighting structures.

Figure 6 Example of a hazard map for the Kansanshi Main Pit (First Quantum Minerals 2022)

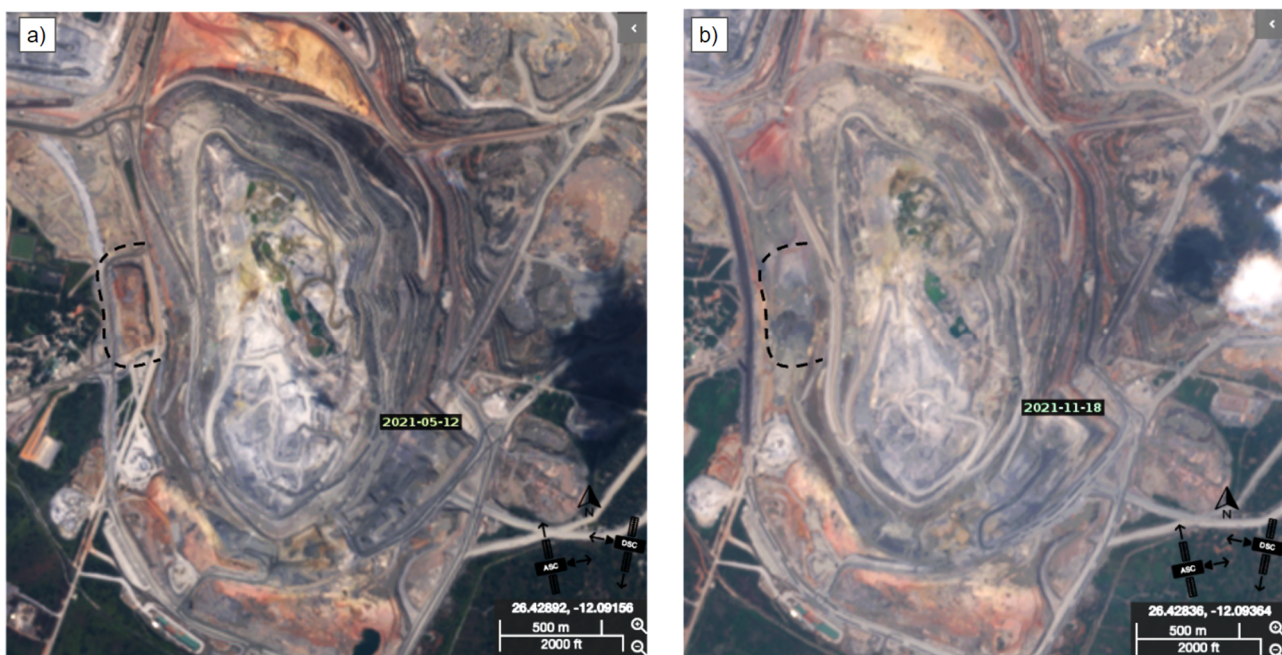
However, the current area known as the M15 west wall of Main Pit exhibited consistent displacement over the two-year period. This was of interest because the underlying area was originally a region just beyond the pit crest that housed a waste-rock dump, as illustrated by optical satellite imagery from Sentinel-2 in Figure 7.

Figure 7 Sentinel-2 imagery showing the active mining and pushback of Main Pit's west wall between (a) May 2021 and (b) November 2021

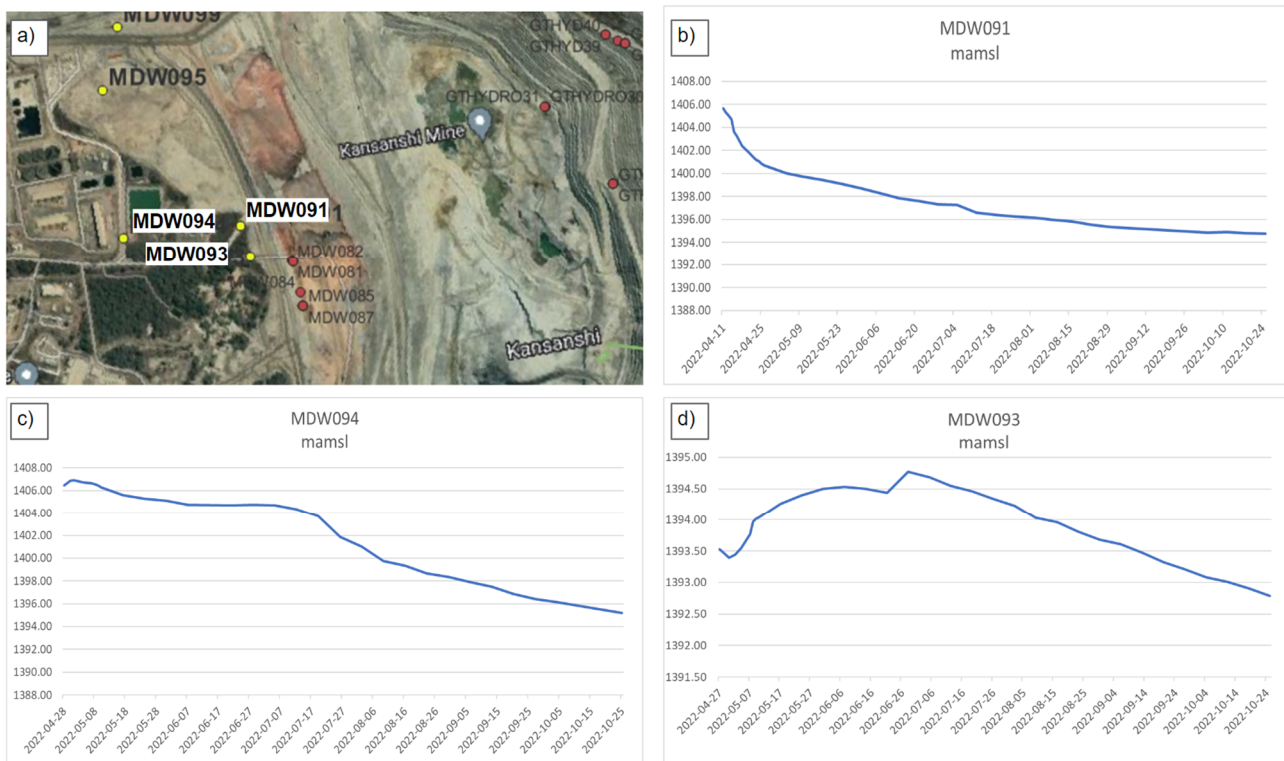
The drainage commenced in November 2022, with horizontal drains installed to a depth of 120 m and spaced 150 m apart at -5° inclination in specific locations. The drains were not cased. The response to groundwater elevations were monitored using the VWP network over the mine, as shown in Figure 11.

Figure 11 The location (a) and the time series of three VVPs: (b) MDW091; (c) MDW093; (d) MDW094

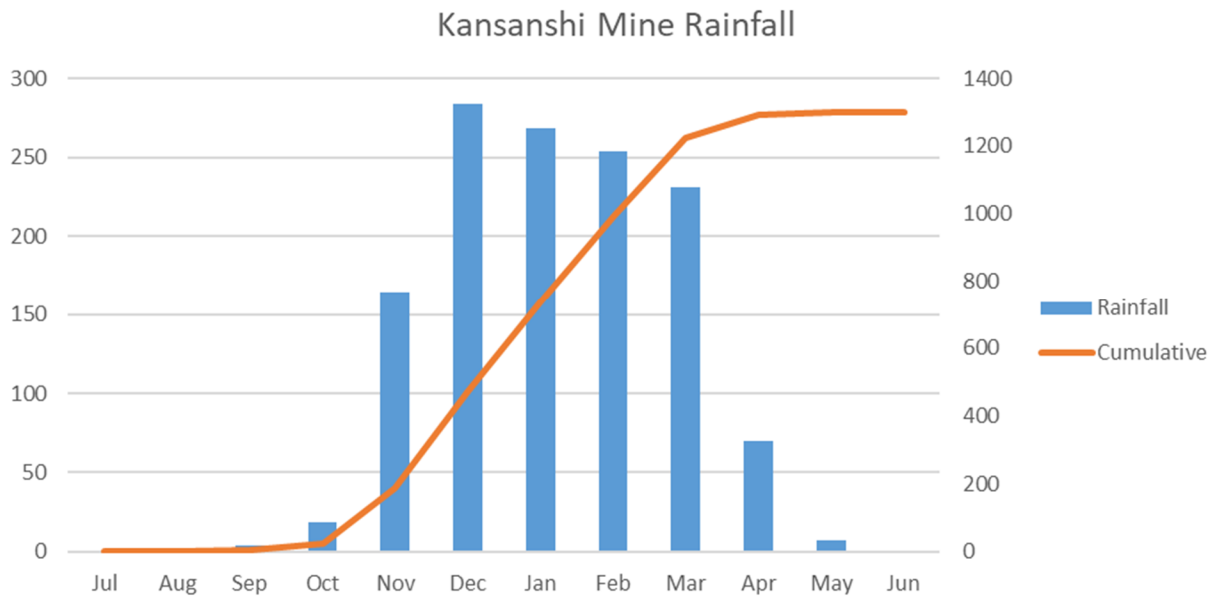
Zambia is classified as having a sub-tropical climate, which is characterised by seasonal rainfall. The wet season typically occurs between October and April. The average annual rainfall is approximately 1.3 m/year with the evaporation of approximately 1.1 m/year. Figure 14 shows the typical rainfall figures for the Kansanshi mine, measured using onsite instrumentation.

Figure 14 Cumulative and monthly rainfall (mm) for Kansanshi mine
